# Beechcraft **CLASS I SERVICE INSTRUCTIONS**

**No. 0448-211, Rev. 1  
ATA Code 32-30  
Recurring Inspection**

**SUBJECT:** LANDING GEAR - MAIN GEAR RETRACT MECHANISM - INSTALLATION OF UP-LOCK ROLLER LUBRICATING BOLT ASSEMBLY.

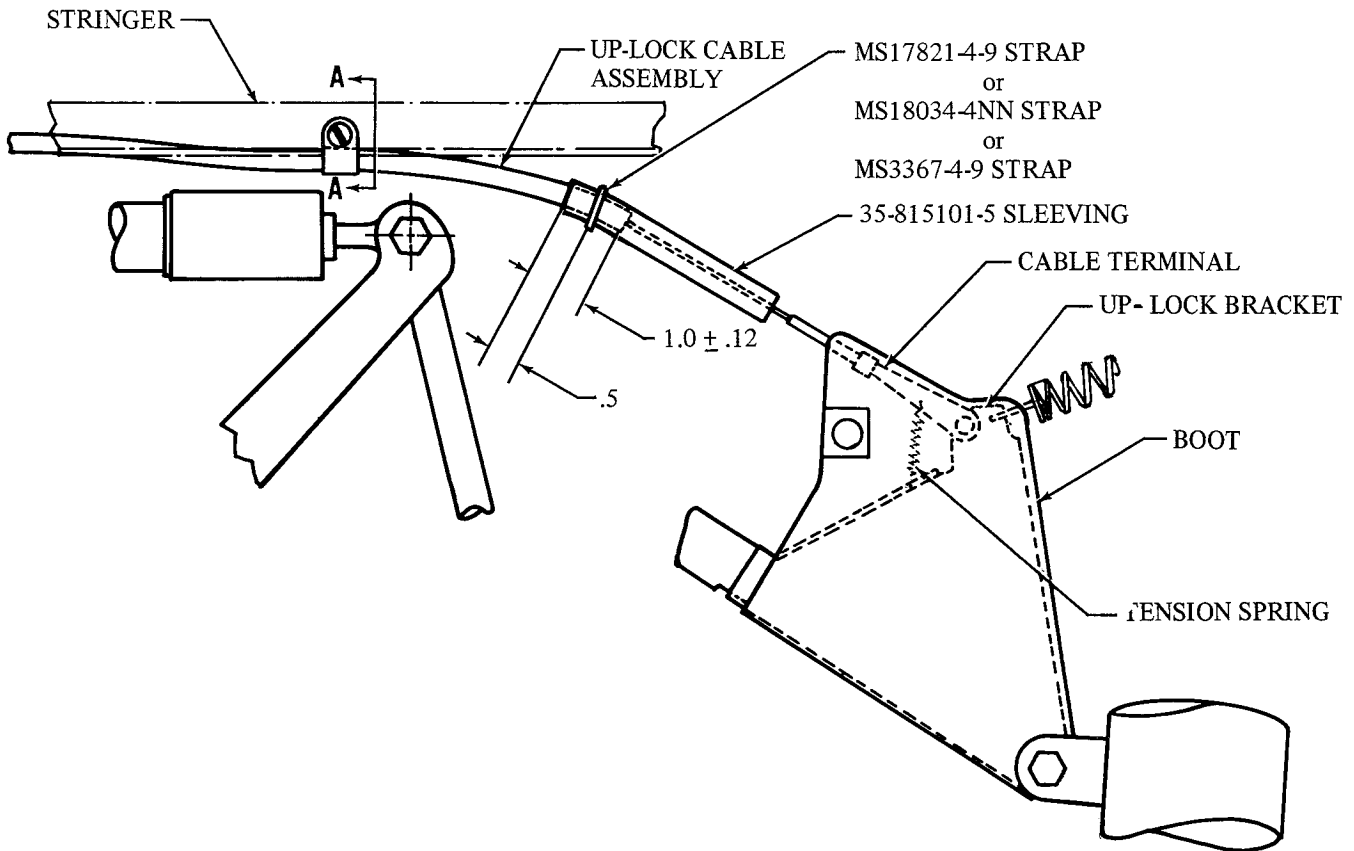
Modification of Main Gear Up-Lock Cable Assembly Installation

5. To prevent the up-lock cable from snagging on the up-lock roller lubrication fitting during cycling of the gears, modify the up-lock cable assembly installation as described below. (Refer to the illustration.)

VIEW A-A  
 ON SINGLE-ENGINE AIRPLANES  
 IF ANGLE IS INSTALLED, DISCARD  
 ANGLE AND REINSTALL CLAMP  
 AS SHOWN AT RIGHT.

c. Slip 35-815101-5 sleeving over the up-lock cable terminal and position on the up-lock cable assembly as shown in the illustration. Secure the sleeving with an MS17821-4-9, MS18034-4NN, or MS3367-4-9 strap (obtain locally).

f. On single-engine airplanes, check the up-lock cable assembly clamp installation shown in View A-A of the illustration. If the clamp is attached to an angle, remove and discard the angle, then attach the clamp directly to the stringer as shown using existing clamp attaching parts.
