ADVISORY CIRCULAR

43-16A

AVIATION MAINTENANCE ALERTS

**ALERT
NUMBER
354**

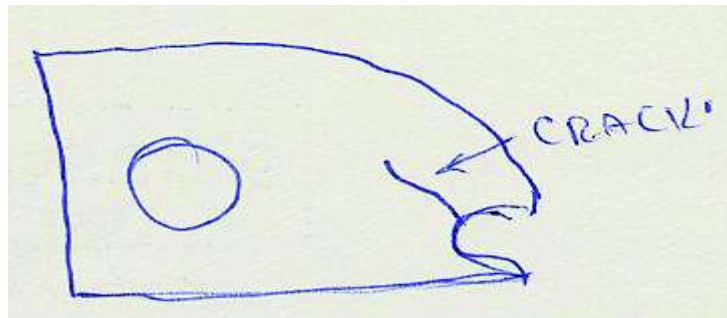
Beech: A36; Cracked Flap Leading Edge Nose Rib; ATA 5753

“At annual inspection, (we) found both the left and right flap attach point ribs cracked.” (An additional note indicates both the flange and web on these parts were cracked or broken. Flap Nose Rib P/N 35-165050-84; L/H and R/H P/N's 35-165050-78 and -79, respectively.)

Part Total Time: 3,144.9 hours.

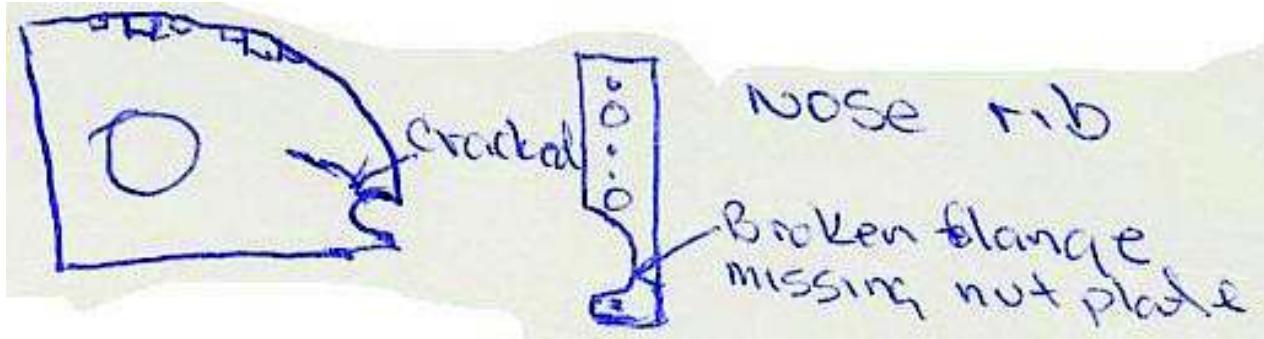
Beech: B95; Cracked Flap Leading Edge Nose Rib; ATA 5753

A repair station technician describes this same defect on two different B95 aircraft. *“(While) in flight, the pilot lowered the flaps and the aircraft started to roll to the right. The pilot noticed the right hand flap was (still) retracted, (so he returned the flap handle to the “up” position.)* The aircraft landed safely without incident.

Inspection found the R/H flap rod attach bracket broken and the flap nose rib nut plate flange torn. Inspection of the L/H side found the (same) nose rib flange and web cracked.” (Flap Nose Rib P/N 35-165050-84; L/H and R/H Flap P/N’s 95-160000-601 and -602, respectively.)

Part Total Time: 4,288.8 hours.

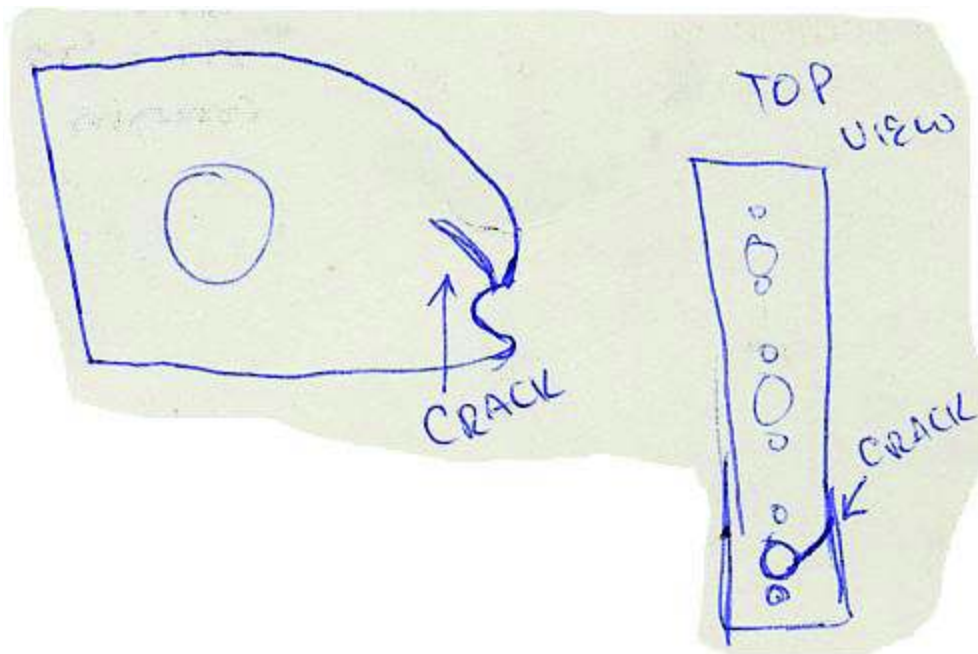
Beech: F33A; Cracked Leading Edge Nose Rib; ATA 5753

“An annual inspection found the R/H flap rod attach point rib cracked.” (Rib P/N 35-165050-84; Flap P/N 35-165050-606: both the flange and web were found to be cracked.)

Part Total Time: 5,255.1 hours.

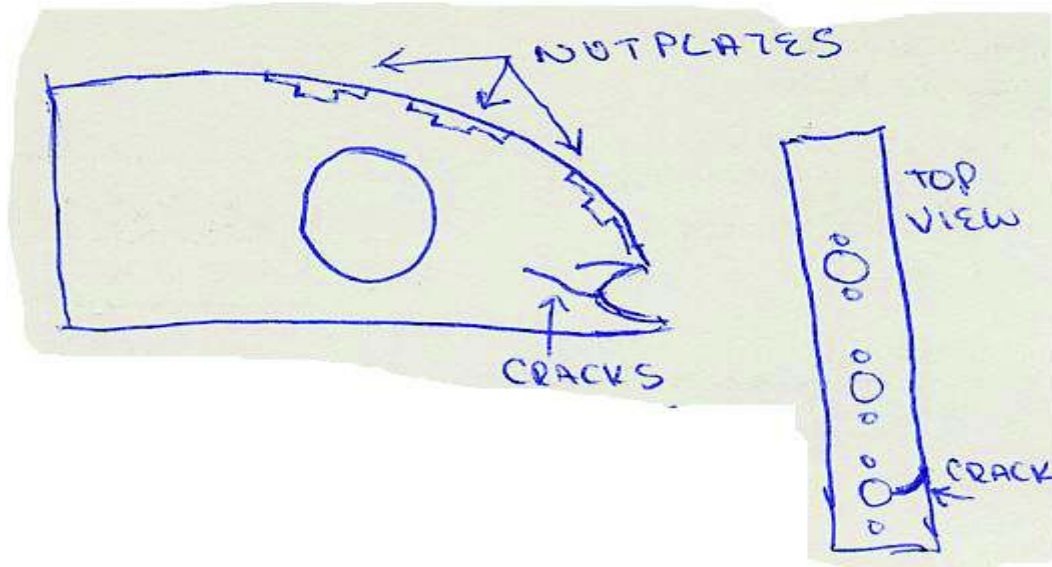
Beech: V35B; Cracked Flap Leading Edge Nose Rib; ATA 5753

“Annual inspection found the R/H flap rod attach point rib cracked.” (Rib P/N 35-165050-84; R/H flap P/N 35-165050-606)

(This technician also includes another such report of a cracked attach point for the flap actuating rod on a Beech 55 having 4,552.7 hours. Of these six above referenced Beech aircraft, the time ranged from 3,144.9—to 5,255.1 hours yielding 2,110.2 hours difference. This is awfully good anecdotal evidence arguing for close attention to these actuation attach points after a couple thousand hours.)
