No. 2460, Rev. I  
ATA Code 27-50

**SUBJECT:** FLIGHT CONTROLS - INSPECTION OF FLAP DRIVE CABLE/FLAP DRIVE MOTOR COUPLING CONNECTION

**Service Bulletin No. 2460, Rev. I**

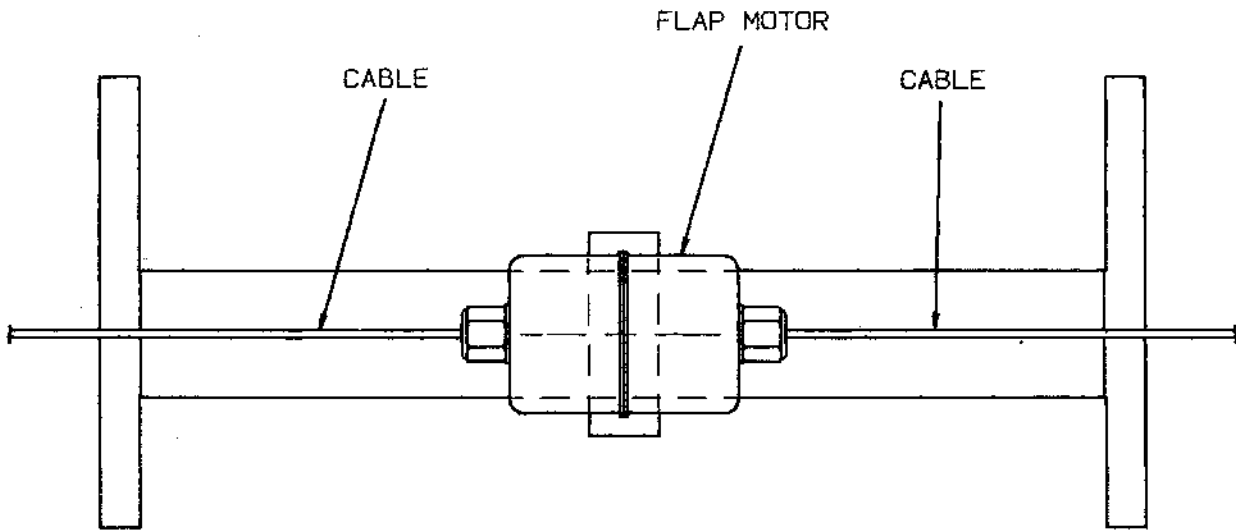
DETAIL A  
LOOKING FORWARD

AIRPLANES WITH EITHER OF THESE  
CONFIGURATIONS ARE NOT AFFECTED  
BY THIS SERVICE BULLETIN.

a. The flap drive cable configurations shown in Figure 1 are not affected by this Service Bulletin. If the airplane is configured as shown in View A or View B of Figure 1, proceed as follows:

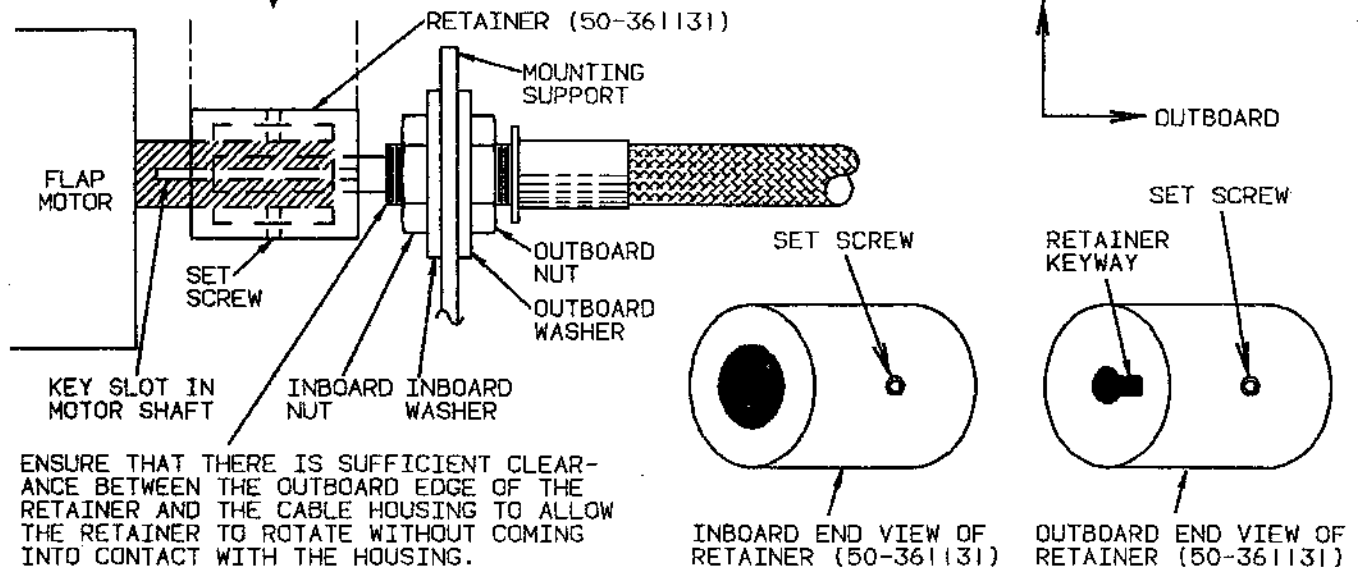
**Flap Drive Cable/Flap Drive Motor Coupling Connection**  
**Figure 2**

MODEL 60 AIRPLANES ARE EQUIPPED WITH A SPRING IN THIS LOCATION. ENSURE THAT THE SPRING IS INSTALLED.

AIRPLANES WITH THIS CONFIGURATION ARE AFFECTED BY THIS SERVICE BULLETIN.

5. Verify that retainers are installed and cable housings and hardware are arranged as shown in Figure 2. Ensure that the keyway slot is rotated 90° relative to the slot in the motor drive shaft. Clearance must exist between the outboard end of the retainer and the inboard

end of the flap cable housing. If retainers are not installed and/or if flap cable housings need to be repositioned, proceed in accordance with the FLAP DRIVE CABLE CONNECTION instructions in this Service Bulletin. Refer to the applicable Shop/Maintenance Manual for instructions to disconnect the flap cables from the flap motor drive shaft.

1. Connect the LH and RH flap drive cables to the flap drive motor as follows, using Figure 2 for component locations:

a. Install the outboard nut and washer as far as it will go on the threaded portion of the flap cable.

b. Insert the retainer through the mount support and onto the motor shaft as far as it will go. Align the retainer keyway with the key slot in the flap motor drive shaft and tighten one set screw temporarily.

c. While inserting the flap cable through the mount support, install the inboard washer and nut. Fully install the cable through the retainer and into the motor drive shaft until the keyway is just past the key slot in the retainer.

d. Loosen the set screw that was tightened in Step b. Ensure that the retainer is still installed on the motor shaft as far as it will go and rotate the retainer 90°.

e. Keep inboard pressure on the retainer and tighten both retainer set screws.

f. Secure the flap drive cable to the mounting support by tightening the nuts. Tighten the inboard nut to ensure that there is sufficient clearance between the out-

board edge of the retainer and the cable housing to allow the retainer to rotate without coming into contact with the cable housing. If the threaded part of the cable housing is not long enough to install the two nuts and washers, using a die, add 5/8-24 UNEF threads until .88 inch thread length is reached. Tighten the outboard nut against the mounting support.
