SERVICE BULLETIN

TITLE: LANDING GEAR - NOSE LANDING GEAR FORWARD RETRACT PLUNGER ROD INSPECTION / REPLACEMENT

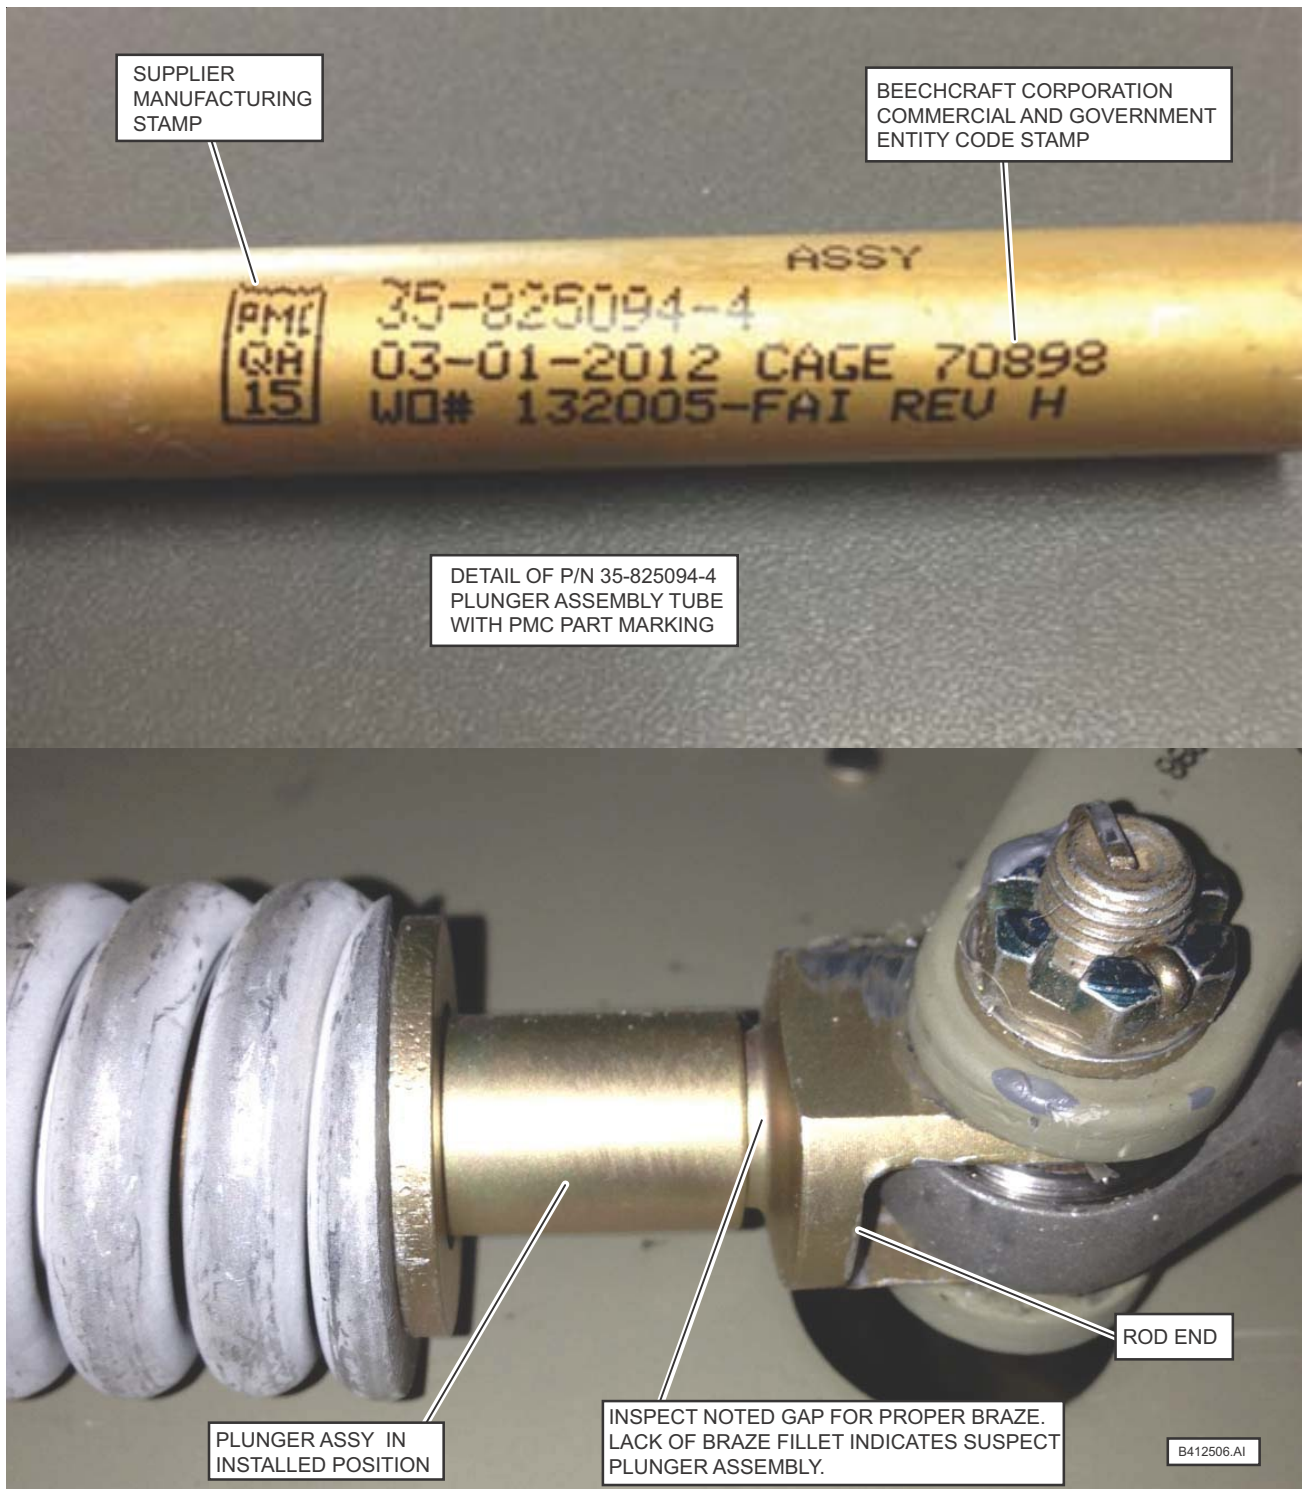
Figure 1

This Service Bulletin is being issued to inspect for, and if necessary, replace the P/N 35-825094-4 NLG plunger assemblies. An improperly brazed rod end might separate from the plunger assembly during landing gear operation. The plunger assembly is part of the NLG extension/retraction system and a separated push-pull retract rod assembly plunger rod end might result in a NLG disconnect from the retraction system that could allow the nose landing gear to collapse on landing.

- (3) Inspect the P/N 35-825094-4 NLG plunger assembly rod end at the intersection with the plunger tube and rod end in accordance with the following:
 - (a) For Bonanza models - Refer to Figure 4 for access points for the P/N 35-825094-4 NLG plunger assembly. Inspect for a braze (fillet) between the plunger tube and the rod end. Refer to Figure 1. Lack of a braze will be indicated by a recessed gap. If no braze is present, proceed to Step (4) to remove and replace the P/N 35-825094-4 NLG plunger assembly with a properly brazed P/N 35-825094-4 NLG plunger assembly. If a braze fillet is present, proceed to Step (16).

PMC P/N 35-825094-4 NLG Plunger Assembly Braze Inspection

- (9) Remove plunger assembly from retract rod. Discard cotter pin but retain other hardware.
- (10) Red tag and return ONLY the removed P/N 35-825094-4 plunger assembly to HBP&D for warranty consideration. Refer to Paragraph 1.M. for return address.

- (11) Replace ONLY the P/N 35-825094-4 plunger assembly using hardware retained from Step (9) and new cotter pin, P/N MS24665-132. Refer to applicable MM Chapter 32-00-00, Figure 3, and Figure 4 (Bonanza) or Figure 5 (Baron).

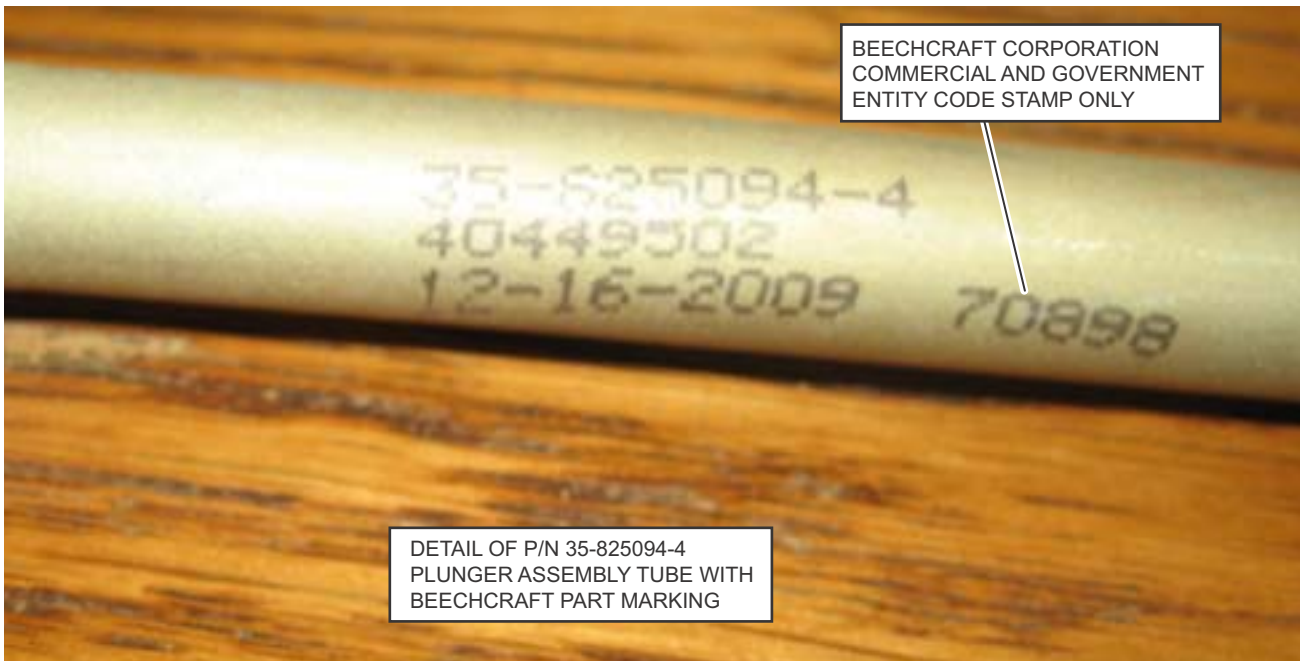
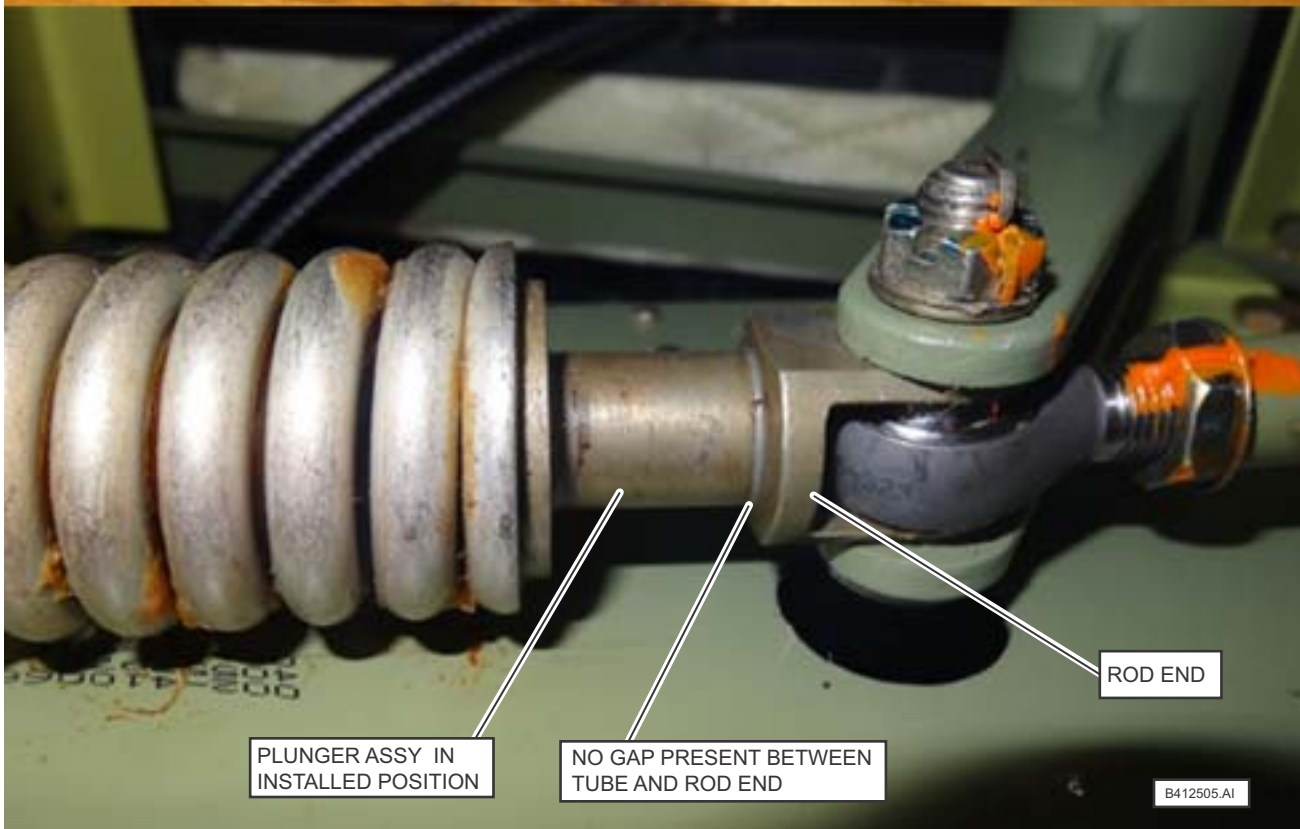
Figure 2

- (b) For Baron models - Refer to Figure 5 and remove access panel 15 by removing and retaining attachment screws. Retain the access panel and attachment screws for reinstallation following inspection/replacement. Inspect for a braze (fillet) between the plunger tube and the rod end. Refer to Figure 2. Lack of a braze will be indicated by a recessed gap. If no braze is present, proceed to Step (4) to remove and replace the P/N 35-825094-4 NLG plunger assembly with a properly brazed P/N 35-825094-4 NLG plunger assembly. If a braze fillet is present, proceed to Step (16).

Beechcraft P/N 35-825094-4 NLG Plunger Assembly Braze Inspection

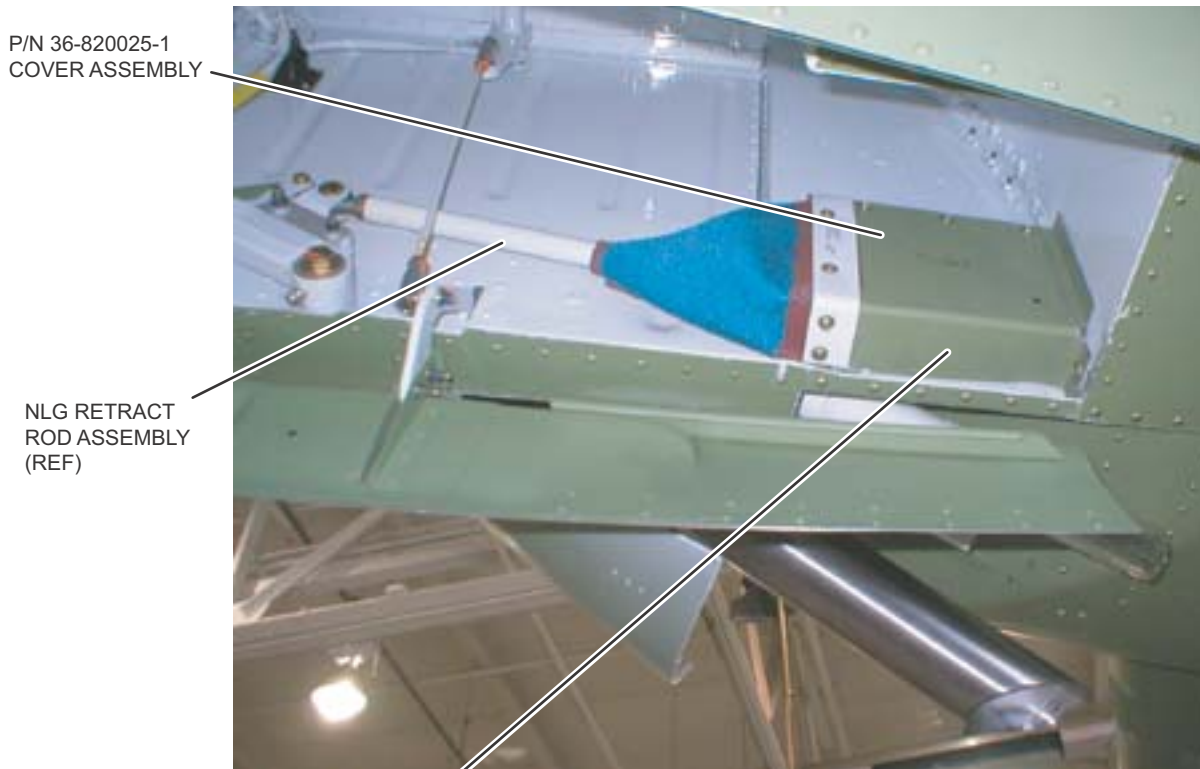
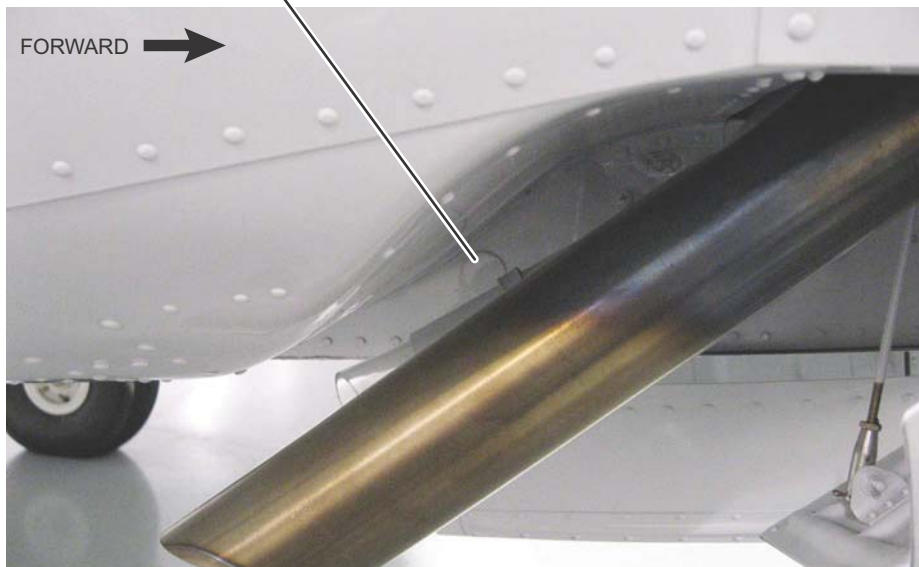
Figure 4

ACCESS FOR REMOVING AFT BOLT

Access Points for Removal of Retract Rod Assembly in Nose Wheel Well

- G58 Baron: Perform: *ELECTRICAL POWER - DISCONNECT*. Refer to MMS Chapter 24-35-00;
 - 58 Baron: Disconnect batteries. Refer to MM Chapter 24-30-00.
- (7) Gain access to NLG plunger assembly through nose wheel well (Bonanza and Baron) and by removing floorboards, if necessary, under the copilot's rudder pedals (Baron only). Refer to Figures 4 and 5.

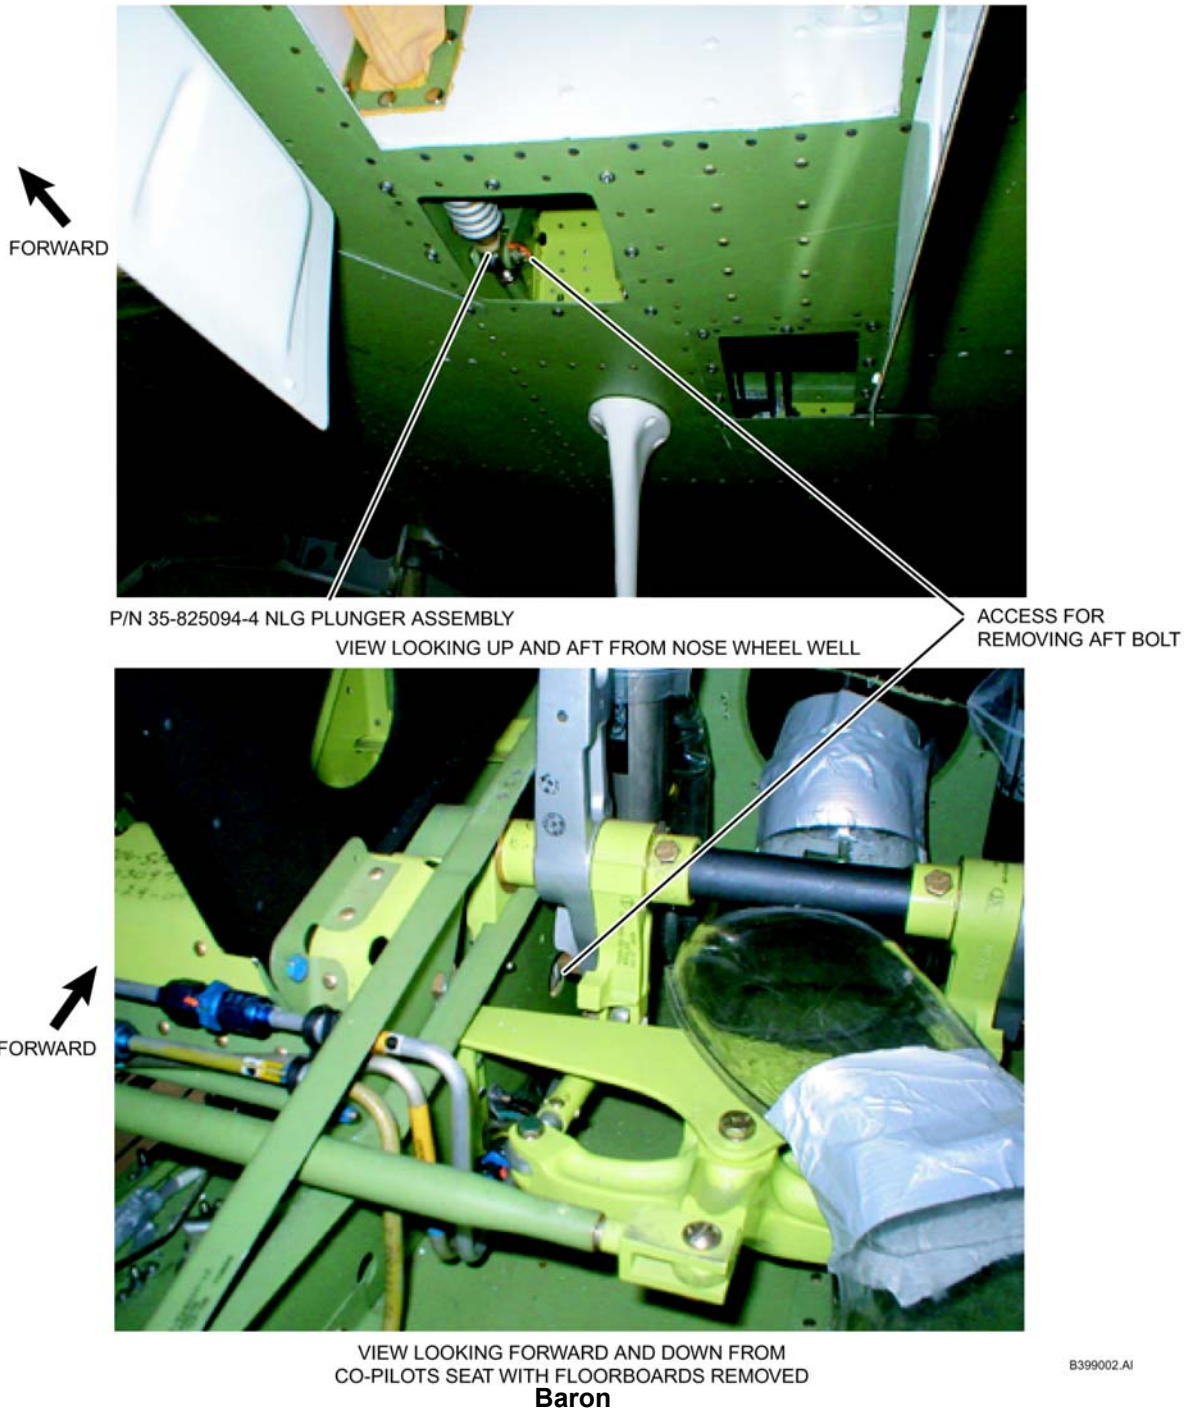
Figure 5

Access Points for Removal of Retract Rod Assembly in Nose Wheel Well
