Safety Communique

December, 2010

SUBJECT: FLAP ACTUATOR ATTACHMENT BRACKET AND NOSE RIB ASSEMBLY

Safety Communiqué No. 313

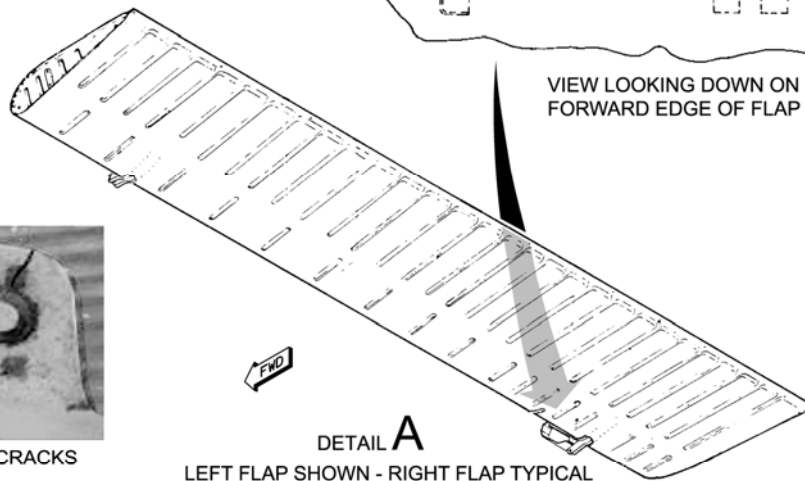
DETAIL A
LEFT FLAP SHOWN - RIGHT FLAP TYPICAL

AREA OF POTENTIAL CRACKS
DETAIL B

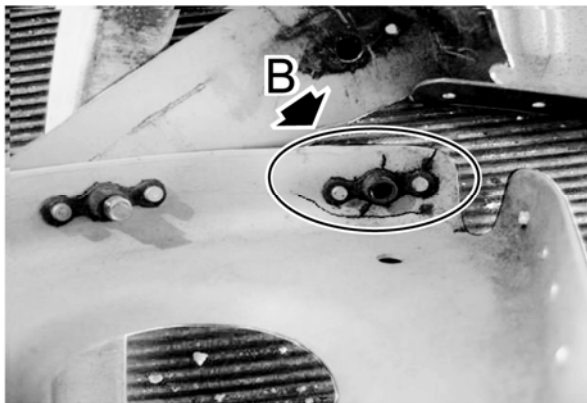
HBC has received ten reports from the field of crack damage on the part number (P/N) 35-165050-84 nose rib assembly for the flap actuator attachment bracket. Refer to Figure 1. In October 2007, a pilot reported a split flap condition during flap extension to a 14 CFR Part 145 repair station. The repair station found the flap actuator mounting plate cracked. The mounting plate is secured to the flap by three screws, which are attached to the nose rib assembly by nutplates. Further inspection of the flap revealed cracks in this nose rib. Since the repair station regularly performed inspections on several models of HBC airplanes, they began paying particular attention during inspections to these areas and submitted six service difficulty reports on Model 33, 35, 36, and 95 airplanes. In January 2008, Advisory Circular 43-16A was issued detailing these reports. The flap actuator mounting is of similar design on all of the reported airplanes. Through May 2010, this repair station addressed four additional service difficulty reports for cracks found on the same part number nose rib assembly.

Flap leading edge nose rib and/or the flap actuator mounting bracket cracking has the potential to cause the part to become disconnected, and could result in a split flap condition.

EXAMPLE OF CRACK IN P/N 35-165050-84 NOSE RIB

HBC reminds maintenance facilities of the importance of adhering to existing inspection and maintenance procedures in the applicable airplane series Maintenance Manual or Shop Manual and specified spare parts in the applicable Illustrated Parts Catalog when replacing components during routine maintenance.

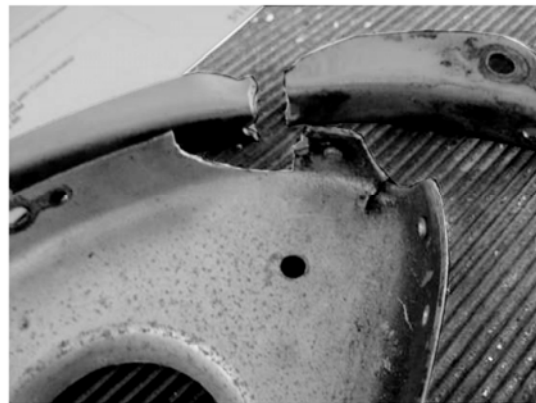
EXAMPLE OF TORN FLANGE IN P/N 35-165050-84 WITH NUTPLATE MISSING
