ALERT SERVICE BULLETIN No. 081 Rev. A

Alternator Castellated Hex-Nut Inspection

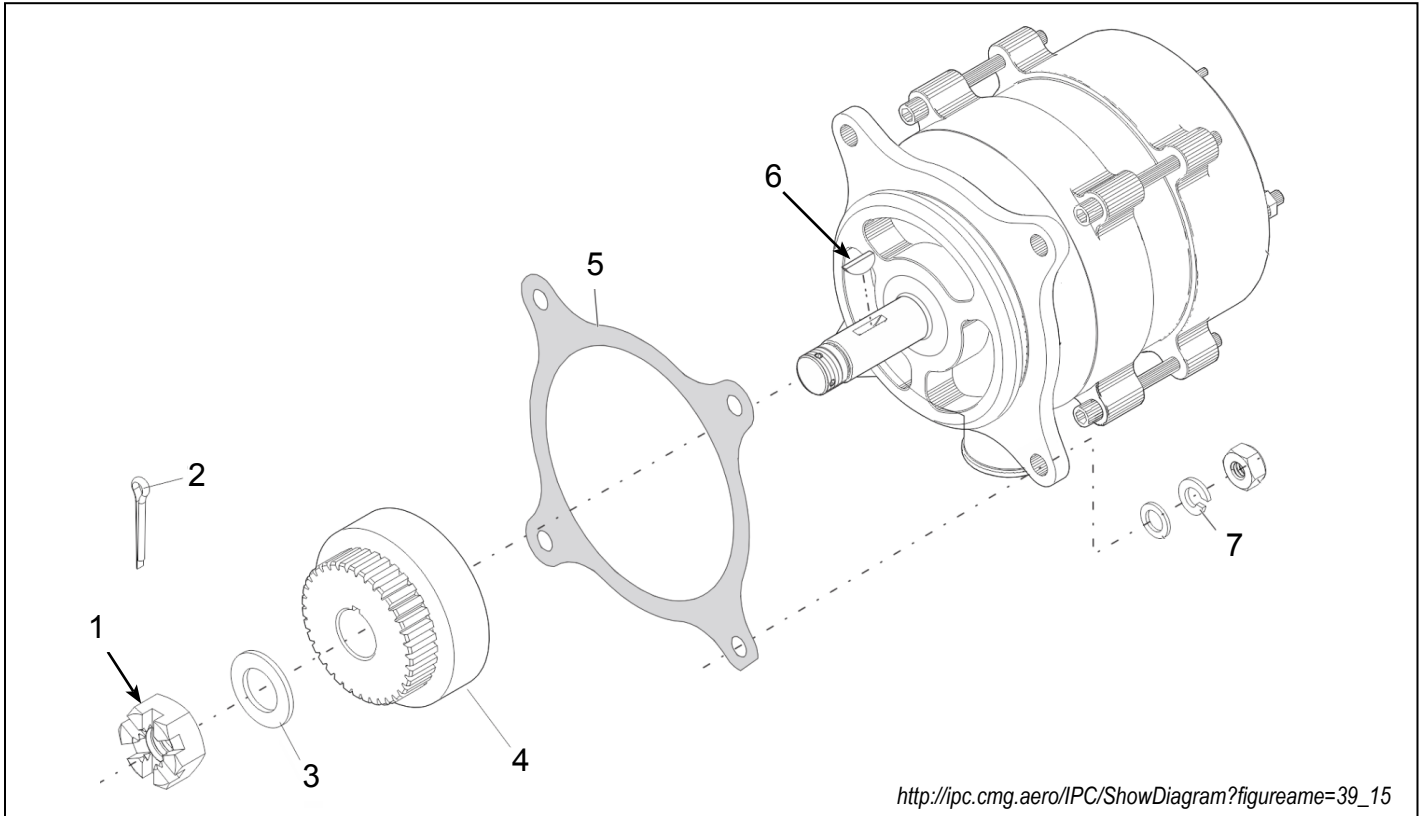
Figure 1 - Alternator, Typical - Continental Aerospace Technologies

- (1) Alternators listed in section 1.A could contain a castellated hex-nut (1, Figure 1) that does not torque flush with the thrust washer (3). This condition could compromise the integrity of the drive coupling retention system.
 - (a) Loss of drive coupling retention may result in engine damage and/or unexpected loss of engine power.
- (2) This ASB is to advise the field of a known condition and to supply inspection criteria to identify affected alternators.

- (5) Remove and discard from alternator; cotter pin (2), castellated hex-nut (1), thrust washer (3), and woodruff key (6). Refer to Figure 1.
- (6) Inspect drive coupling (4) in accordance with applicable service instructions.
- (7) Install new replacement components not affected by this ASB onto the alternator in accordance with applicable engine manufacturer's maintenance manual. Refer to Table 1 - Materials Required.

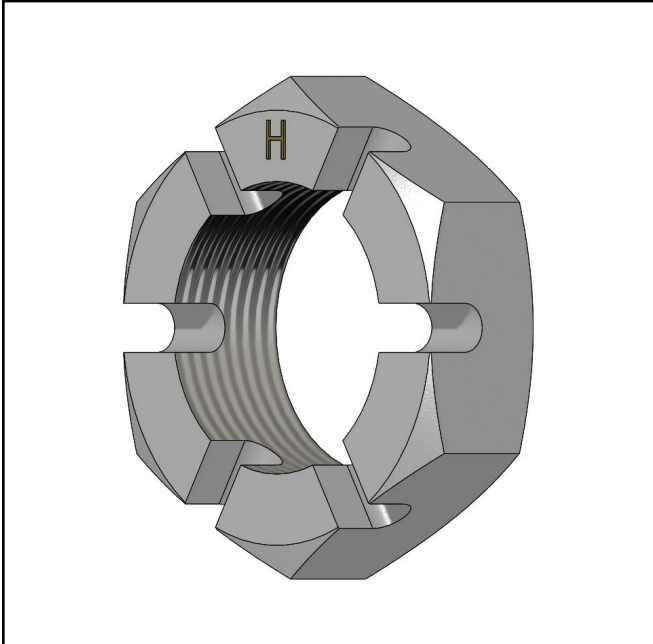
Figure 3 - Laser Etched "H"

- (1) Remove the alternator from the engine in accordance with the latest revision of the aircraft and/or engine manufacturer's maintenance manual.
- (2) Inspect castellated hex-nut (1). If one the following indicators is present, the alternator is in compliance with this ASB. Refer to Figures 3 thru 5.
 - (a) Hex-nut (1) is laser etched with the letter "H";
 - (b) Hex-nut (1) is stamped with a center-punch;
 - (c) Hex-nut (1) is roll-stamped with the letters "AD".
- (3) If any indicator stated above **is not** present, proceed to 3.B.(4). If one of the indicators stated above **is** present, continue to 3.B.(8).
- (4) Using a .002 in. (.0508 mm) feeler-gauge, measure the gap between the nut thrust face and the thrust washer at each of the six hex-nut flats. Refer to Figure 6.

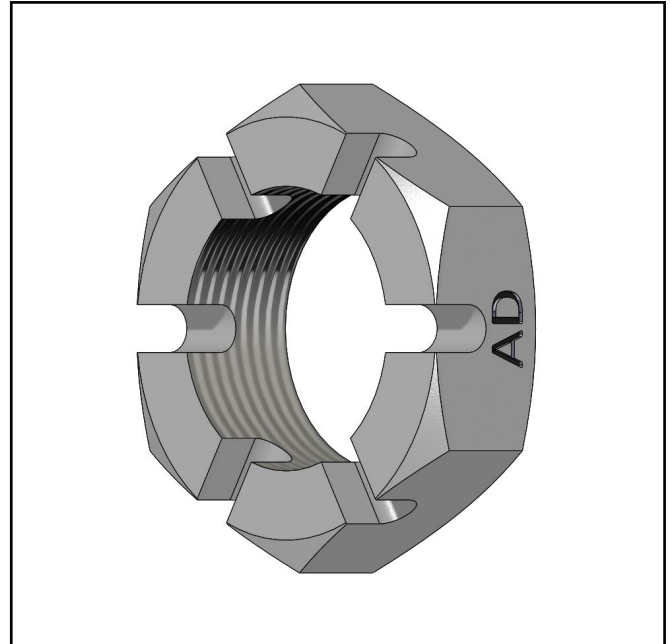
Figure 4 - Roll-Stamped "AD"

- B. Revise 3.B.2.(c) to reflect change to Figure 4:
 - (1) Change to: Hex-nut (1) is roll-stamped with the letters "**AD**".
 - C. Add task 3.B.(6) for clarification:

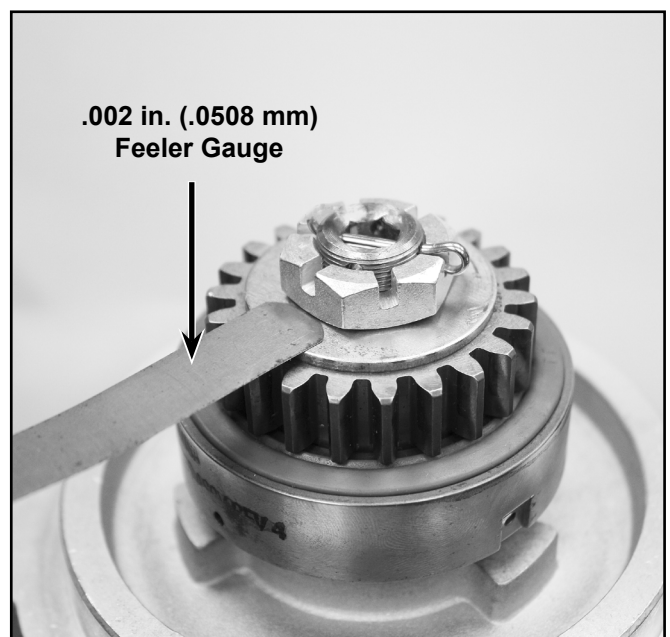
Figure 6 - Gap Measurement

- (a) If the measurement at any nut flat is \geq .002 in. (.0508 mm), continue to 3.B.(5).
- (b) If the measurement at each nut flat is $<$.002 in. (.0508 mm), no corrective action is required.
 - 1) Using an automatic center punch, punch the face of the hex-nut (1) so that it will be easily identified for future reference (Refer to Figure 5). Continue to 3.B.(8).
