From: Savvy Aviation support@savvyaviation.com
Subject: Melted Piston
Date: January 25, 2022 at 2:00 PM
To: [REDACTED]

The aluminum in the oil filter clearly came from the #1 piston, so why was Roy's shop so intent on tearing down the engine?

Melted Piston

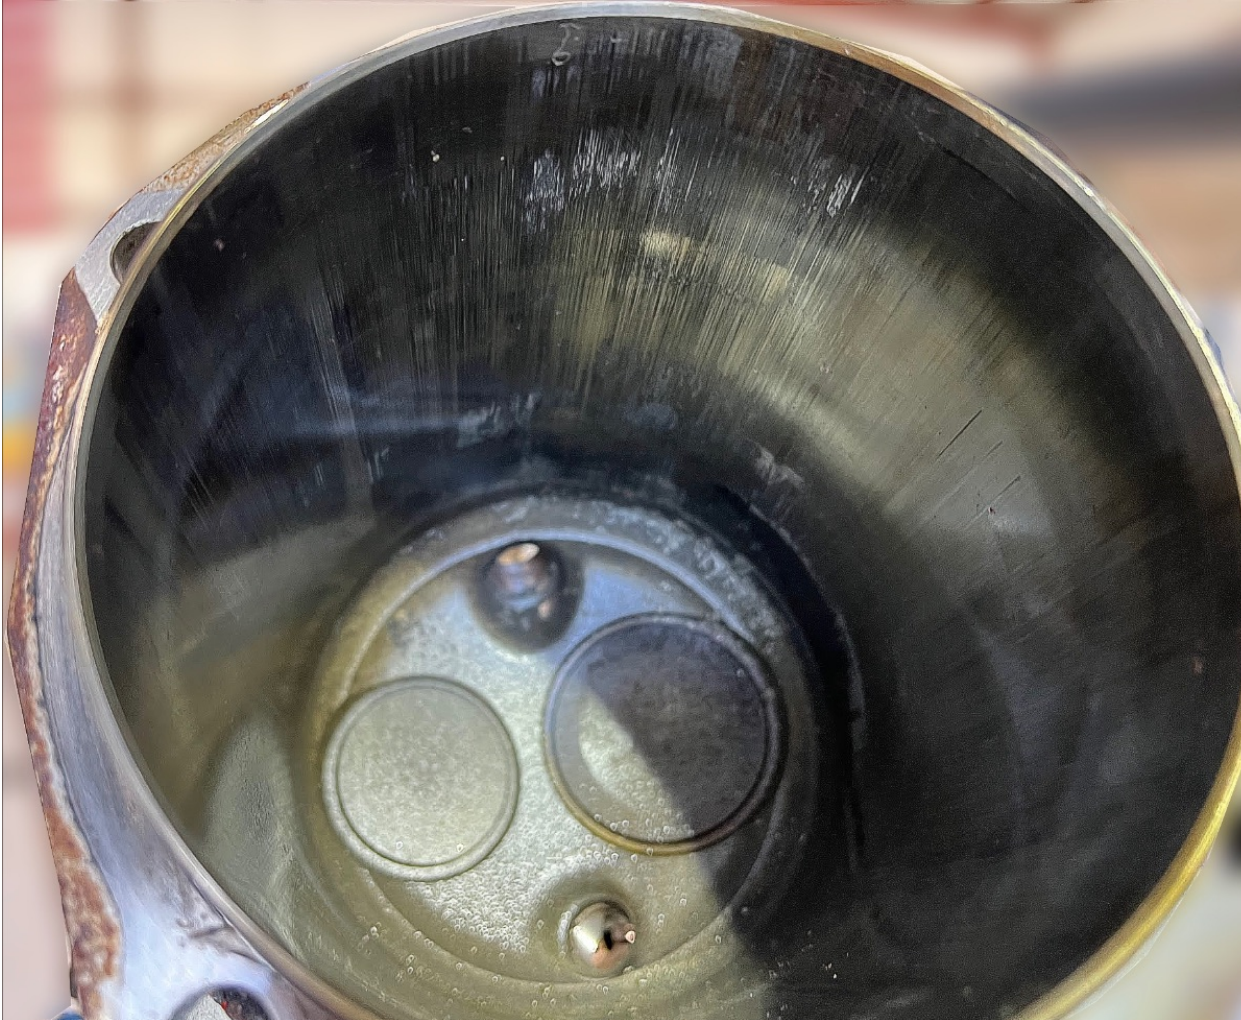
"A borescope inspection of right engine cylinder #1 revealed scoring of the cylinder walls and some corner melting of the piston," Roy continued. "The shop asked for permission to pull the cylinder, which I approved since it seemed obvious that this needed to be done."

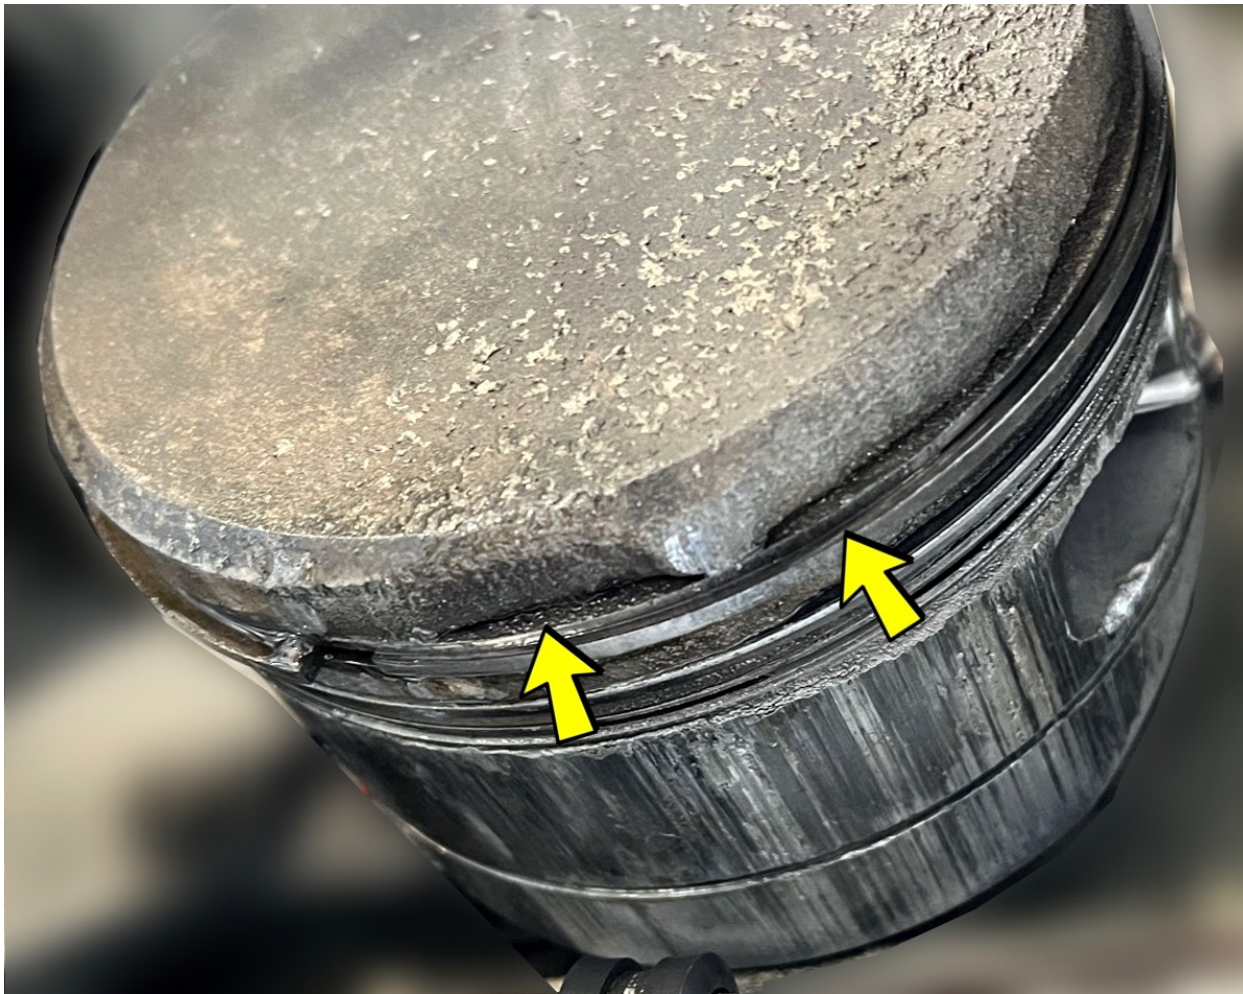
“With the cylinder removed, the full extent of piston damage was obvious,” Roy noted. “The engine had 1,540 hours SMOH, but ironically had a top overhaul only 100 hours ago due to the ECi cylinder AD. At this point it’s obvious that the #1 cylinder needs to be addressed, and I’m thinking it should probably be scrapped and replaced due to the way-over-red-line CHT and consequent metallurgical trauma. The piston is obviously trashed, too.”

“From the piston photos,” said Brandon, “it sure looks to me like detonation or pre-ignition.”

"Based on the photos, the #1 cylinder clearly experienced a pre-ignition event, which is the only thing we know of that can cause such a rapid and profound CHT rise," Mike posted to Roy's ticket. "The pre-ignition event caused corner melting of the piston, which caused molten aluminum to get into the sump and also cause the #1 compression ring to become locked in its groove, resulting in scoring of the cylinder barrel by the immobilized compression ring."

"Since we know the source of the metal, and it doesn't appear to have traveled through the engine," Brandon continued, "my suggestion is that you have the shop flush the oil sump with solvent, install a new piston, pin and cylinder, service the engine with clean oil and a new oil filter, then run it on the ground for about 20 minutes and cut open the oil filter. If the filter is relatively clean, install a new filter and fly the airplane for two hours in the vicinity of the airport to break-in the new cylinder, then cut open the filter again. If the filter is still relatively clean, you should be good to go. I'm guessing that'll be the case. But if it's not, then you should consider an

"The #1 cylinder and piston are clearly trash," Mike continued. "The piston pin is stuck because the piston experienced severe overheating and warping, and may need to be extracted forcefully to remove the piston. Once the piston has been removed, it might be prudent to remove the #1 connecting rod. This will accomplish two things. First, it will provide assurance that the #1 connecting rod was not bent or otherwise damaged either by the violent pre-ignition event or by the forceful piston pin extraction procedure. Second, it will provide a good opportunity to inspect the #1 connecting rod big-end bearing and the #1 crankpin. If the bearing is not contaminated and the crankpin is not scored, you can be quite certain that none of the other rod or main bearings are contaminated or damaged and you can relax that there's no further collateral damage."

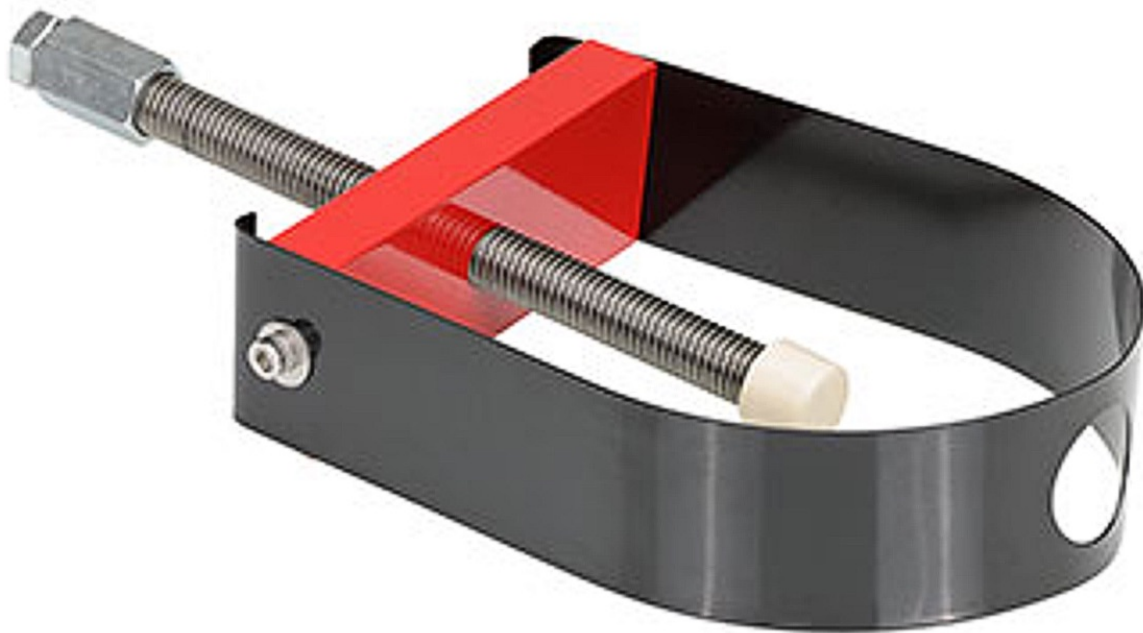
"I visited the shop this morning," Roy posted. "They're trying to soak the piston pin in penetrating oil but so far it is frozen. The piston rotates freely on the piston pin, but they can't get it off."

"That's not surprising given how badly overheated that piston was," said Brandon. "I use [this tool](#) on a regular basis to extract stubborn piston pins..."
