MANDATORY**MEL-74-03****TITLE**

IGNITION - TRANSMITTAL OF CONTINENTAL MOTORS SB19-02A, LYCOMING SB 637, AND CHAMPION AEROSPACE SLICK SERVICE BULLETIN SB1-19

November 19, 2019

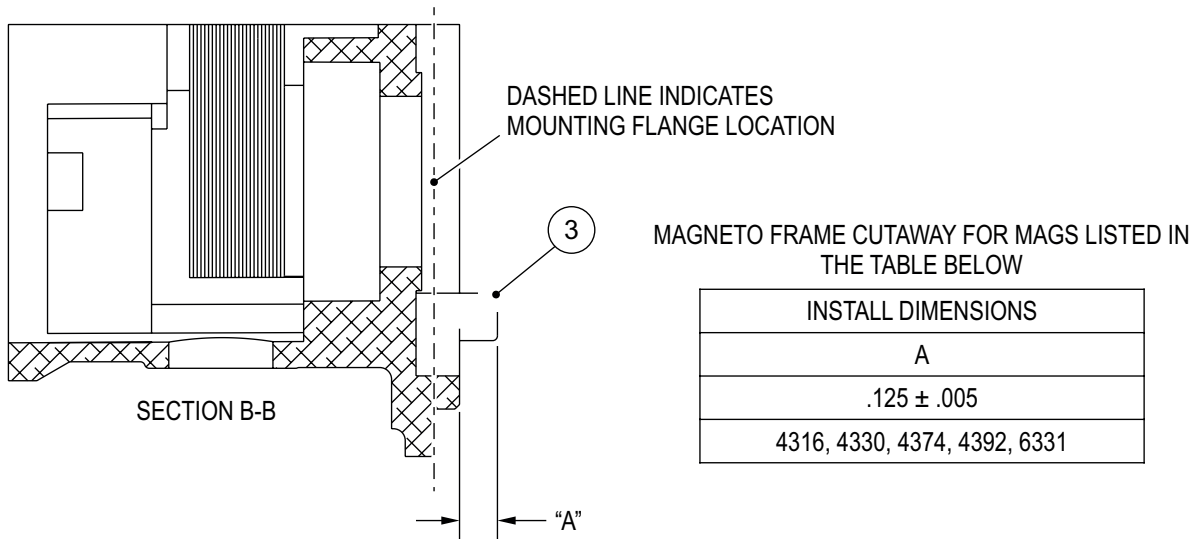
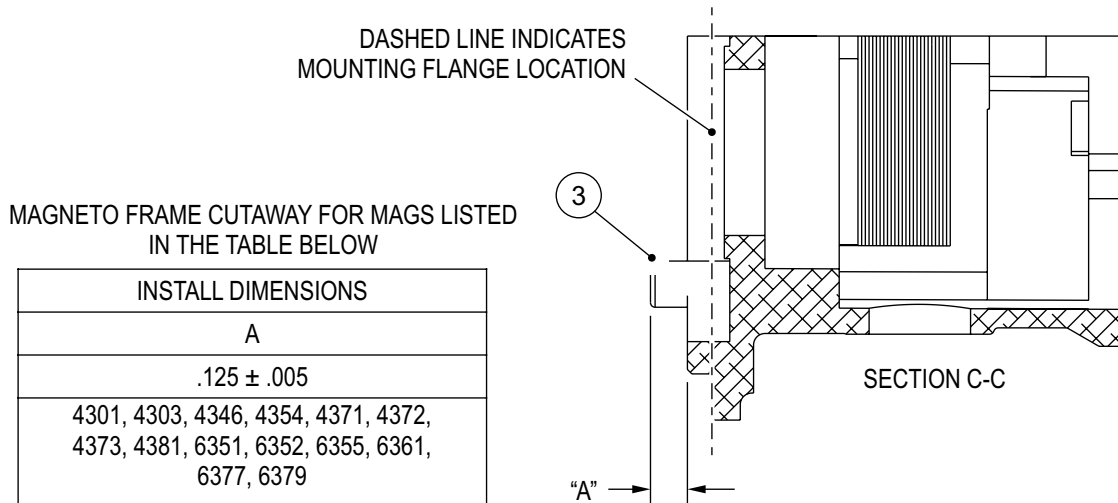
FIGURE 1. MAGNETO FRAME CUTAWAY SECTIONS B-B AND C-C

USE A CALIBRATED MEASURING DEVICE TO MEASURE DISTANCE "A", AS SHOWN IN CUTAWAY SECTIONS B-B AND C-C. MAKE SURE THE FRAME SURFACE IS FREE OF CONTAMINANTS. ANY MEASUREMENT GREATER THAN 0.130 INCH OF ANY PART OF THE STOP PIN (3), THE MAGNETO SHOULD BE REMOVED FROM SERVICE AND RETURNED TO CHAMPION FOR WARRANTY.

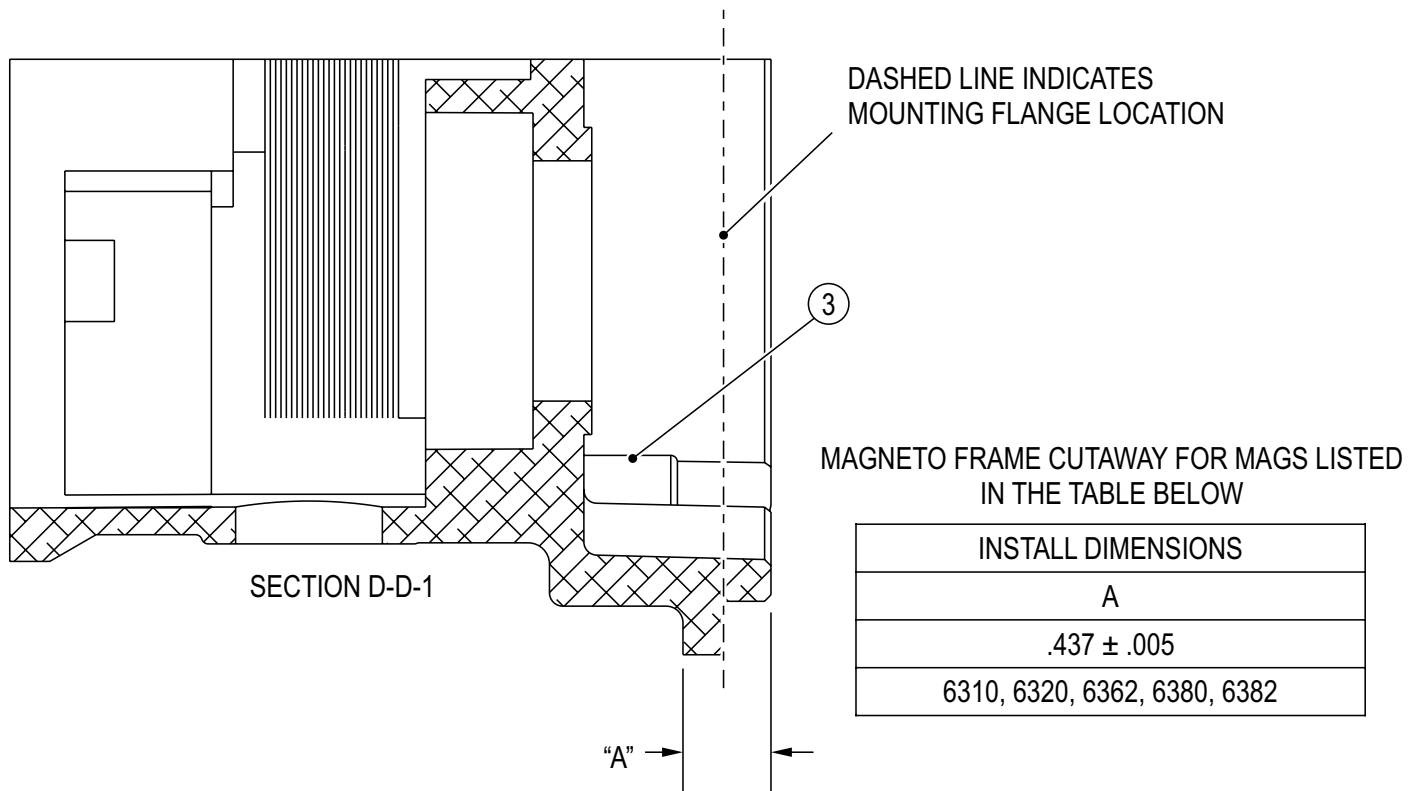
FIGURE 2. MAGNETO FRAME CUTAWAY SECTION D-D-1

USE A CALIBRATED MEASURING DEVICE TO MEASURE DISTANCE "A", AS SHOWN IN CUTAWAY SECTION D-D-1. MAKE SURE THE FRAME SURFACE IS FREE OF CONTAMINANTS. ANY MEASUREMENT LESS THAN 0.432 INCH OF ANY PART OF THE STOP PIN (3), THE MAGNETO SHOULD BE REMOVED FROM SERVICE AND RETURNED TO CHAMPION FOR WARRANTY.

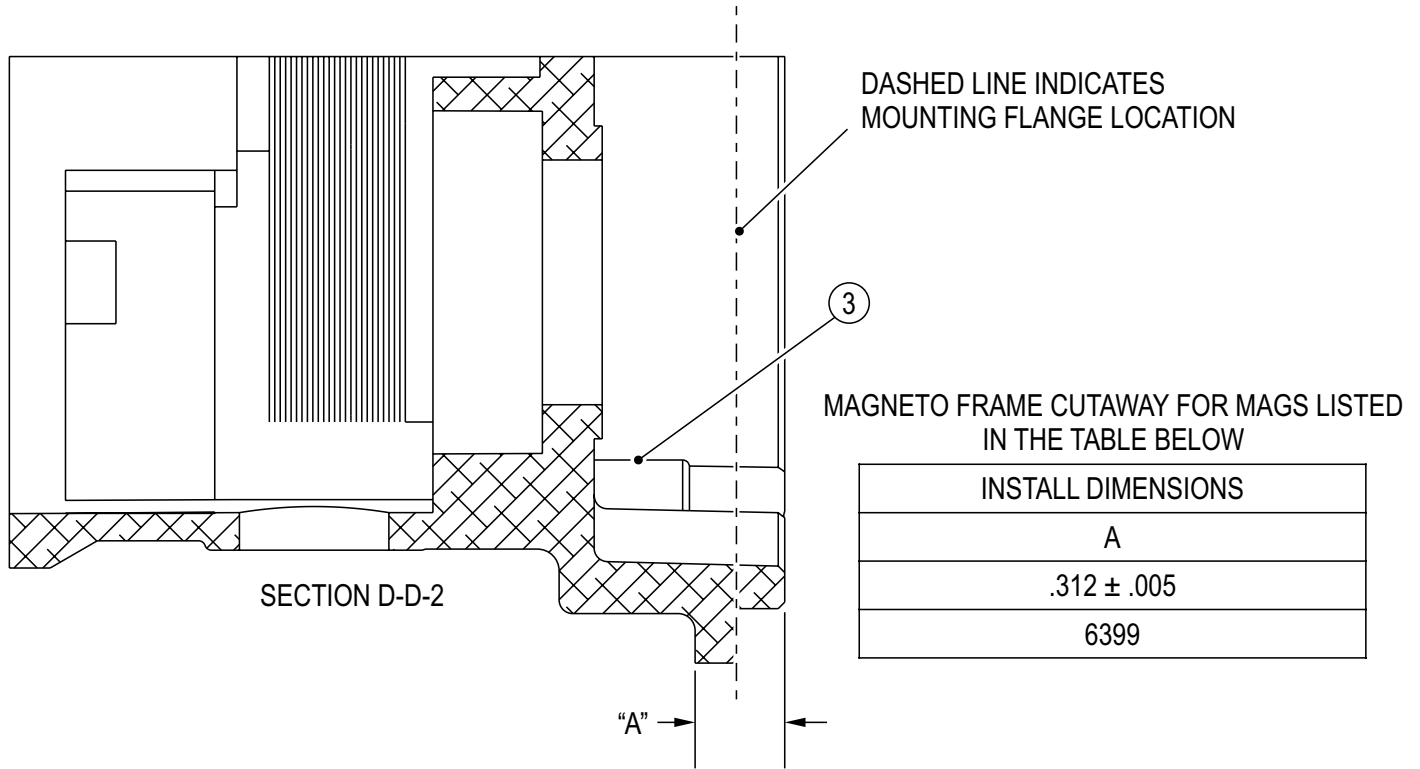
FIGURE 3. MAGNETO FRAME CUTAWAY SECTION D-D-2

USE A CALIBRATED MEASURING DEVICE TO MEASURE DISTANCE "A", AS SHOWN IN CUTAWAY SECTION D-D-2. MAKE SURE THE FRAME SURFACE IS FREE OF CONTAMINANTS. ANY MEASUREMENT LESS THAN 0.307 INCH OF ANY PART OF THE STOP PIN (3), THE MAGNETO SHOULD BE REMOVED FROM SERVICE AND RETURNED TO CHAMPION FOR WARRANTY.

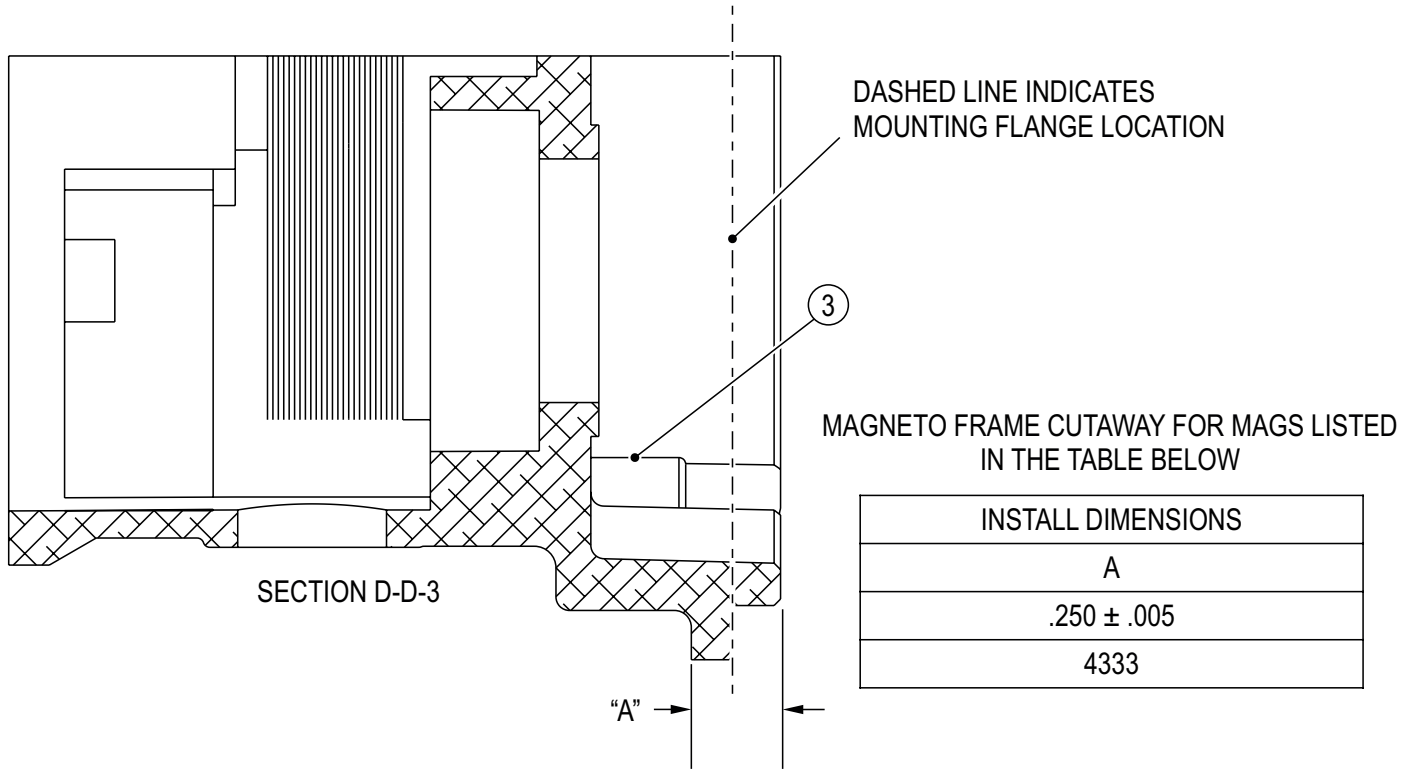
FIGURE 4. MAGNETO FRAME CUTAWAY SECTION D-D-3

USE A CALIBRATED MEASURING DEVICE TO MEASURE DISTANCE "A", AS SHOWN IN CUTAWAY SECTION D-D-3. MAKE SURE THE FRAME SURFACE IS FREE OF CONTAMINANTS. ANY MEASUREMENT LESS THAN 0.245 INCH OF ANY PART OF THE STOP PIN (3), THE MAGNETO SHOULD BE REMOVED FROM SERVICE AND RETURNED TO CHAMPION FOR WARRANTY.

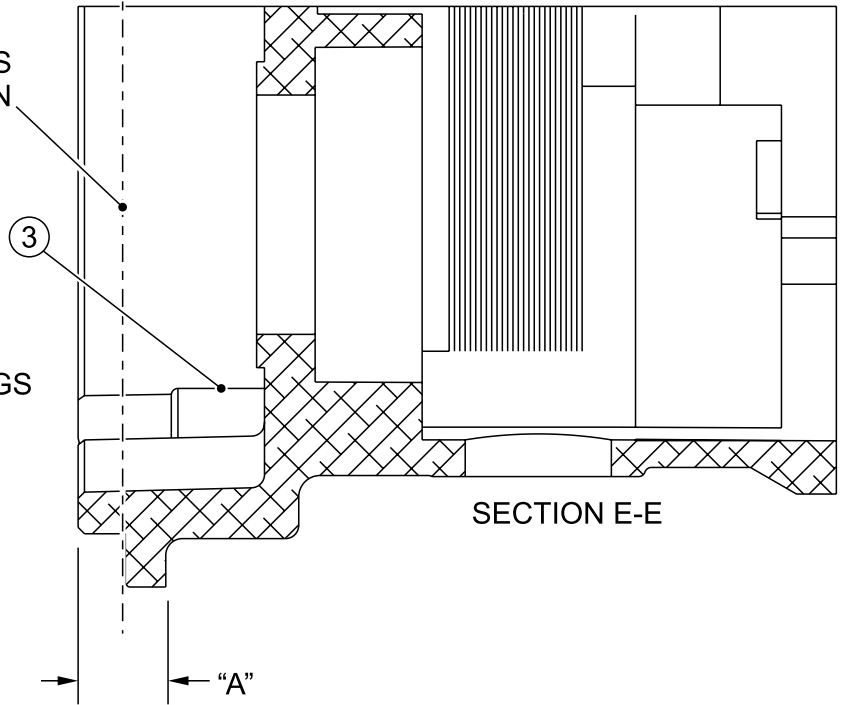
FIGURE 5. MAGNETO FRAME CUTAWAY SECTION E-E

INSTALL DIMENSIONS
A
.437 ± .005
6314, 6324

USE A CALIBRATED MEASURING DEVICE TO MEASURE DISTANCE "A", AS SHOWN IN CUTAWAY SECTION E-E. MAKE SURE THE FRAME SURFACE IS FREE OF CONTAMINANTS. ANY MEASUREMENT LESS THAN 0.432 INCH OF ANY PART OF THE STOP PIN (3), THE MAGNETO SHOULD BE REMOVED FROM SERVICE AND RETURNED TO CHAMPION FOR WARRANTY.

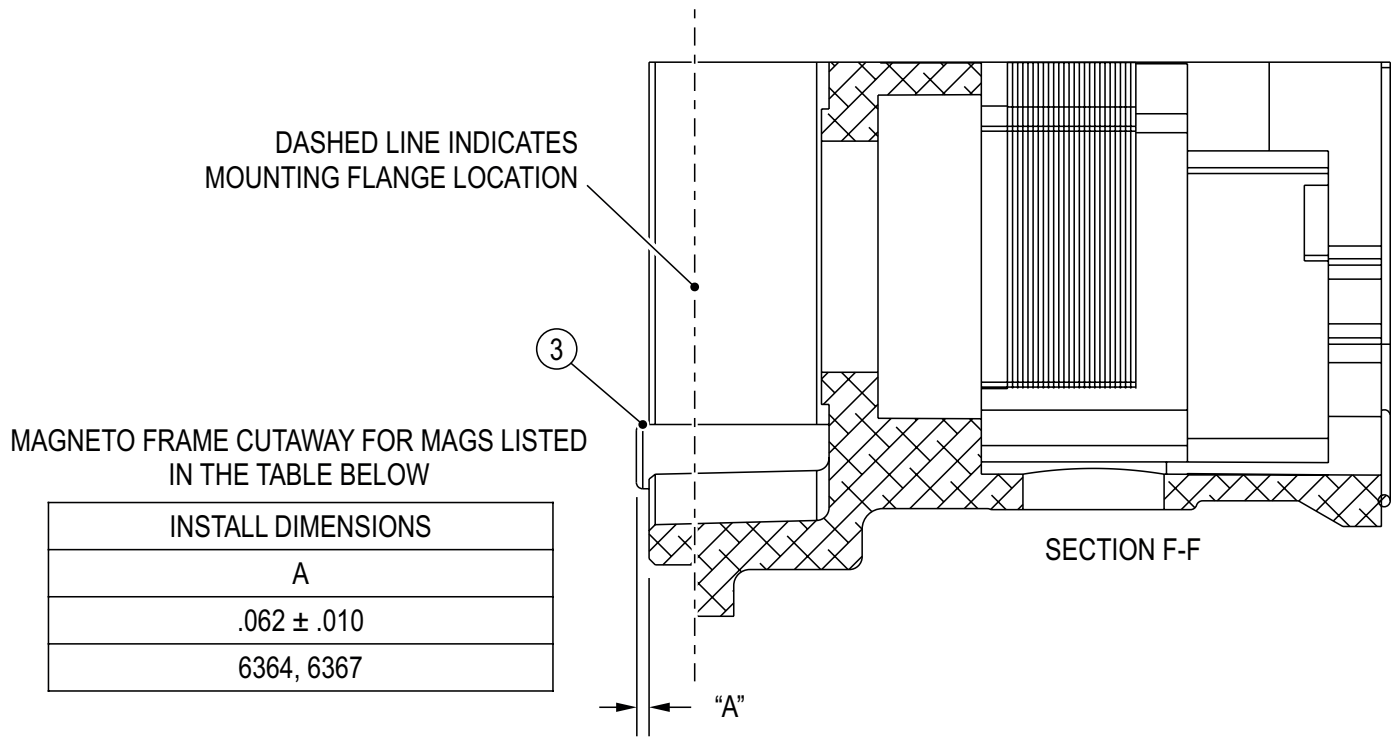
FIGURE 6. MAGNETO FRAME CUTAWAY F-F

USE A CALIBRATED MEASURING DEVICE TO MEASURE DISTANCE "A", AS SHOWN IN CUTAWAY SECTION F-F. MAKE SURE THE FRAME SURFACE IS FREE OF CONTAMINANTS. ANY MEASUREMENT GREATER THAN .072 INCH OF ANY PART OF THE STOP PIN (3), THE MAGNETO SHOULD BE REMOVED FROM SERVICE AND RETURNED TO CHAMPION FOR WARRANTY.

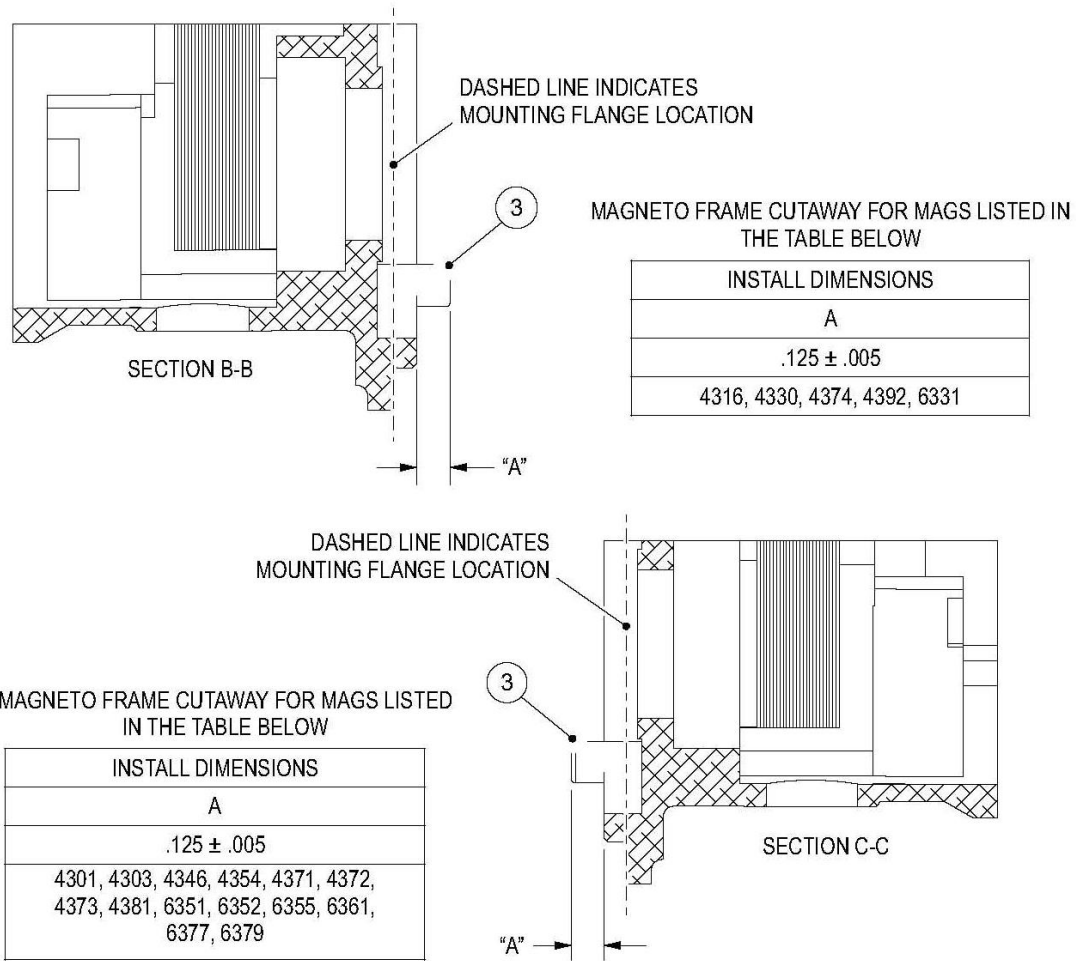
FIGURE 1. MAGNETO FRAME CUTAWAY SECTIONS B-B AND C-C

USE A CALIBRATED MEASURING DEVICE TO MEASURE DISTANCE "A", AS SHOWN IN CUTAWAY SECTIONS B-B AND C-C. MAKE SURE THE FRAME SURFACE IS FREE OF CONTAMINANTS. ANY MEASUREMENT GREATER THAN 0.130 INCH OF ANY PART OF THE STOP PIN (3), THE MAGNETO SHOULD BE REMOVED FROM SERVICE AND RETURNED TO CHAMPION FOR WARRANTY.

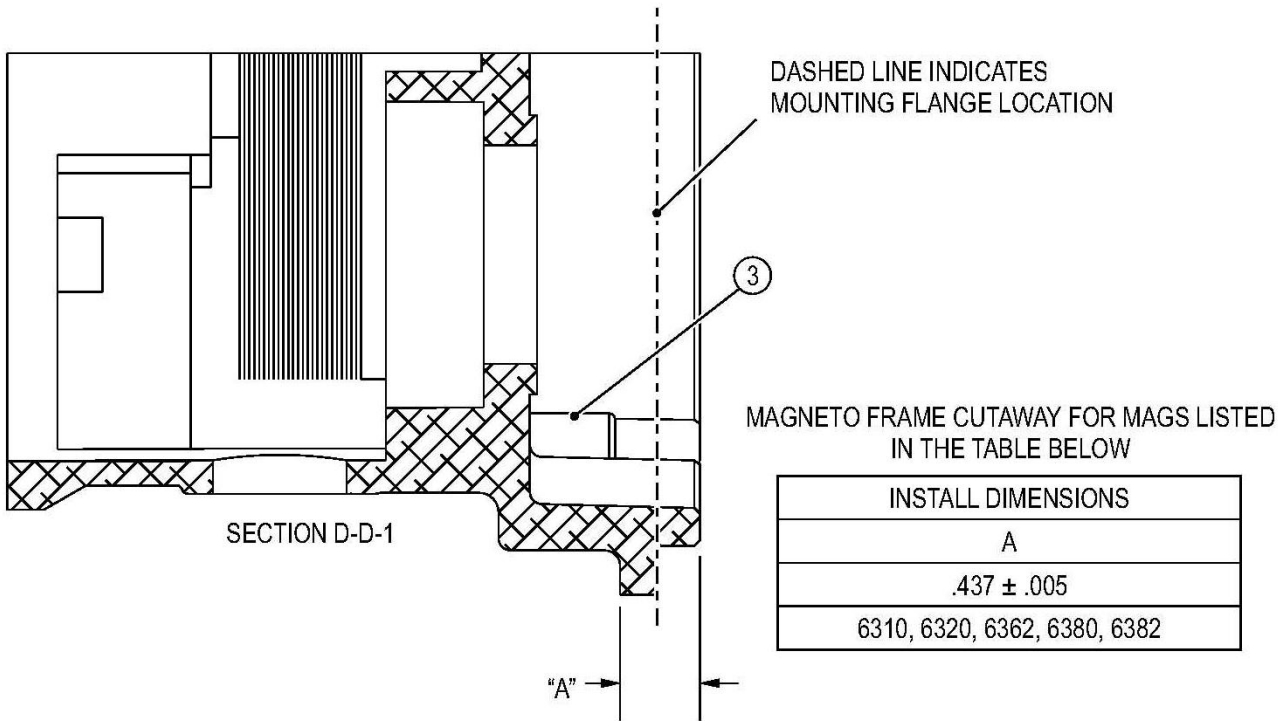
FIGURE 2. MAGNETO FRAME CUTAWAY SECTION D-D-1

USE A CALIBRATED MEASURING DEVICE TO MEASURE DISTANCE "A", AS SHOWN IN CUTAWAY SECTION D-D-1. MAKE SURE THE FRAME SURFACE IS FREE OF CONTAMINANTS. ANY MEASUREMENT LESS THAN 0.432 INCH OF ANY PART OF THE STOP PIN (3), THE MAGNETO SHOULD BE REMOVED FROM SERVICE AND RETURNED TO CHAMPION FOR WARRANTY.

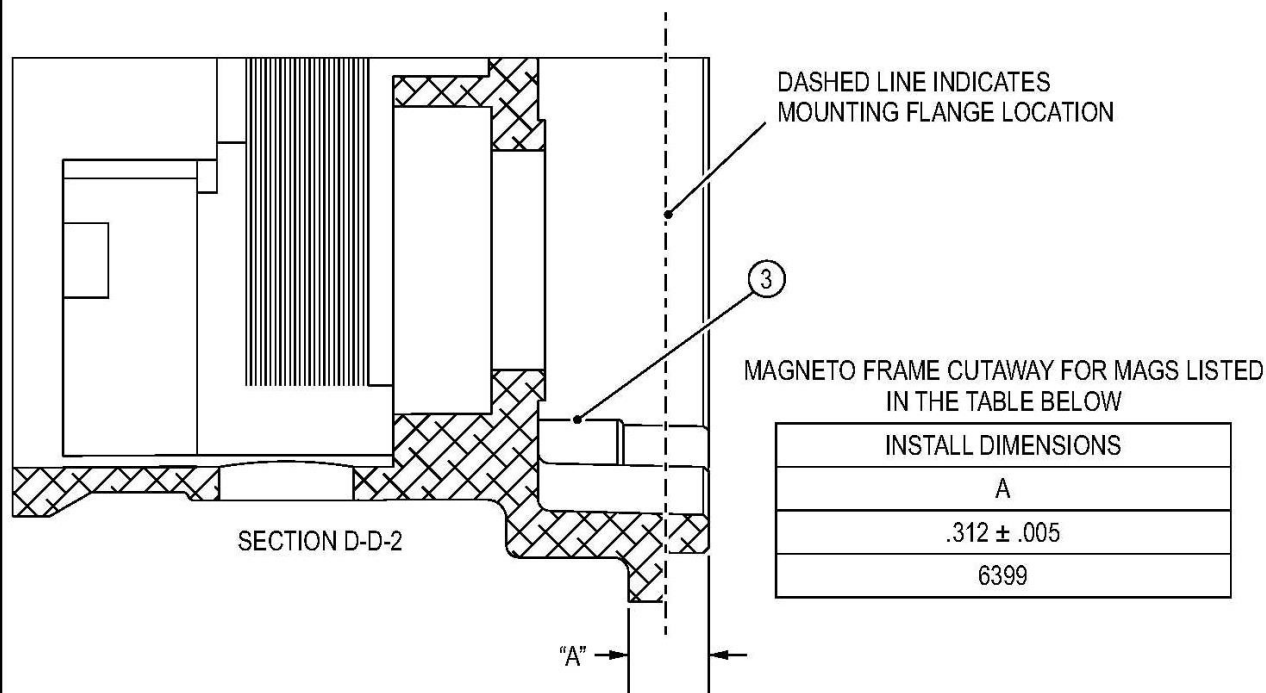
FIGURE 3. MAGNETO FRAME CUTAWAY SECTION D-D-2

USE A CALIBRATED MEASURING DEVICE TO MEASURE DISTANCE "A", AS SHOWN IN CUTAWAY SECTION D-D-2. MAKE SURE THE FRAME SURFACE IS FREE OF CONTAMINANTS. ANY MEASUREMENT LESS THAN 0.307 INCH OF ANY PART OF THE STOP PIN (3), THE MAGNETO SHOULD BE REMOVED FROM SERVICE AND RETURNED TO CHAMPION FOR WARRANTY.

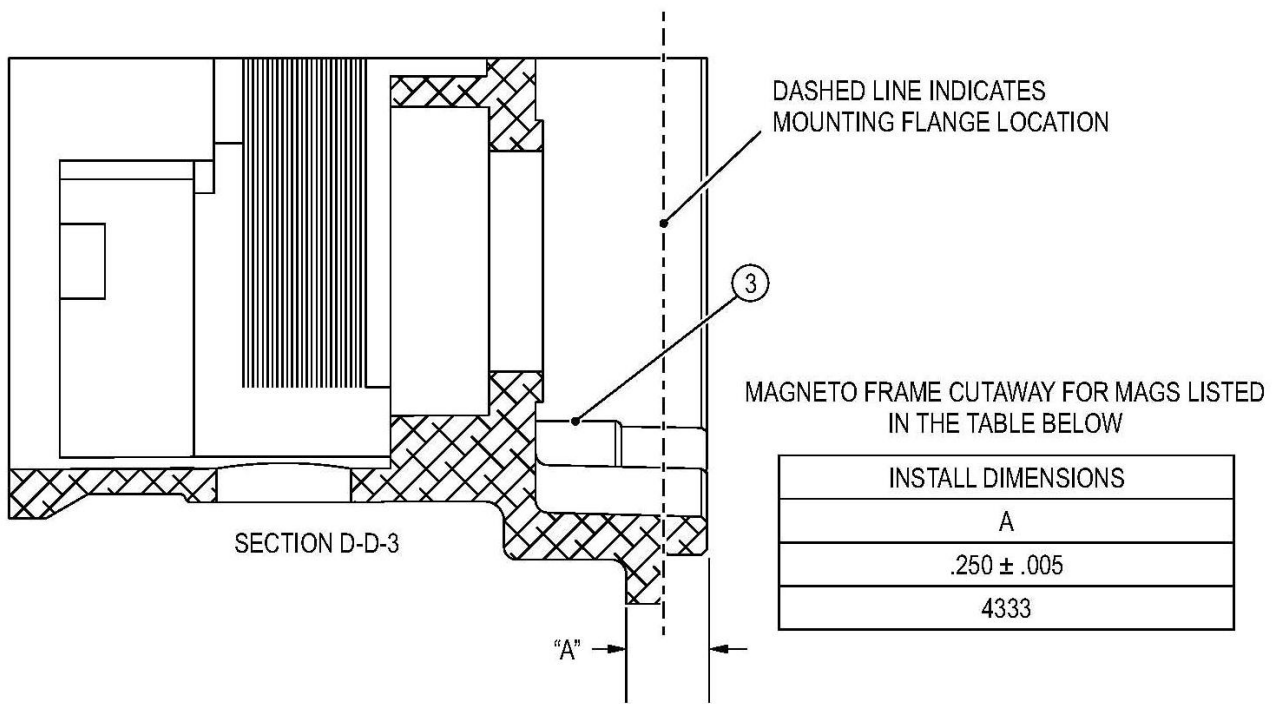
FIGURE 4. MAGNETO FRAME CUTAWAY SECTION D-D-3

USE A CALIBRATED MEASURING DEVICE TO MEASURE DISTANCE "A", AS SHOWN IN CUTAWAY SECTION D-D-3. MAKE SURE THE FRAME SURFACE IS FREE OF CONTAMINANTS. ANY MEASUREMENT LESS THAN 0.245 INCH OF ANY PART OF THE STOP PIN (3), THE MAGNETO SHOULD BE REMOVED FROM SERVICE AND RETURNED TO CHAMPION FOR WARRANTY.

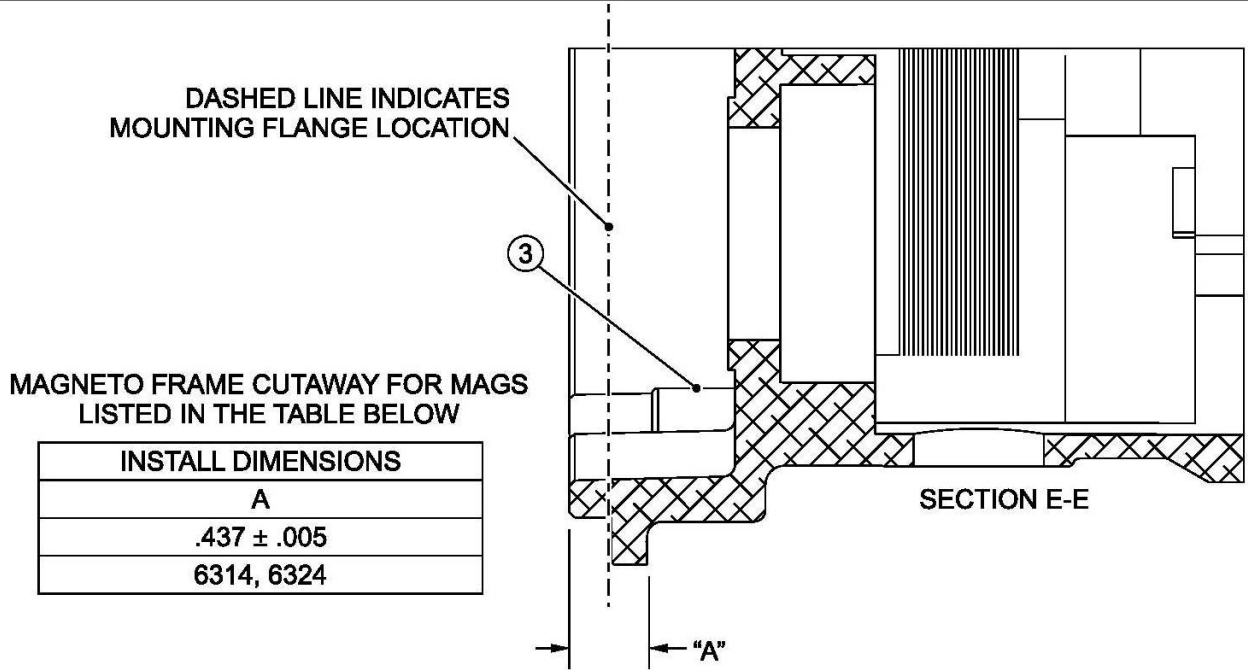
FIGURE 5. MAGNETO FRAME CUTAWAY SECTION E-E

USE A CALIBRATED MEASURING DEVICE TO MEASURE DISTANCE "A", AS SHOWN IN CUTAWAY SECTION E-E. MAKE SURE THE FRAME SURFACE IS FREE OF CONTAMINANTS. ANY MEASUREMENT LESS THAN 0.432 INCH OF ANY PART OF THE STOP PIN (3), THE MAGNETO SHOULD BE REMOVED FROM SERVICE AND RETURNED TO CHAMPION FOR WARRANTY.

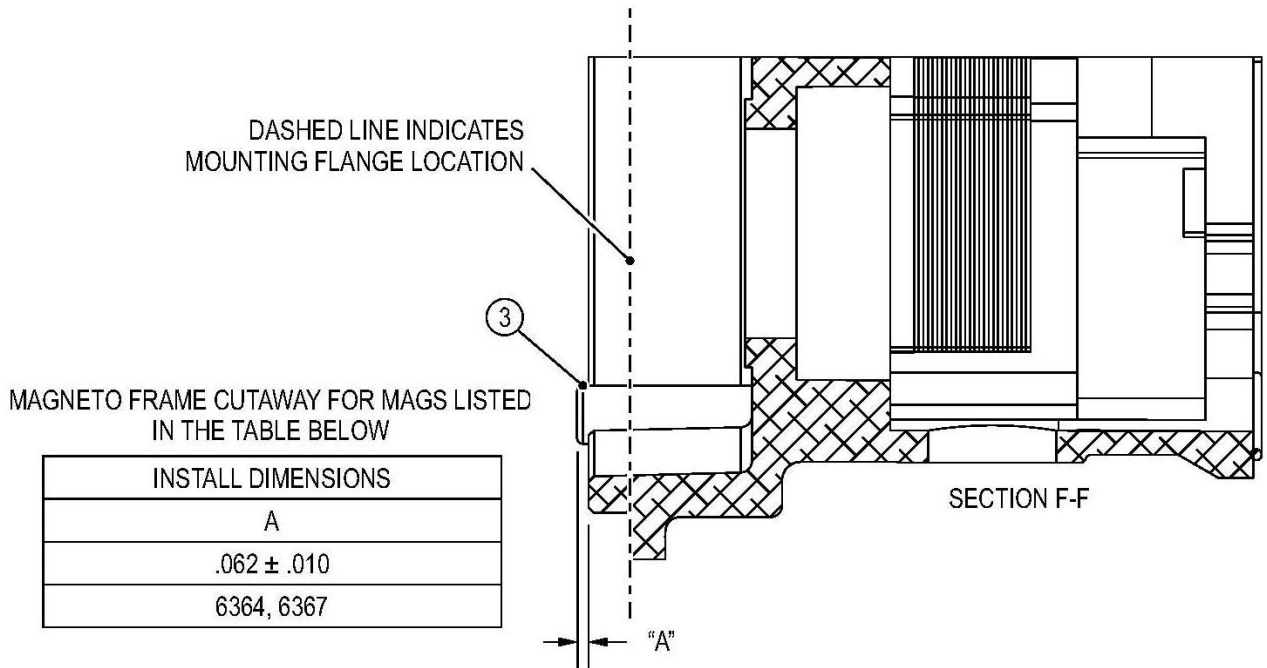
FIGURE 6. MAGNETO FRAME CUTAWAY F-F

USE A CALIBRATED MEASURING DEVICE TO MEASURE DISTANCE "A", AS SHOWN IN CUTAWAY SECTION F-F. MAKE SURE THE FRAME SURFACE IS FREE OF CONTAMINANTS. ANY MEASUREMENT GREATER THAN .072 INCH OF ANY PART OF THE STOP PIN (3), THE MAGNETO SHOULD BE REMOVED FROM SERVICE AND RETURNED TO CHAMPION FOR WARRANTY.

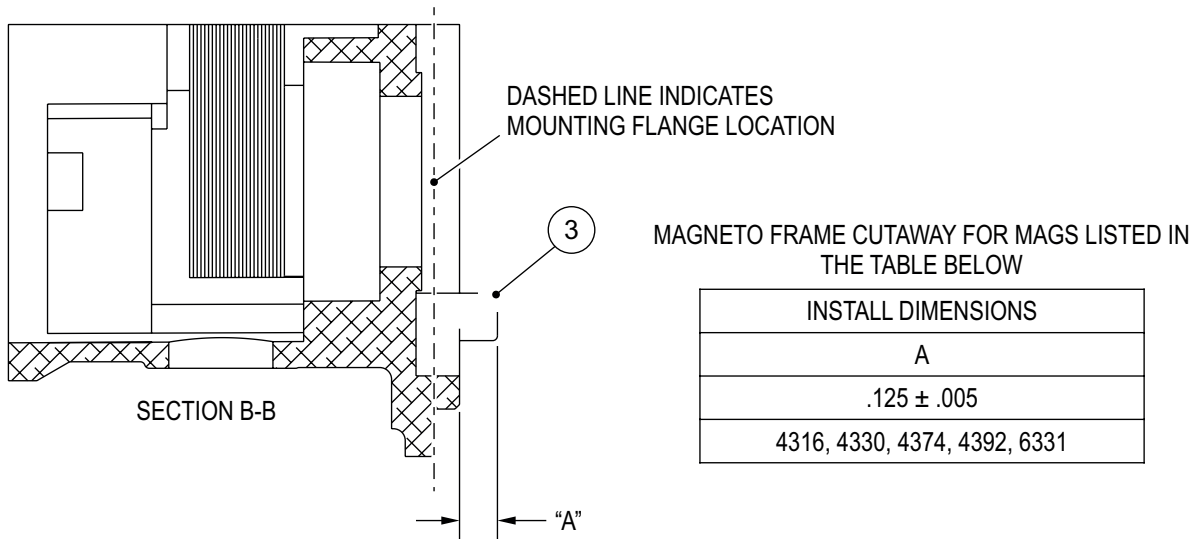
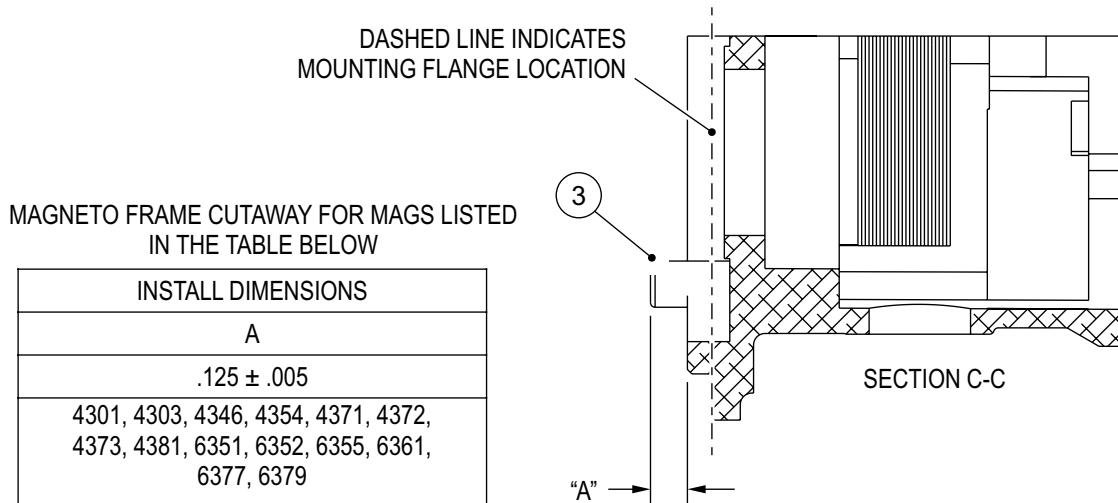
FIGURE 1. MAGNETO FRAME CUTAWAY SECTIONS B-B AND C-C

USE A CALIBRATED MEASURING DEVICE TO MEASURE DISTANCE "A", AS SHOWN IN CUTAWAY SECTIONS B-B AND C-C. MAKE SURE THE FRAME SURFACE IS FREE OF CONTAMINANTS. ANY MEASUREMENT GREATER THAN 0.130 INCH OF ANY PART OF THE STOP PIN (3), THE MAGNETO SHOULD BE REMOVED FROM SERVICE AND RETURNED TO CHAMPION FOR WARRANTY.

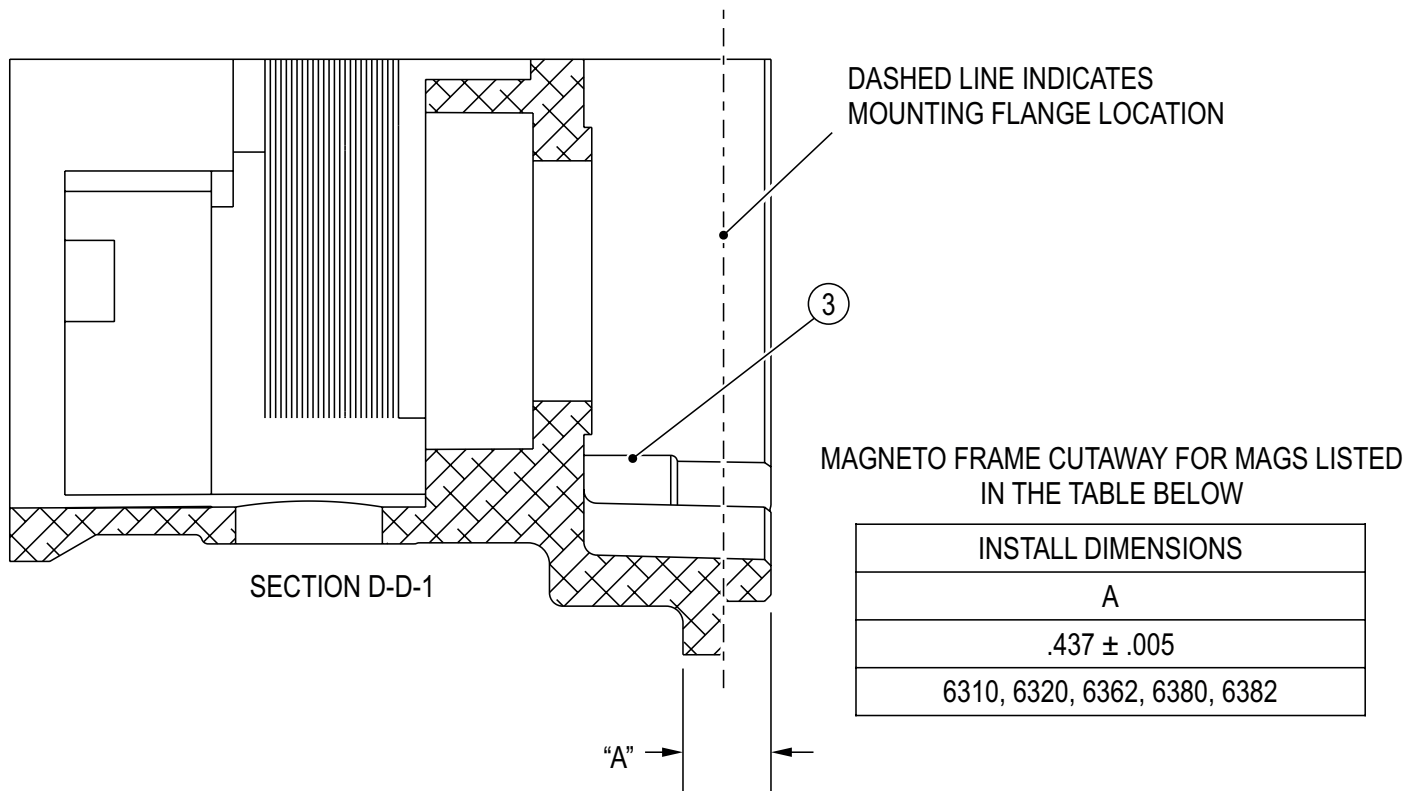
FIGURE 2. MAGNETO FRAME CUTAWAY SECTION D-D-1

USE A CALIBRATED MEASURING DEVICE TO MEASURE DISTANCE "A", AS SHOWN IN CUTAWAY SECTION D-D-1. MAKE SURE THE FRAME SURFACE IS FREE OF CONTAMINANTS. ANY MEASUREMENT LESS THAN 0.432 INCH OF ANY PART OF THE STOP PIN (3), THE MAGNETO SHOULD BE REMOVED FROM SERVICE AND RETURNED TO CHAMPION FOR WARRANTY.

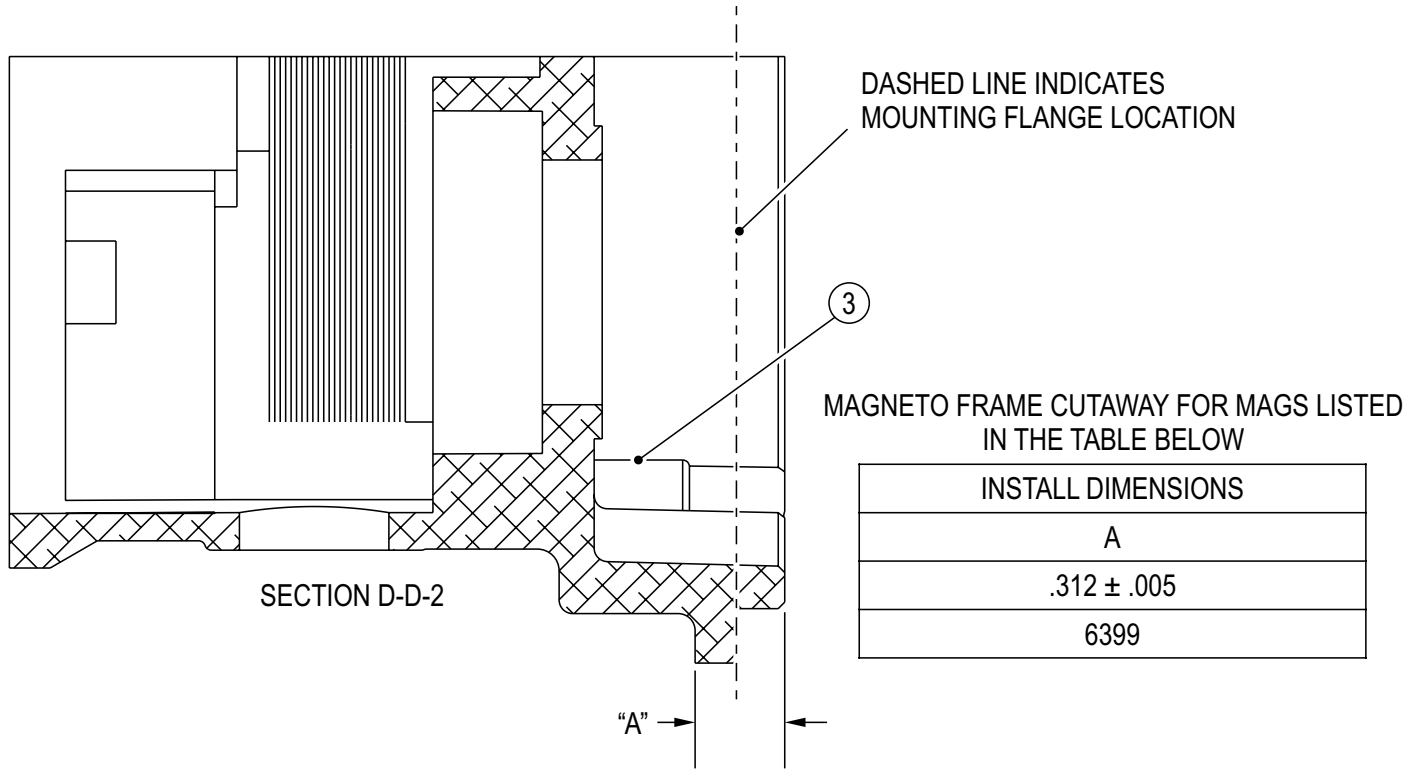
FIGURE 3. MAGNETO FRAME CUTAWAY SECTION D-D-2

USE A CALIBRATED MEASURING DEVICE TO MEASURE DISTANCE "A", AS SHOWN IN CUTAWAY SECTION D-D-2. MAKE SURE THE FRAME SURFACE IS FREE OF CONTAMINANTS. ANY MEASUREMENT LESS THAN 0.307 INCH OF ANY PART OF THE STOP PIN (3), THE MAGNETO SHOULD BE REMOVED FROM SERVICE AND RETURNED TO CHAMPION FOR WARRANTY.

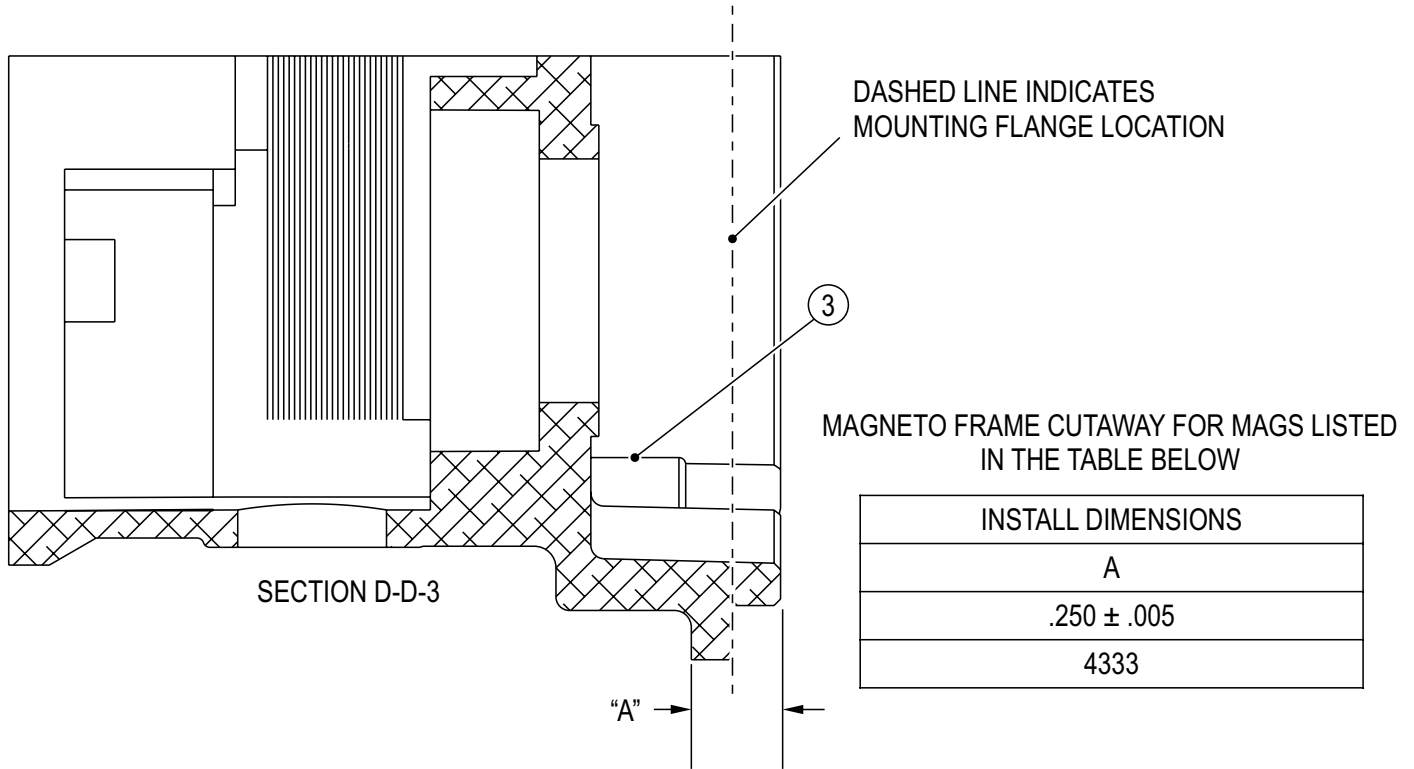
FIGURE 4. MAGNETO FRAME CUTAWAY SECTION D-D-3

USE A CALIBRATED MEASURING DEVICE TO MEASURE DISTANCE "A", AS SHOWN IN CUTAWAY SECTION D-D-3. MAKE SURE THE FRAME SURFACE IS FREE OF CONTAMINANTS. ANY MEASUREMENT LESS THAN 0.245 INCH OF ANY PART OF THE STOP PIN (3), THE MAGNETO SHOULD BE REMOVED FROM SERVICE AND RETURNED TO CHAMPION FOR WARRANTY.

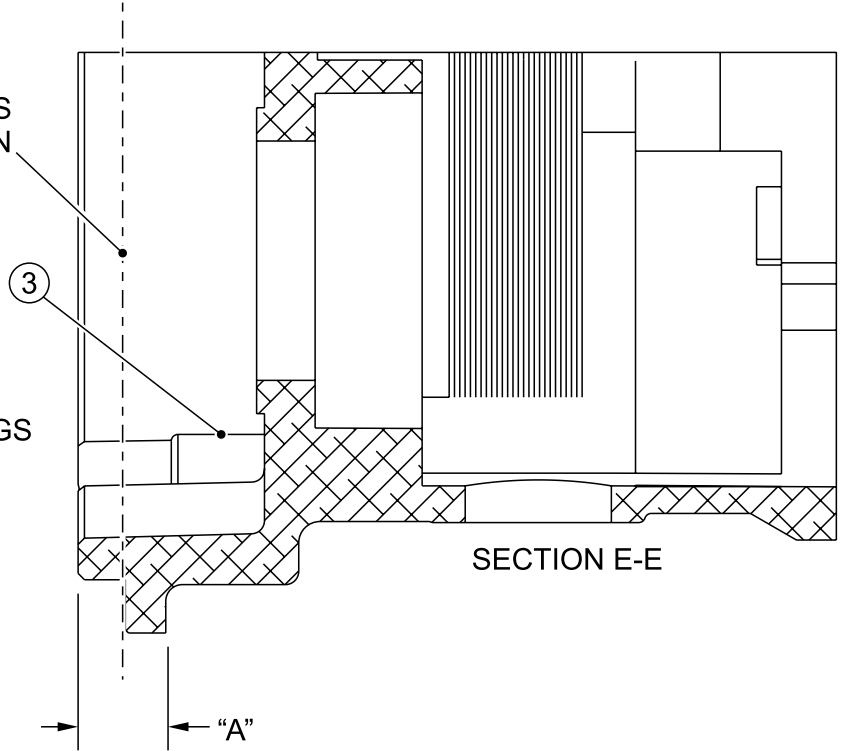
FIGURE 5. MAGNETO FRAME CUTAWAY SECTION E-E

INSTALL DIMENSIONS
A
.437 ± .005
6314, 6324

USE A CALIBRATED MEASURING DEVICE TO MEASURE DISTANCE "A", AS SHOWN IN CUTAWAY SECTION E-E. MAKE SURE THE FRAME SURFACE IS FREE OF CONTAMINANTS. ANY MEASUREMENT LESS THAN 0.432 INCH OF ANY PART OF THE STOP PIN (3), THE MAGNETO SHOULD BE REMOVED FROM SERVICE AND RETURNED TO CHAMPION FOR WARRANTY.

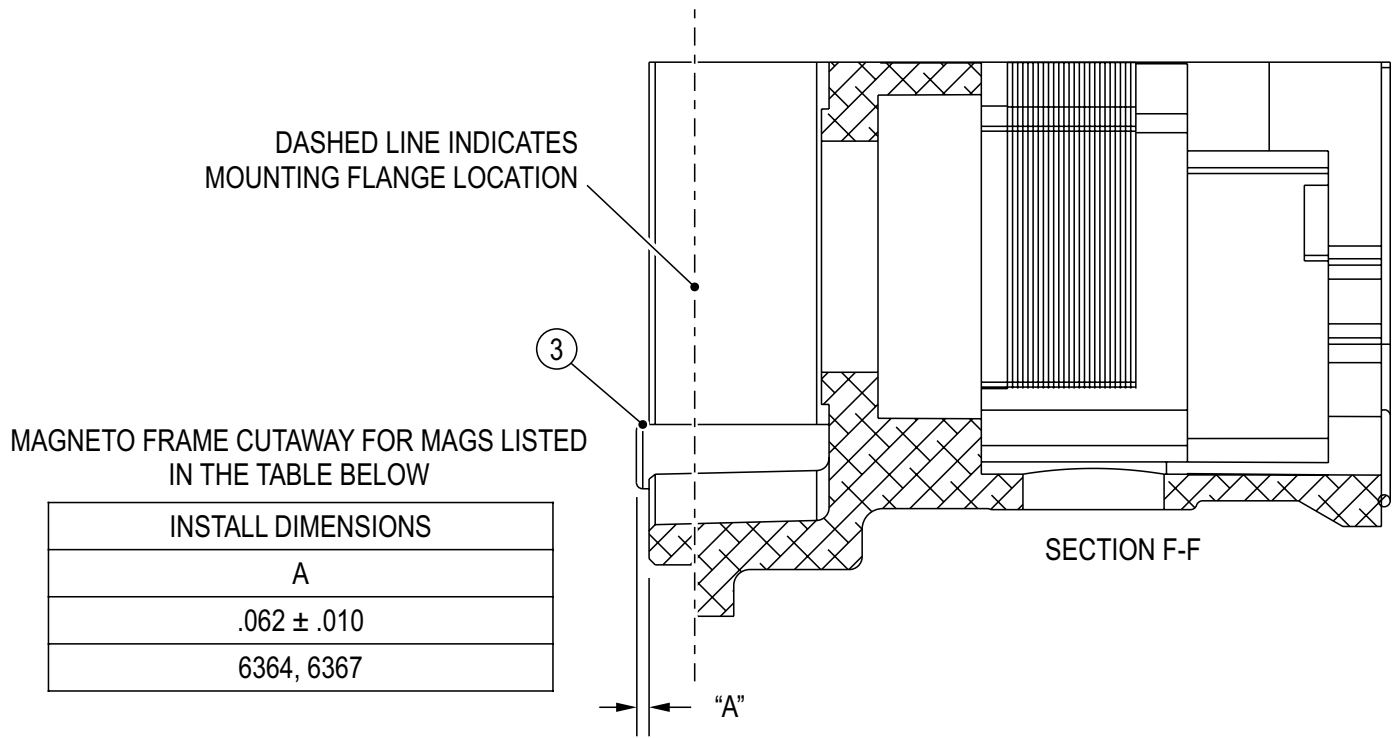
FIGURE 6. MAGNETO FRAME CUTAWAY F-F

USE A CALIBRATED MEASURING DEVICE TO MEASURE DISTANCE "A", AS SHOWN IN CUTAWAY SECTION F-F. MAKE SURE THE FRAME SURFACE IS FREE OF CONTAMINANTS. ANY MEASUREMENT GREATER THAN .072 INCH OF ANY PART OF THE STOP PIN (3), THE MAGNETO SHOULD BE REMOVED FROM SERVICE AND RETURNED TO CHAMPION FOR WARRANTY.
