TELEDYNE CONTINENTAL ® AIRCRAFT ENGINE

MANDATORY SERVICE BULLETIN

MSB94-4G

SUBJECT: STARTER ADAPTER SHAFTGEAR AND CRANKSHAFT GEAR INSPECTION

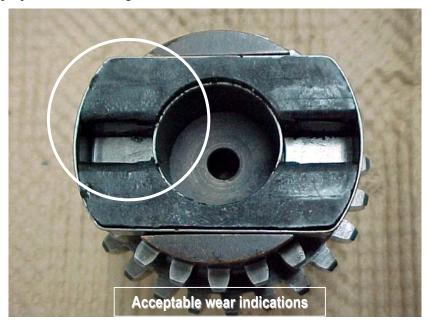
FIGURE 1. MAGNETO DRIVE RUBBER BUSHINGS

- 6. Remove the left and right magneto drive gear assemblies.
- 7. Inspect the left and right magneto drive rubber bushings for damage. Refer to Figure 1 on page 3 for typical wear signatures.

- Replace the magneto drive rubber bushings with new bushings. Insure that the rubber bushings are installed with the beveled edge facing out. Lubricate the magneto drive gear needle bearing with Molyshield Grease, TCM P/N 656817, and reinstall the left and right magneto drive gear assemblies and magnetos in the reverse order of removal. Time the magnetos to the engine in accordance with the instructions detailed in the latest revision of TCM Mandatory Service Bulletin MSB94-8. Torque attaching hardware to the value specified in the latest revision of TCM Service Bulletin SB96-7.

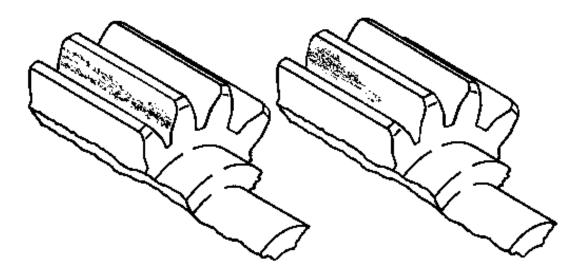
FIGURE 6

The crankshaft gear, starter adapter assembly and viscous damper must be replaced at the same time if the tooth wear of either gear is unacceptable in accordance with this bulletin.

UNACCEPTABLE
HEAVY WEAR, SPALLING AND
PITTING FULL TOOTH WIDTH

UNACCEPTABLE
HEAVY WEAR, SPALLING AND
PITTING PARTIAL WIDTH

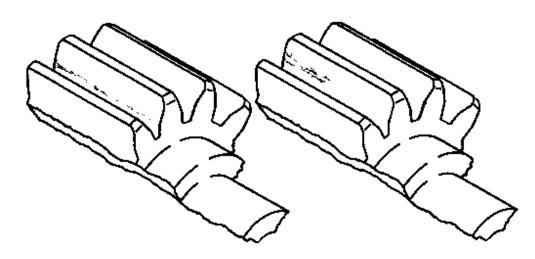
FIGURE 7

8. If the condition of the crankshaft gear and starter adapter shaft gear teeth are acceptable, as indicated in Figure 7 on page 9, they may be continued in service. Comply with the recurring inspections listed in the "COMPLIANCE" section of this bulletin.

ACCEPTABLE LIGHT WEAR LINE, FULL TOOTH WIDTH UP TO .01 INCH WIDE ACCEPTABLE MODERATE WEAR LINE, NO MORE THAN 50% TOOTH LENGTH AND .05 INCH WIDE
