MEL-79-01

OIL - TRANSMITTAL OF CONTINENTAL AEROSPACE TECHNOLOGIES CSB07-1A CONNECTING ROD PISTON PIN BUSHING INSPECTION

CATEGORY 2
CSB07-01A**Supersedes SB07-1**
TECHNICAL PORTIONS
FAA APPROVED**SUBJECT:** Connecting Rod Piston Pin Bushing Inspection**PURPOSE:** Provide inspection instructions for the connecting rod piston pin bushing**COMPLIANCE:** At each cylinder removal or anytime piston pin bushing material is identified during routine maintenance**MODELS****AFFECTED:** Continental Aerospace Technologies new and rebuilt A Series, C Series, E Series, O-200, IO-240, IOF-240, GO-300, O-300, IO-346, IO-360, LTSIO-360, TSIO-360, GIO-470, O-470, IO-470, TSIO-470, IO-520, GTSIO-520, LTSIO-520, TSIO-520, IO-550, IOF-550, TIARA, TSIO-550, TSIOF-550, and TSIOL-550 engine models.**I. GENERAL INFORMATION**

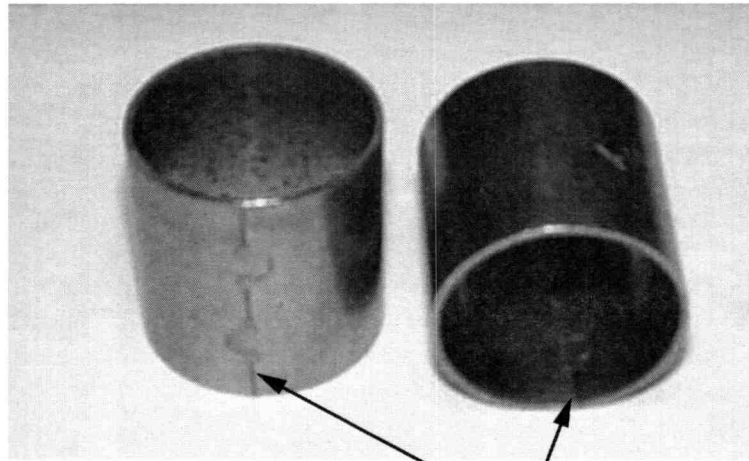
Continental Aerospace Technologies, Inc. (Continental™) has received reports from the field of piston pin bushing material being found in the oil sump or the oil filter. Piston pin bushings are manufactured from steel-backed bronze and are curved on a radius of approximately 0.62" (see Figure 1).

**BUSHING SPLIT LINE****Figure 1. Typical New Piston Pin Bushings****II. OIL CHANGE**

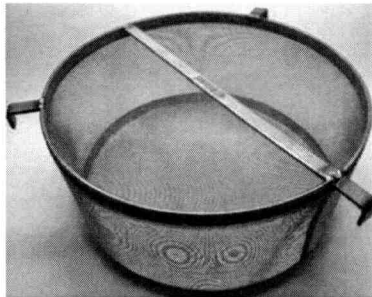
Figure 2. 1000 Micron Stainless Steel Oil Strainer

1. Perform the oil change at the next scheduled interval according to the instructions in M-0, Section 6-4.8.
 - a. Rather than drain the oil into catch basin and try to strain the spent oil through a paper filter, Continental recommends the following enhanced instructions:
 - 1) Place a pre-cleaned catch basin beneath the oil sump drain.
 - 2) Position a 1000 micron or less (approximately 0.040” or less) mesh screen in the catch basin to strain the oil sump contents. The 1000 micron stainless steel oil strainer (part number 2000) shown in Figure 2 is designed to fit the opening of a standard 5 gallon bucket. It is available for purchased from Arborfab.com. Arbor Fabricating, 14030 Tuttle Hill, Milan, MI 48160. (734) 626-5864.
 - b. Rinse the excess oil residue from the screen, retaining any fragments, particles, or sediment in the screen for analysis.

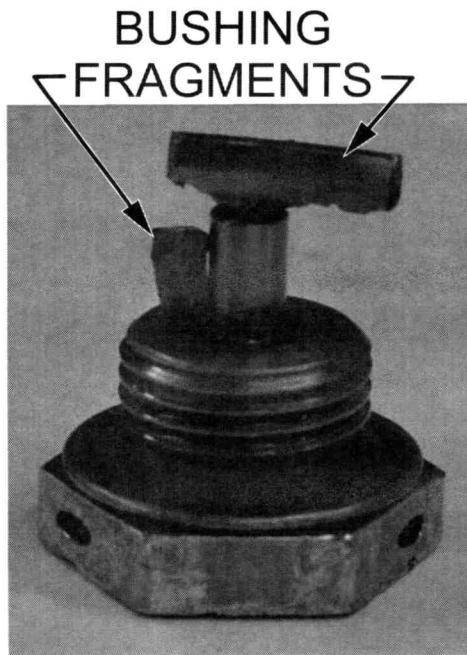
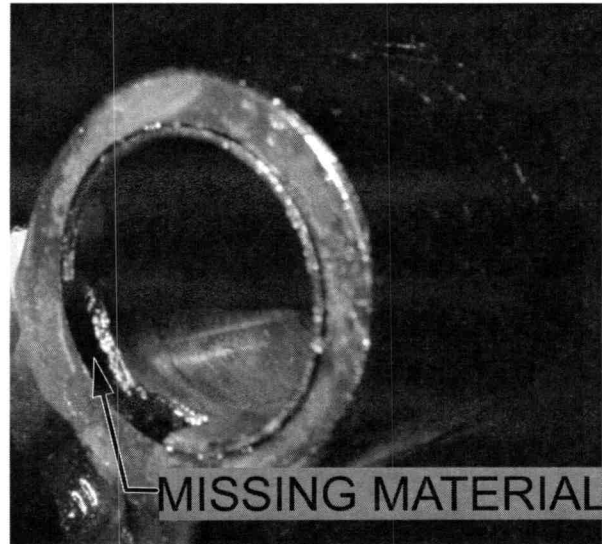
Figure 3. Typical Indications of Bushing Fragments

If piston pin bushing material (see Figure 3) is recovered from an engine, remove the cylinders, pistons, and piston pins (no more than two cylinders at a time) to inspect the connecting rod piston pin bushings. In addition, the piston pin bushing must be inspected for condition each time a cylinder is removed for any reason.

**MAGNETIC OIL
DRAIN PLUG**

**CONNECTING ROD
AND BUSHING**

1. Remove the cylinders and pistons from the engine using the instructions contained in the appropriate maintenance or overhaul manual to gain access to the piston pin bushings.
2. Inspect the connecting rods according to the instructions in **M-0**, Section 10-9.4.
3. Visually inspect the piston pin bushing for any signs of cracks emanating from the piston pin bushing split line, missing bushing material, or signs of bushing movement.
4. Inspect the piston pin bushing for wear according to the instructions in **M-0**, Standard Practice Maintenance Manual, **Section 10-9.4**.
 - a. Replace any piston pin bushing that does not meet the installation criteria in **M-0**, Section 10-9.4 or is found cracked per during the inspection in step 3.
 - b. Replace any piston pin bushing that does not meet the inspection criteria in **M-0**, Standard Practice Maintenance Manual, **Section 10-9.4**.
