SERVICE ALERT

NO.: 0936 Revision B

SUBJECT: Navigation error condition concerning terminal procedures with Direct-to-Fix (DF) legs

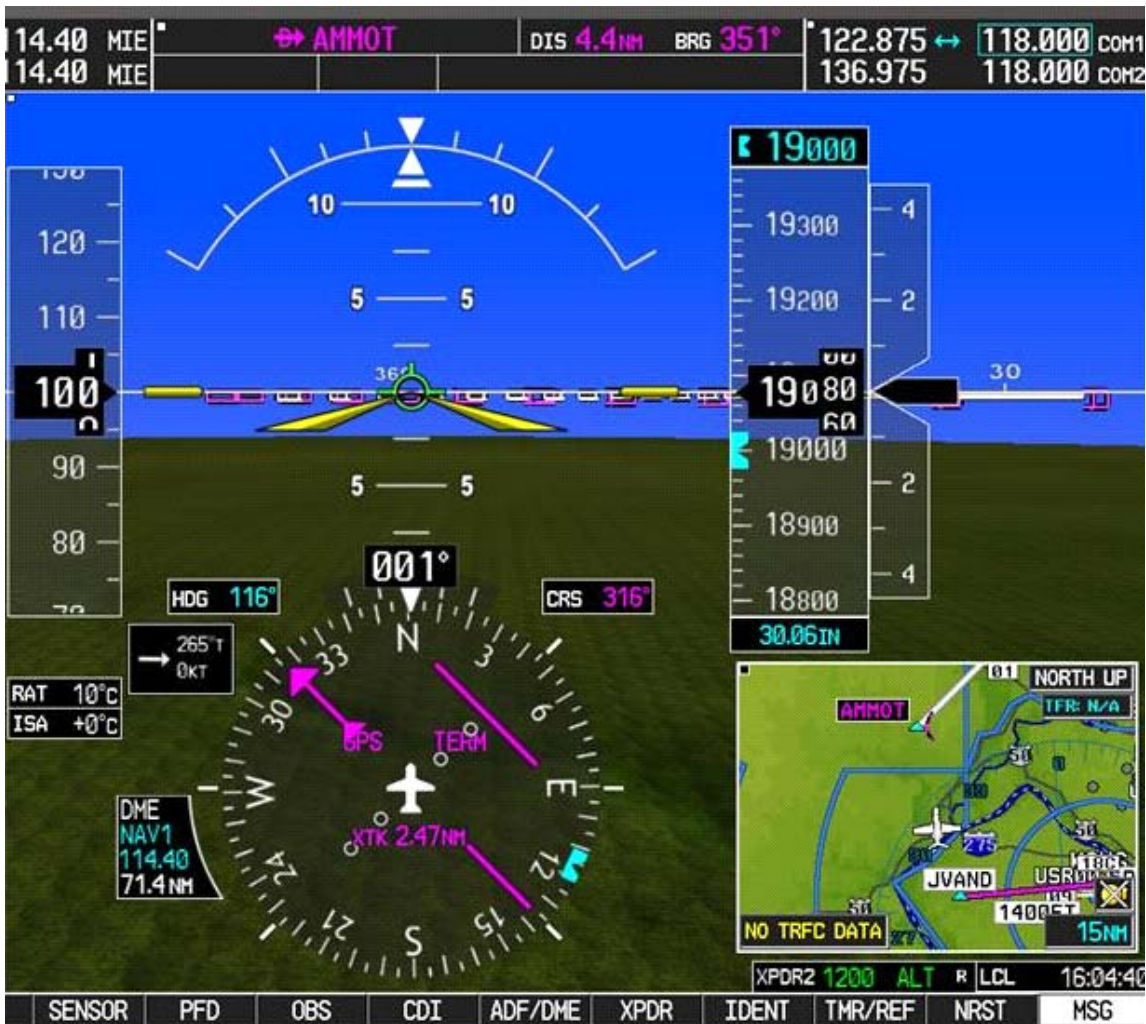
- a) Waypoint alerts are not provided at the waypoint prior to the automatic Direct-to-fix leg.
- b) The selected course, desired track, and CDI provide guidance to a non-published course. The non-published course may be depicted by Pathways (if equipped), but is NOT displayed on the navigation map.
- c) The previous leg of the flight plan remains shown as a magenta line on the navigation map, though it is no longer the active leg.
- d) On the GNS 400W/500W series, the previous waypoint of the flight plan is incorrectly displayed as the active waypoint.

Figure 1. Garmin Integrated Flight Deck System PFD Display While on Second DF Leg

Figures 1 and 2 show the magenta course line behind the aircraft position.

Do not rely on automatic sequencing of Direct-to-fix waypoints. Do not delete an active Direct-to waypoint from the flight plan. If any of the above indications occur at any time, stay on the published course using back-up navigation techniques and manually activate a Direct-to leg using the Direct-to button (

) to the appropriate published waypoint in the published terminal procedure.
