Safety Communique

May, 2012

SUBJECT: IMPROPER AILERON INSTALLATION

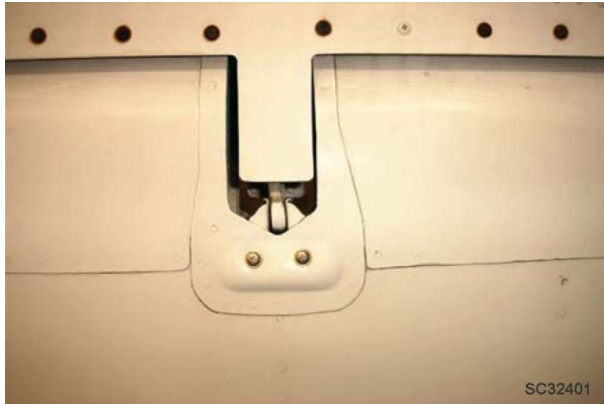
Figure 1 – Correct Aileron Hinge Bracket Installation

Although the most recent incident was on a King Air airplane, all airplanes listed in the MODELS section of this Safety Communiqué are affected. During aileron installation, it is important to ensure that procedures are followed for correct installation of screws through the hinges and into the nutplates on the aileron hinge points.

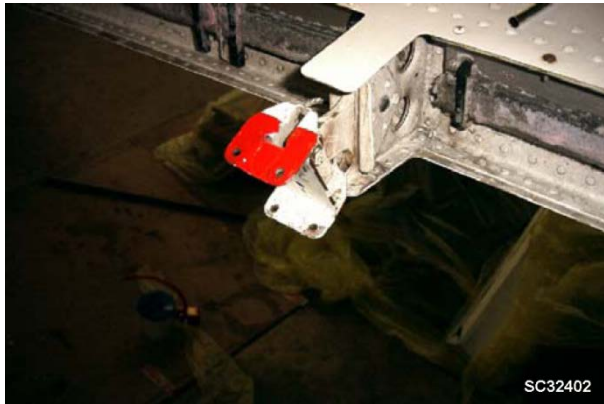
Figure 2 – Witness Mark Painted on Aileron Hinge Bracket (Aileron Removed)

HBC issued King Air Series Model Communiqué 2003-03 in September 2003 to warn of the potential for improper attachment of ailerons. At that time, HBC suggested that witness marks be painted on the aileron hinge bracket in a contrasting color to provide a visual cue to improper aileron installation. Figures 1 and 3 depict a correct and incorrect installation, respectively. If a witness mark is **not** showing, the aileron is aligned properly. A witness mark showing indicates an improperly installed aileron. Figure 2 depicts an aileron hinge point of a disassembled aileron installation with a painted aileron hinge bracket. The previously published Model Communiqué 2003-03 illustrations on page 2 were provided to owner/operators of record at that time and will be available online to all affected owner/operators for 90 days from publication date. Current information is available in the Online Service Information library to registered users at www.hawkerbeechcraft.com.

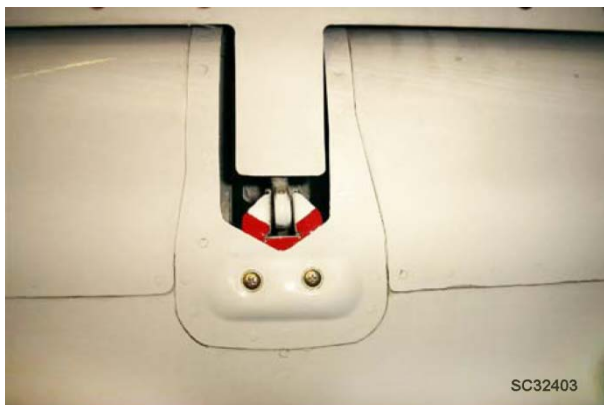
HBC has received four (4) reports of improper maintenance practices resulting in partial or complete aileron separation on Hawker Beechcraft airplanes. On April 11, 2011, (the most recent incident) the right aileron partially separated from a Model C90A King Air airplane during flight. The pilot executed a normal landing.

Figure 3 – Incorrect Aileron Hinge Bracket Installation (Witness Mark Paint Showing)
