# SERVICE BULLETIN

**TITLE: FUEL - INSPECTION / REPLACEMENT OF FUEL VENT HOSE CLAMPS**

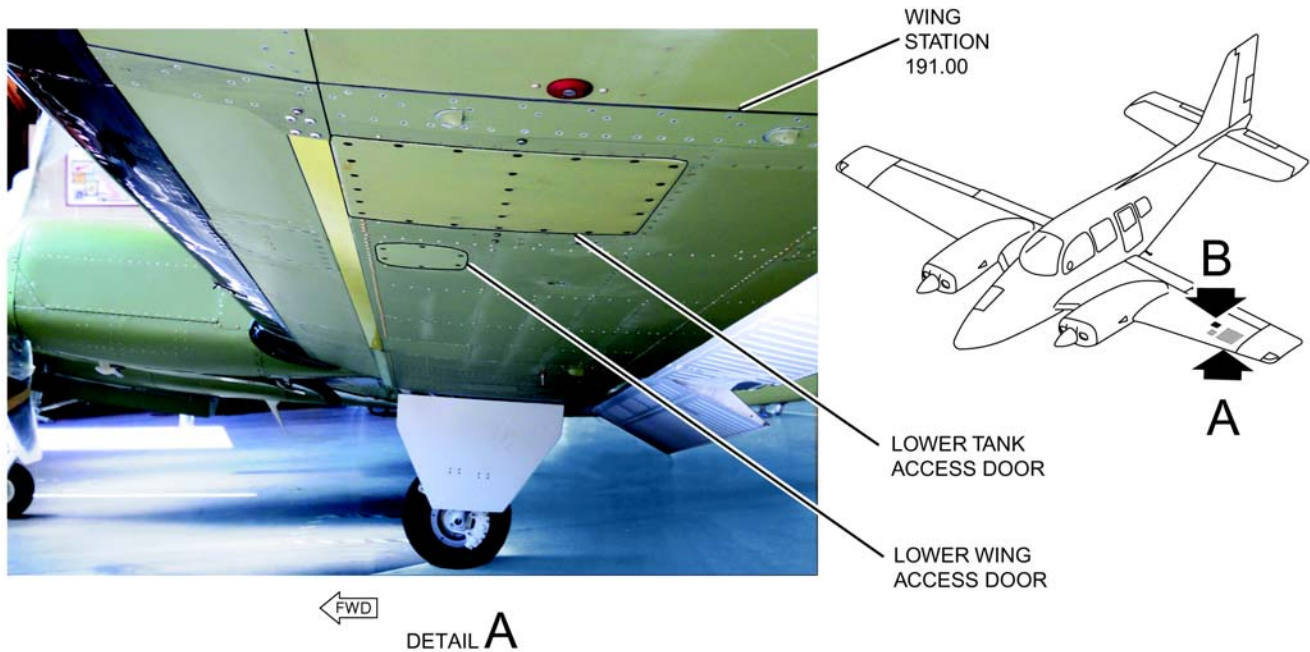
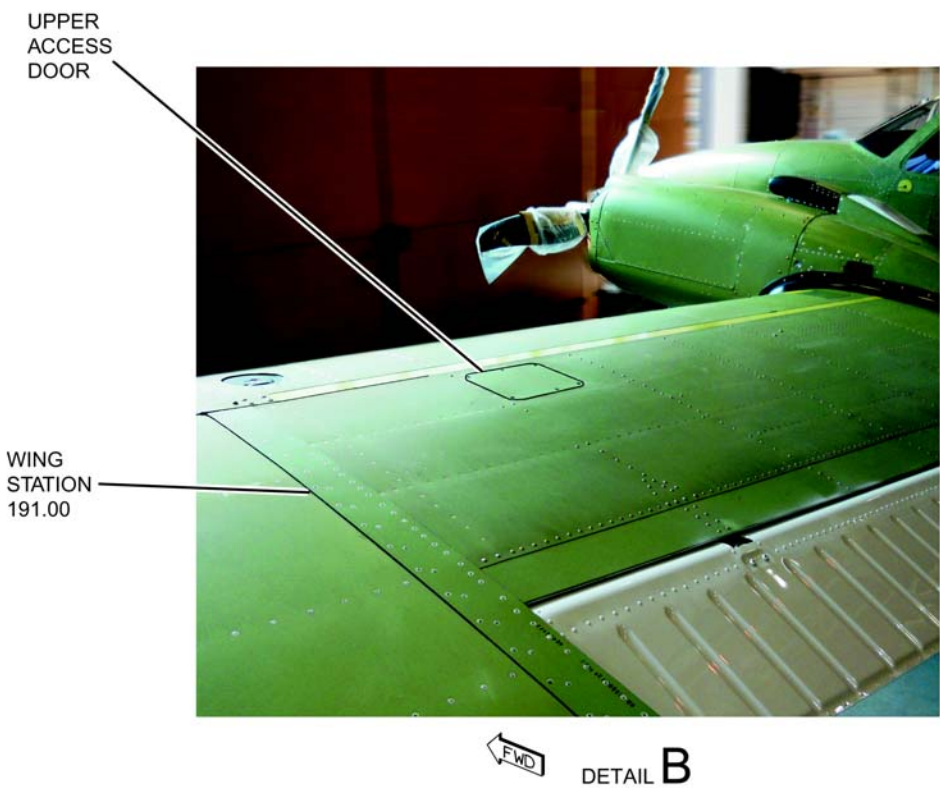
Fuel Hose Access on Left Wing  
Figure 1

- (a) On left wing, remove three (3) access doors; two (2) on lower side and one (1) on upper side. Refer to Figure 1.
  - (b) On right wing, remove two (2) access doors on lower side. Refer to Figure 2.

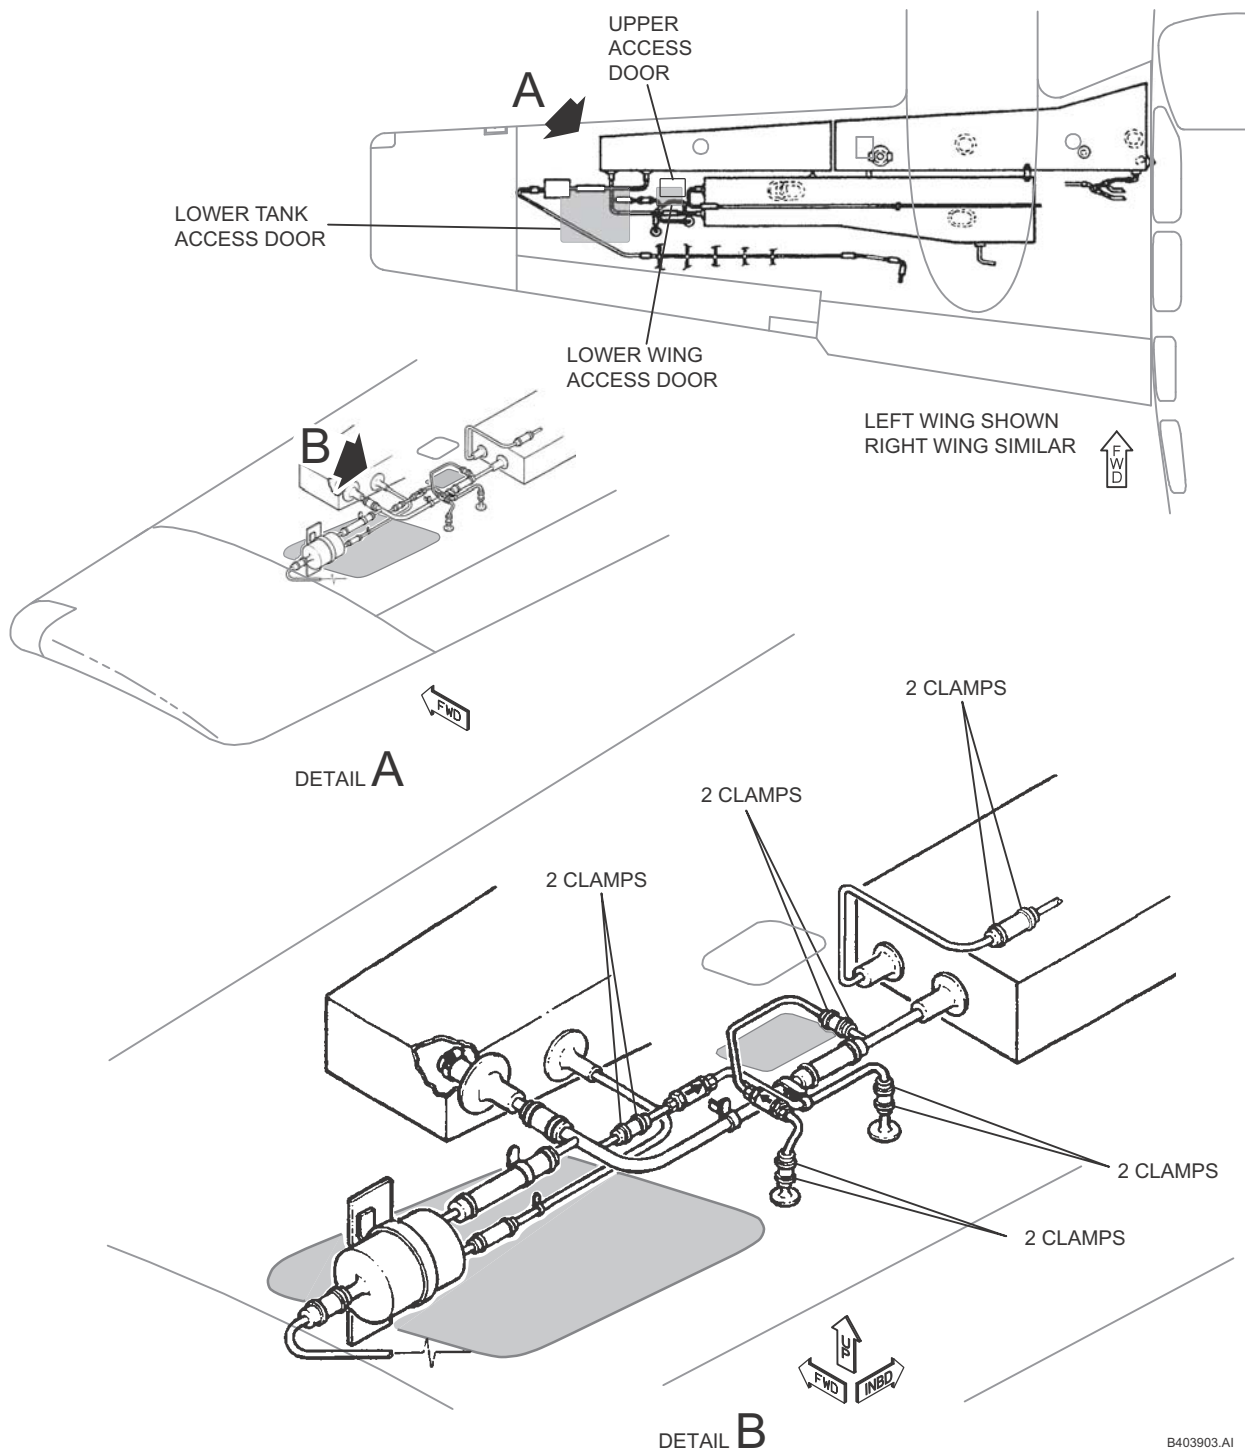
**Fuel Hose Suspect Clamp Locations  
Standard Configuration (Serials TH-1931 thru TH-2124)  
Figure 3**

This Service Bulletin is being issued to address a quality escape regarding the fuel hose clamps located within the outboard sections of both wings. Clamps may have been installed during manufacturing that have a larger inside diameter than is required for the supported fuel hoses. An oversized or deformed clamp does not close around the hose uniformly, creating the possibility of fuel leakage and a potential fire hazard.

- (c) With a mirror and a non-explosive flashlight, inspect areas for oversized/deformed clamps around the fuel hoses. Refer to Paragraph 2.C. for the quantity of clamps, depending on configuration. Refer to Figures 3, 4, and 5.

- (i) Inspect for gaps between the clamp and the hose. Clamps must be replaced if they do not close uniformly around the hose, are not concentric, or do not fit securely on the hose.

- (ii) If oversized/deformed clamp(s) are present, defuel the airplane before replacing clamps. Refer to MM, Chapter 28-00-00.
    - (iii) If oversized/deformed clamps are not present, proceed to Step (6) below.
- (3) Remove oversized/deformed clamp(s) and replace with new clamp(s), P/N 62606.
- (4) Refuel airplane to full capacity. Refer to MM, Chapter 12-10-00.
- (5) Visually inspect for fuel leaks around the hose clamps.
- (6) Install all wing access doors removed in Steps 2(a) and (b) above.
- (7) Reconnect the airplane battery, remove warning notices, and restore power.
- (8) Ensure all work areas are clean and clear of tools and miscellaneous items of equipment.
- (9) Return airplane to service.
