## SERVICE BULLETIN

Beech

TITLE: FUSELAGE - BATTERY DRAIN MAST REMOVAL

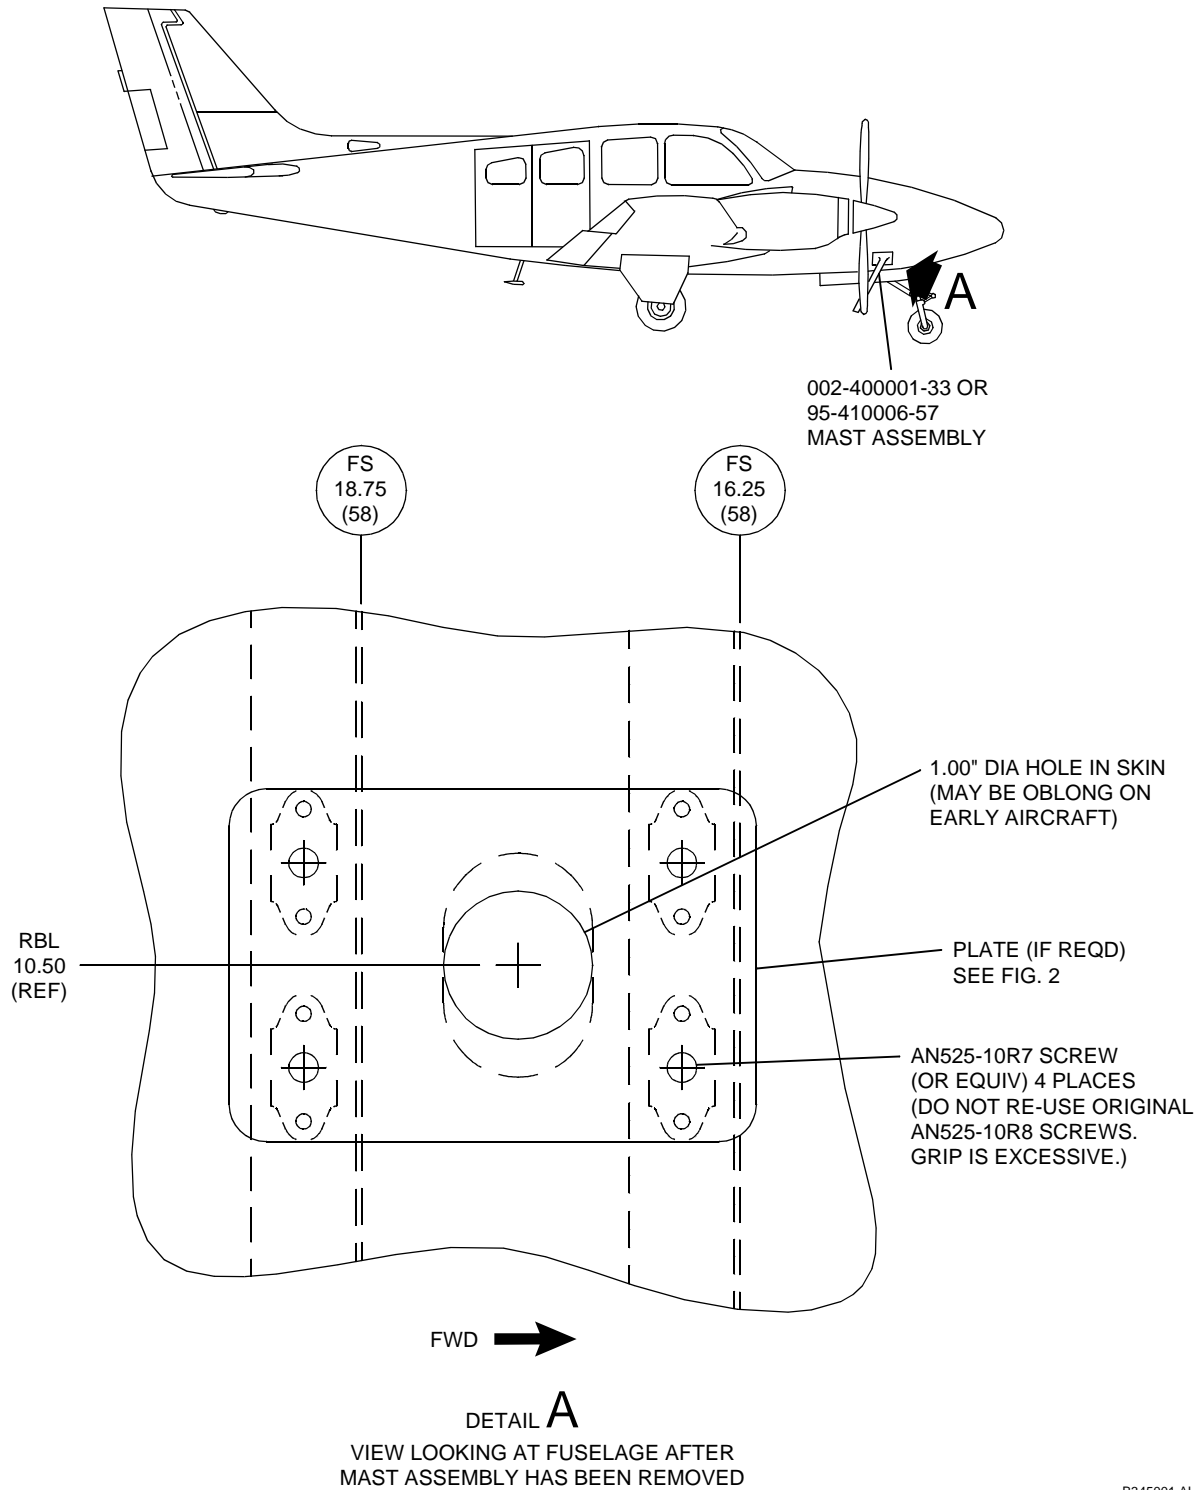
**BATTERY DRAIN MAST REMOVAL**  
**FIGURE 1**

This Service Bulletin is being issued to allow the removal of the P/N 95-410006-57 or P/N 002-400001-33 battery drain mast assembly provided no ADF (long-wire) antenna was anchored to the mast. This Service Bulletin allows the owner/operator the option of removing the mast assembly rather than replacing it in the event of any damage to the mast assembly.

- (1) Remove all power from the airplane and disconnect the battery. Display warning notices prohibiting reconnection of airplane electrical power.
- (2) Remove the P/N 95-410006-57 or P/N 002-40001-33, mast assembly, by removing four AN525-10R8 screws that attach the mast to the fuselage. See figure 1.
- (3) Inspect the hole in the fuselage that the drain tube protrudes through. If the hole is round and approximately 1.00 inch diameter, proceed to step 9. If the hole is oblong or out of round, go to step (4). See figure 1.
- (4) Fabricate a plate made from .032 2024-T3 Alclad aluminum. Form to match skin contour. See figure 2.

- (8) Install the plate using four AN525-10R7 screws. See figure 1. Proceed to step 11.
- (9) Clean the area of the removed mast with cotton cheesecloth or clean wiping rag dampened with appropriate solvent. Repeat solvent wipe cleaning, as necessary. Wipe surfaces dry with clean cotton cheesecloth. Paint to match surrounding paint scheme.
