CRITICAL SERVICE BULLETIN

CSB 01-1
TECHNICAL PORTIONS
FAA APPROVED

SUBJECT: FUEL PUMP INSPECTION and SEAL LEAK TEST

PURPOSE: To Provide A Leak Test Procedure To Insure Integrity Of Basic Fuel Pump Fuel Seal On Fuel Pump Assemblies Manufactured Between July 1, 1998 And May 31, 2000.

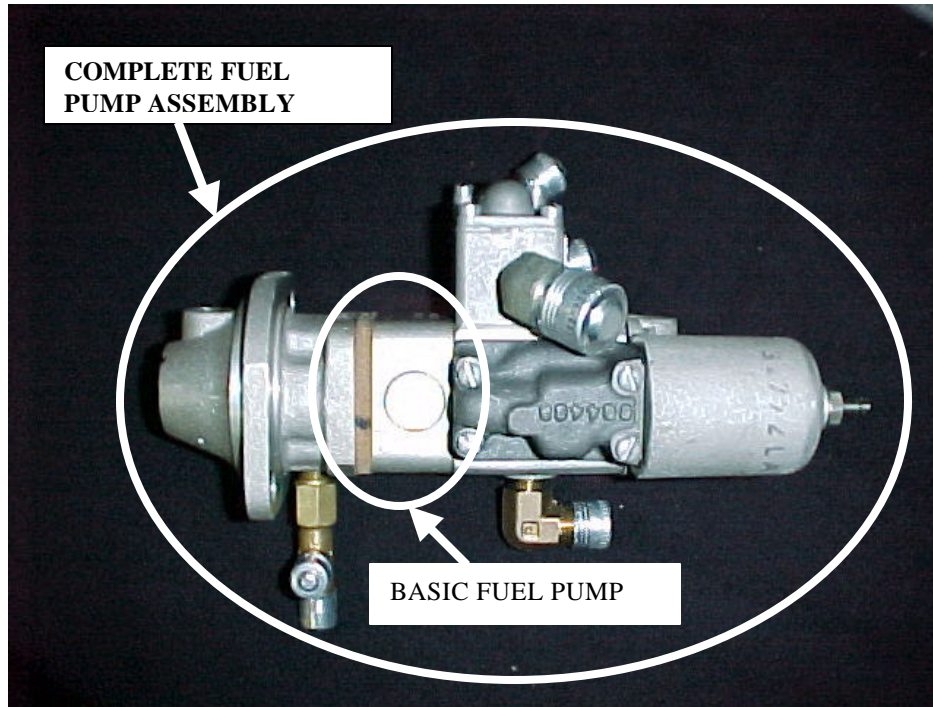
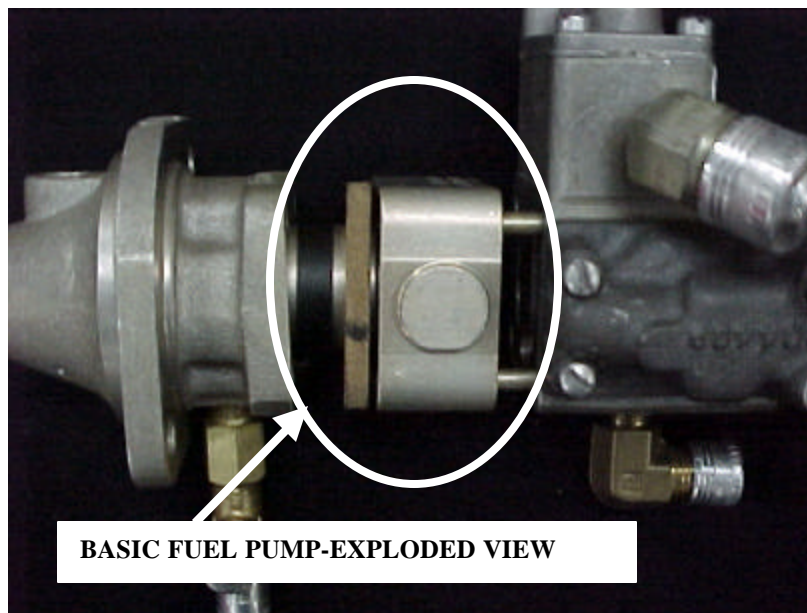
AFFECTED: IO-240, IO-360, IO-346, O-470-G7, O-470-G10, O-470-GCI, IO-470, GIO-470, IO-520, LIO-520, IO-550, GIO-550, LTSIO-360, TSIO-360, TSIO-470, TSIO-520, TSIO-550, TSIOL-550, GTSIO-520 model engines with P/N 642932-1, 2, 3 & 4 basic fuel pump ① manufactured between July 1, 1998, and May 31, 2000 ②.

① Refer to Figures 1 and 2

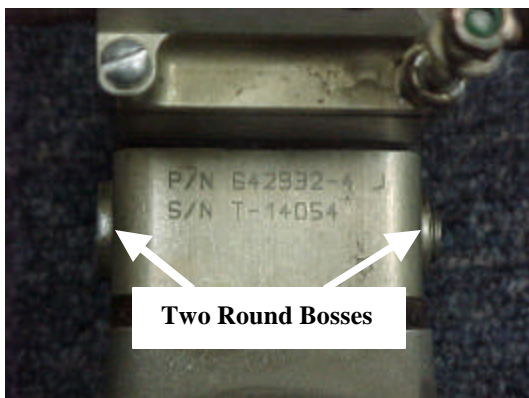
FIGURE 3
Affected Basic Fuel Pump
P/N's 642932-1, -2, -3, & -4

Affected engine driven fuel pump assemblies were manufactured utilizing basic fuel pumps P/N's 642932-1, 642932-2, 642932-3 and 642932-4. These basic fuel pumps may be identified by the presence of two (2) round bosses located on opposite sides of the basic fuel pump housing. Refer to Figure 3.

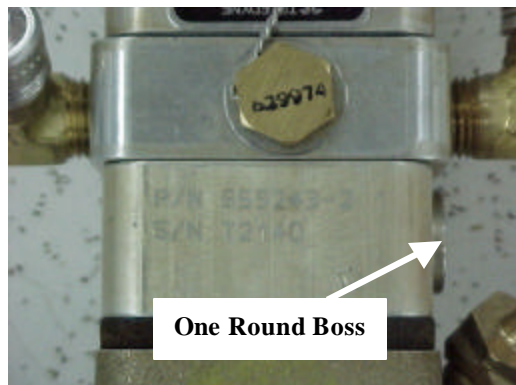
FIGURE 4
Current Production Basic Fuel Pump
P/N's 655243-1,-2,-3,&-4

New basic fuel pumps P/N's 655243-1, 655243-2, 655243-3 and 655243-4 having only one round boss are not affected by this service bulletin. Refer to Figure 4.

(basic fuel pumps with one round boss are not affected by this service bulletin)
