No.: S-2008-01, Rev. 0 Date: January 3, 2008

SUBJECT: S539800 STARTER ADAPTER CLUTCH SPRINGS and STARTER MOTORS

PURPOSE: To provide owners and operators with Instructions for Continued Airworthiness and

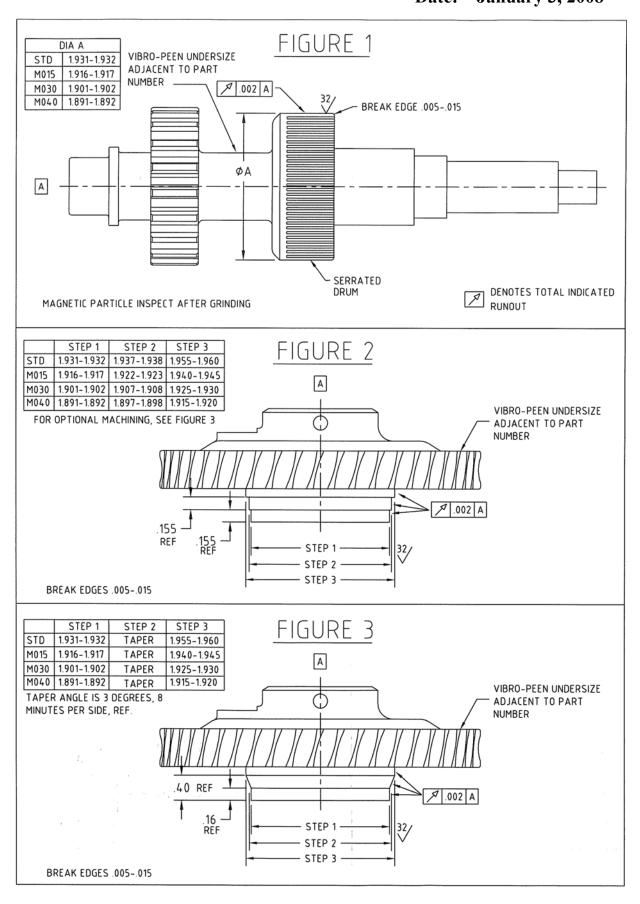
- Aircraft Specialties Services recommends that all starter adapter shaftgear and worm wheel drums be within new part limits at overhaul. See Figures 1-3 below. If machining and grinding are required, Aircraft Specialties Services can provide these services.

- Permissible wear on the shaftgear drum shall not exceed .0015" for either diameter or taper in order to be considered serviceable. Serviceable limits may be observed for mid-TBO reassembly only. If wear exceeds serviceable limits, grind the shaftgear to the next allowable undersize, or replace. See Figure 1.

- Worm wheel drums must be machined to the same undersize as the starter adapter shaftgear. See Figure 2 or Figure 3 below. Either machining configuration is permissible. All earlier worm wheels having three steps (Fig. 2) may be reworked to the current configuration of two diameters joined by a taper (Fig. 3).

- Identify shaftgears and worm wheels reworked to undersize by vibro-peening the undersize (M015, M030 or M040) adjacent to the part number per Figures 1-3. Keep vibro-peening clearly legible but as shallow as possible. Lightly vibro-peen an "X" over previous undersize markings. Identify three-step worm wheels reworked per Figure 3 details by adding the suffix "-1" to the part number.
