Beech on a Budget

Baron Engine Control Cable Replacement

This year's annual on my B55, serial number TC-971, addressed a couple of major items: the right engine's fuel system, right engine hoses, and both engines' mixture and throttle control cables. With about 1900 hours on the great-running factory reman IO-470Ls, it was time to invest in bringing the circa 1999 fuel system and hoses up to a "new" standard. Last winter the mixture control cables had been showing signs of tightness at temperatures under 50°F, and on one occasion the force necessary to move them caused one of them to shift in its locking block (inside the cabin) resulting in something less than full rich at wide open throttle. They were not going to survive another winter! The shame of these cable designs is that they only delivered 49 years/5,000 hours of service. But seriously, in my opinion, with that kind of service it did not owe me another hour.

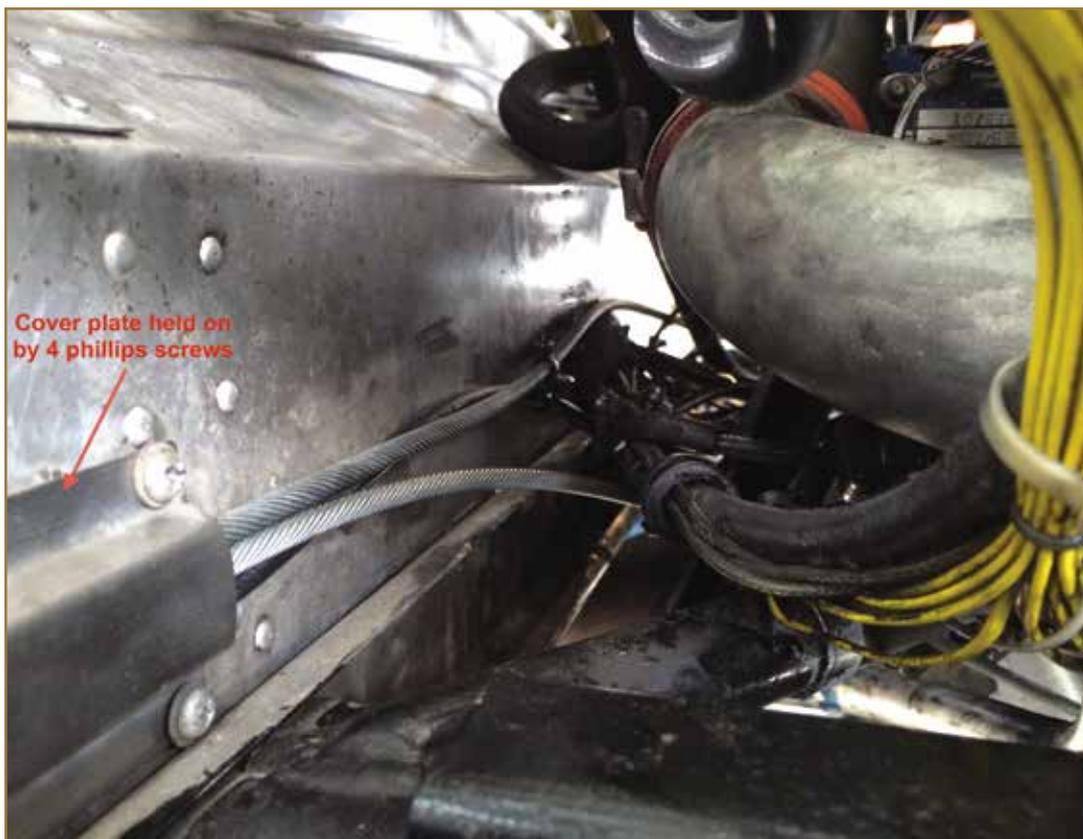
FIGURE 1

Figure 1 shows the entry point from the engine bay to the inner leading edge of the wing (**Figure 2**). The cables enter the fuselage (**Figure 3**) and then route around behind the rudder pedals (**Figure 4**). They are secured by Adel clamps. These Adel clamps are in excruciatingly hard places to reach. Bear in mind, you will be working over the seat tracks and stretching to reach these, so have an old sofa cushion or pillow to prevent seat track imprints in your chest. The forward screws for the console side panels are also excruciatingly difficult to access. Having a ratcheting screwdriver or battery-powered driver is very helpful for this area.

Cover plate held on by 4 phillips screws

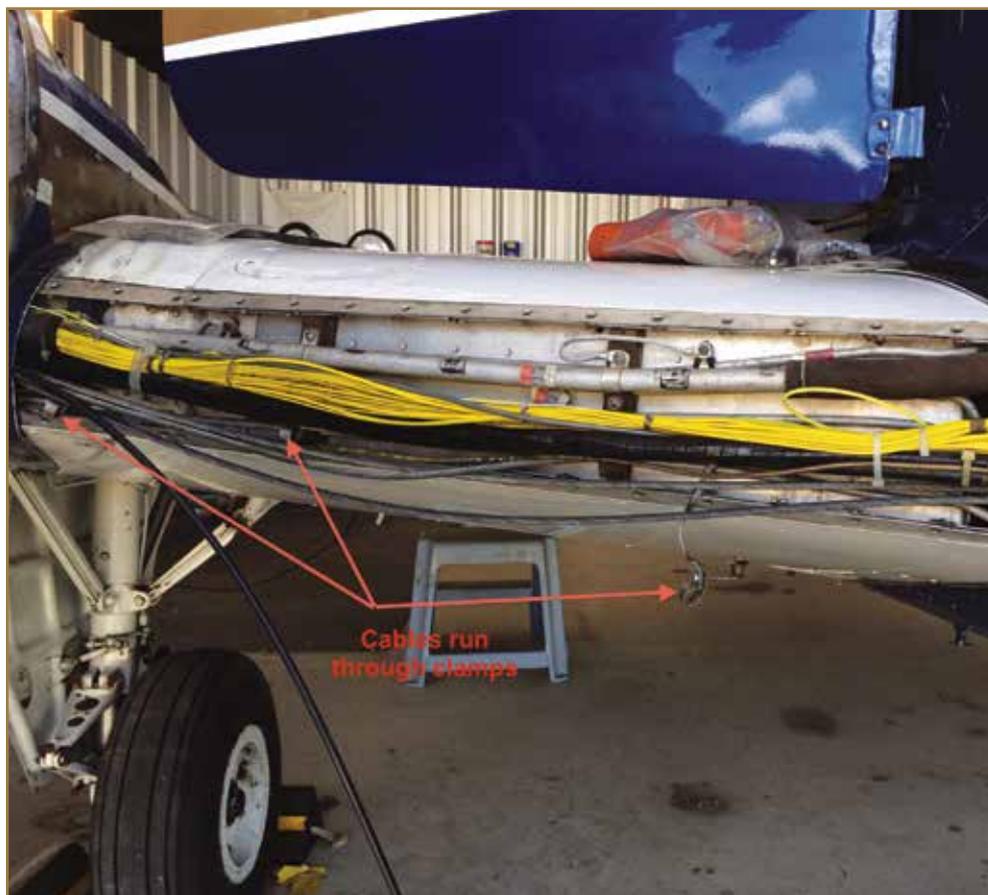
FIGURE 2

Cables run through clamps

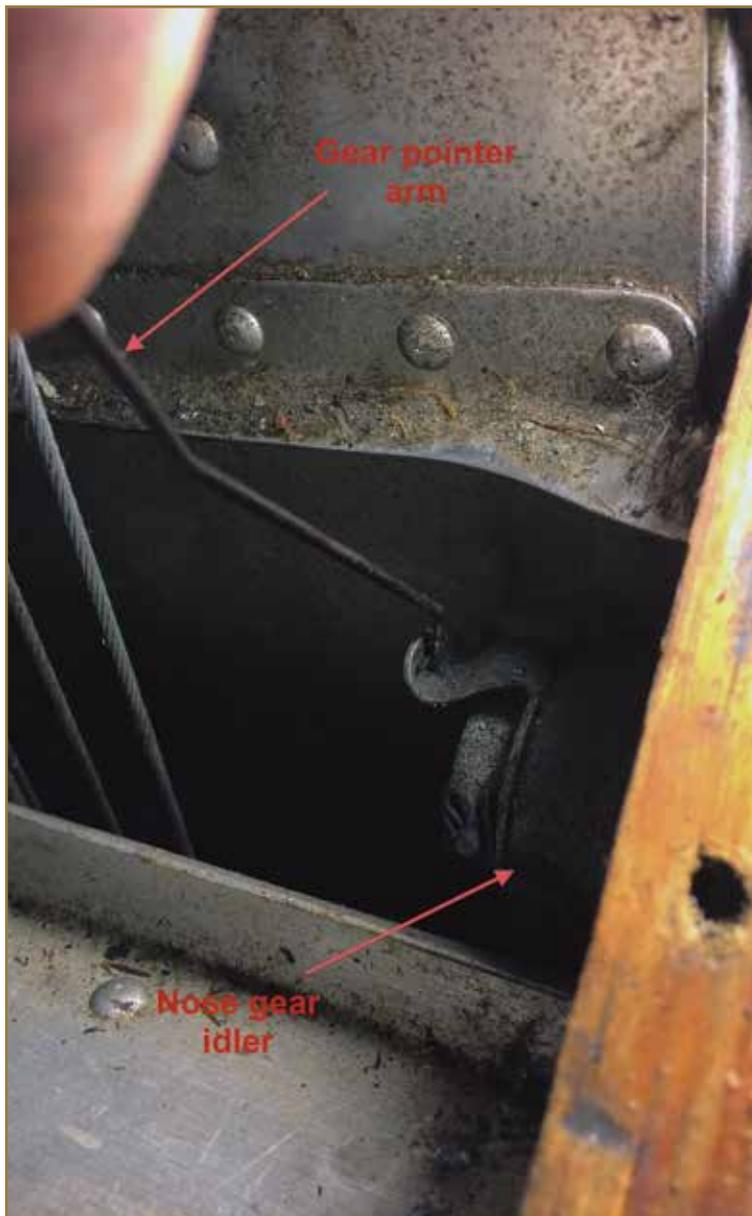
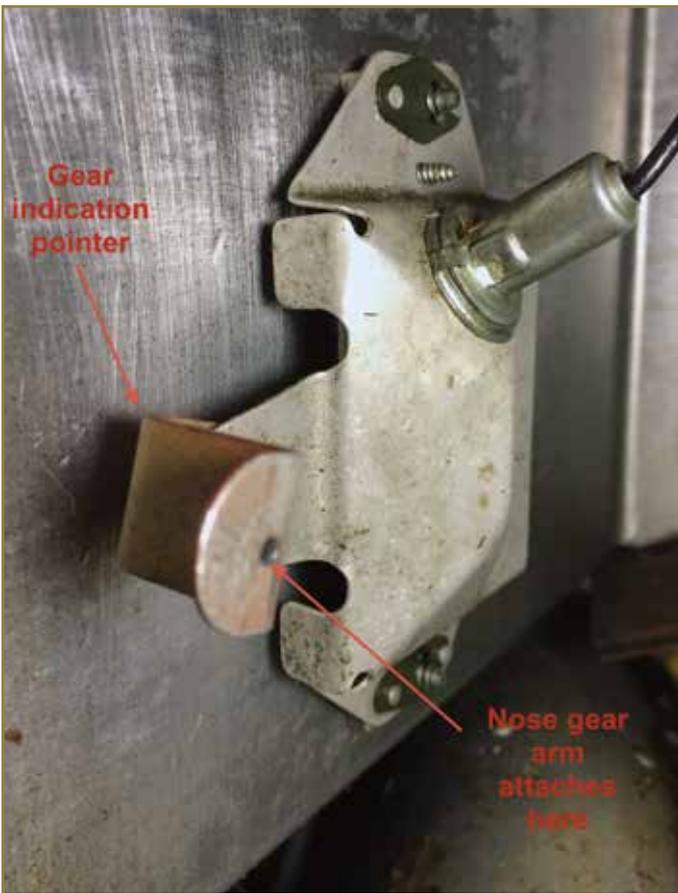
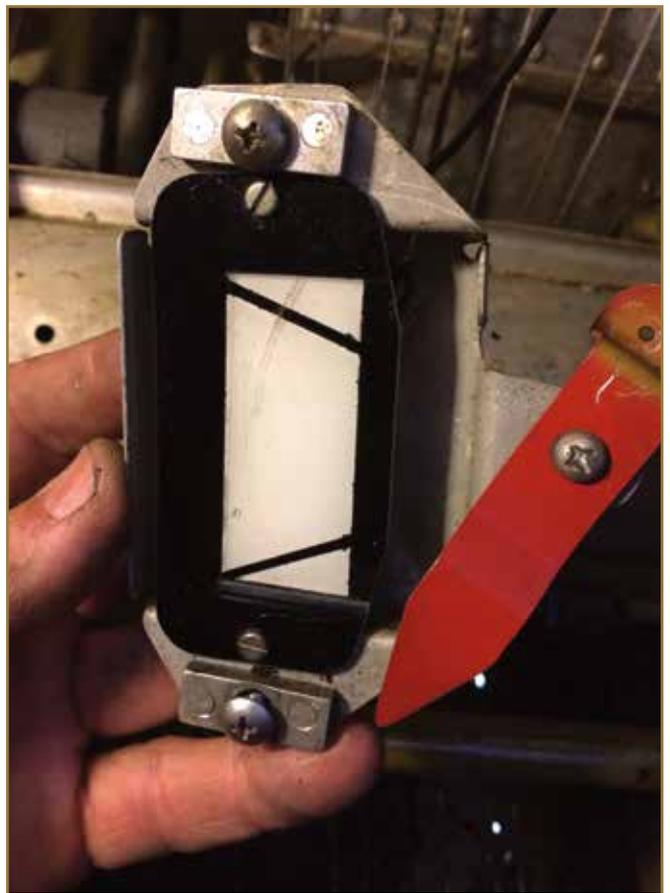
Another area of caution is the landing gear pointer indicator (if your aircraft is so equipped). **Figures 5, 6, and 7** show the little arm that connects the pointer arm to the nose gear idler arm such that when the nose gear rod is pushed forward, the rod transfers this motion into a motion that pulls on the pointer arm.

Side note: You can see that the pointer is only capable of telling you that the nose gear rod was pushed forward so it pulls on the indicator pointer. It does not tell you anything about the real position of the wheels. If all the gear rods and landing gear mechanism is intact, then all will be well. The little rod arm retainers are quite small and easily lost, so be sure to keep track of them for reassembly.

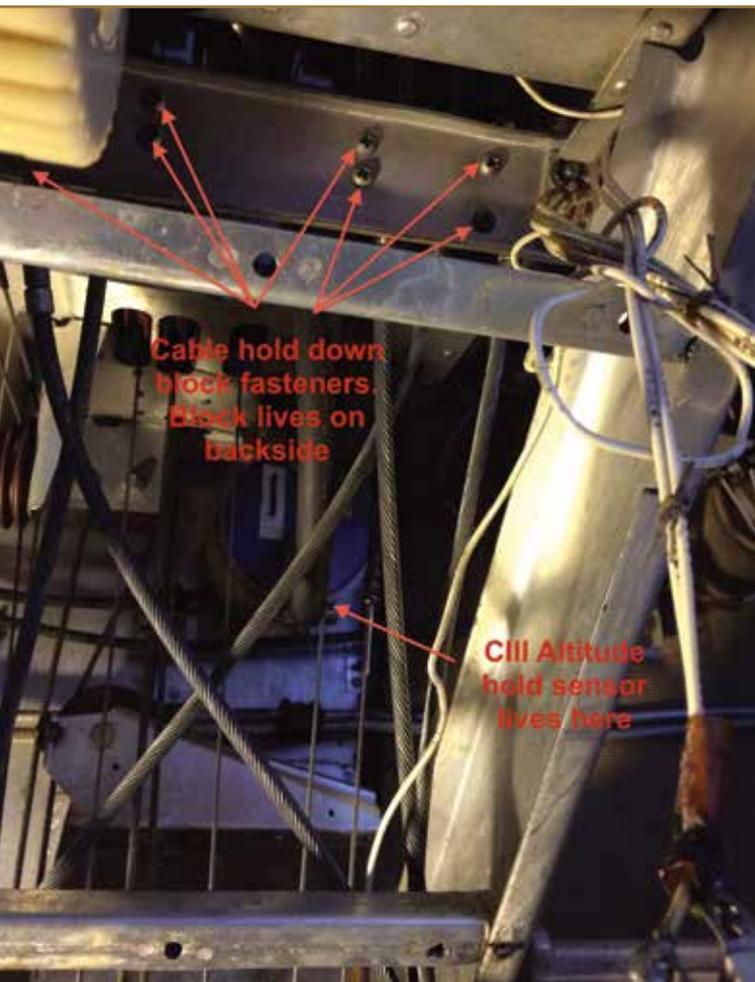
FIGURE 8

The inside cables are held in place by a pair of aluminum blocks that are fastened to the console framework. **Figure 8** shows the block's fasteners and **Figure 9** shows the hold-down block itself. The grooves in the block form a clamping force around the knurled section of the cable and the

console frame arm. These fasteners are small and quite old so you might consider sourcing new ones especially if the Phillips heads start to show any signs of destruction.

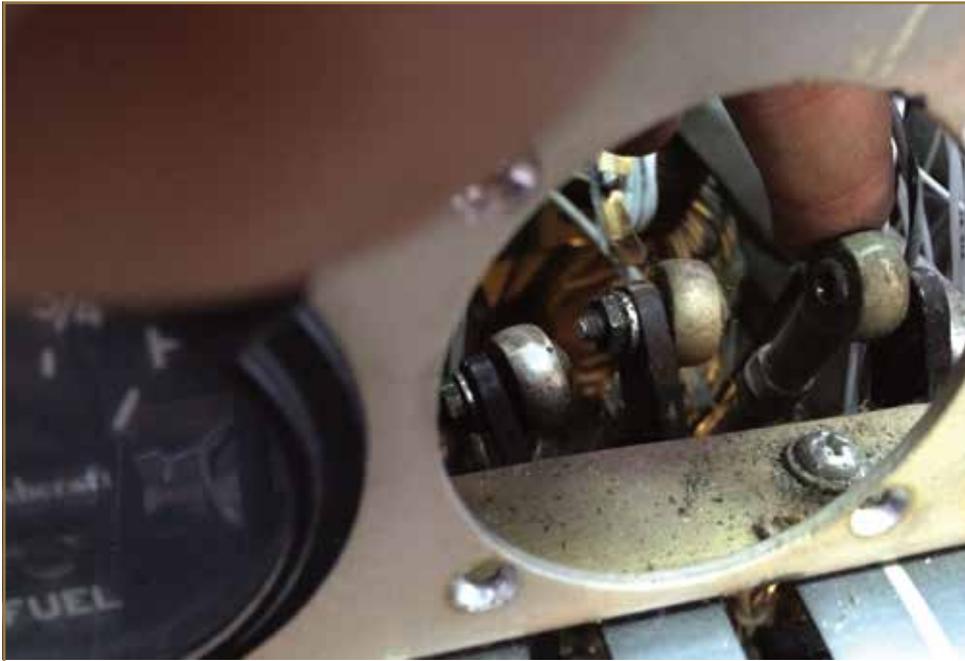
FIGURE 10

The last leg of the interior journey is the rod end attachments at the levers (**Figure 10**). This is where you

will need the center instrument panel cleared of all the instruments so as to operate a stubby flathead screwdriver and wrench. It's a great idea to photograph or draw a diagram of how all the hardware is oriented so that all the screw heads and nuts are oriented exactly as found on the levers.
