## SERVICE BULLETIN

**TITLE: FUEL - INSPECTION FOR CLEARANCE AND ROUTING OF FUEL SELECTOR CABLE**

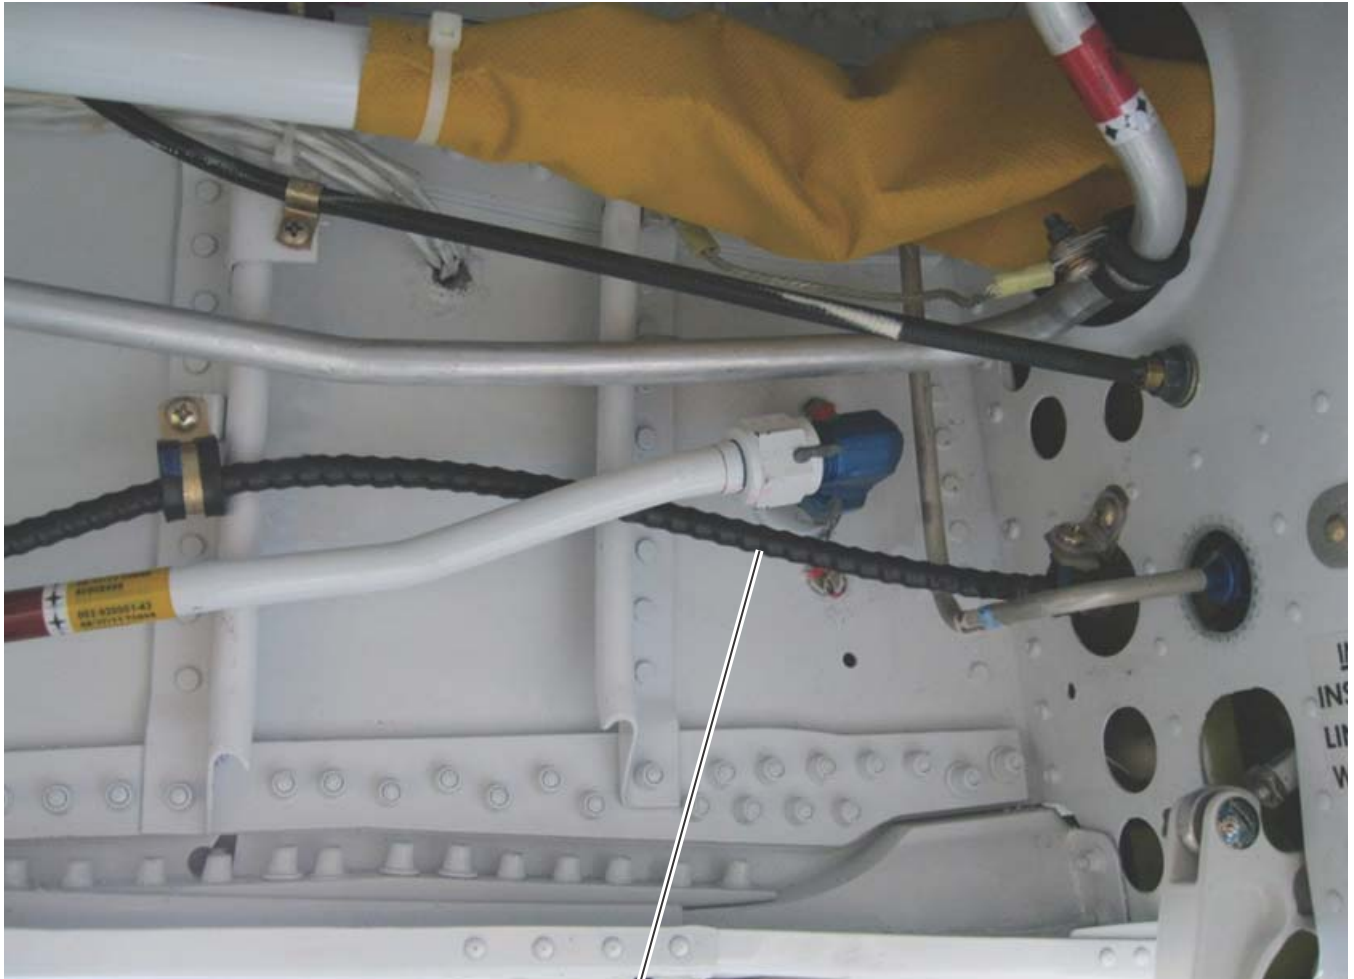
**Inspection of Fuel Selector Cable  
Figure 1**

This Service Bulletin is being issued to verify that fuel selector cables are properly secured and clear of adjacent components within the wheel well compartments of both main landing gears. An unsecured fuel selector cable could lead to chafing against structure, fuel delivery lines, or other systems.

INSPECT TO VERIFY THAT THE FUEL  
SELECTOR CABLE IS SECURE.

DETERMINE IF CLEARANCE EXISTS BETWEEN  
THE CABLE AND ADJACENT COMPONENTS.

DETERMINE IF CHAFING EXISTS.

- (d) If the fuel selector cable is not secure, clearance does not exist, or if chafing can be seen, proceed to Step (7).
- (7) Secure the fuel selector cable and achieve clearance in accordance with guidelines provided in Baron 55 and 58 Maintenance Manual, Chapter 20-10-00-201, or the applicable shop manual. If necessary, repair or replace components in accordance with the applicable maintenance or shop manual.
