Safety Communique

January, 2012

**MODELS: PISTON, ALL MODELS, ALL SERIALS;
KING AIR, ALL MODELS, ALL SERIALS;
AIRLINERS, ALL MODELS, ALL SERIALS**

SUBJECT: FLIGHT CONTROL CABLE SYSTEM INSPECTIONS

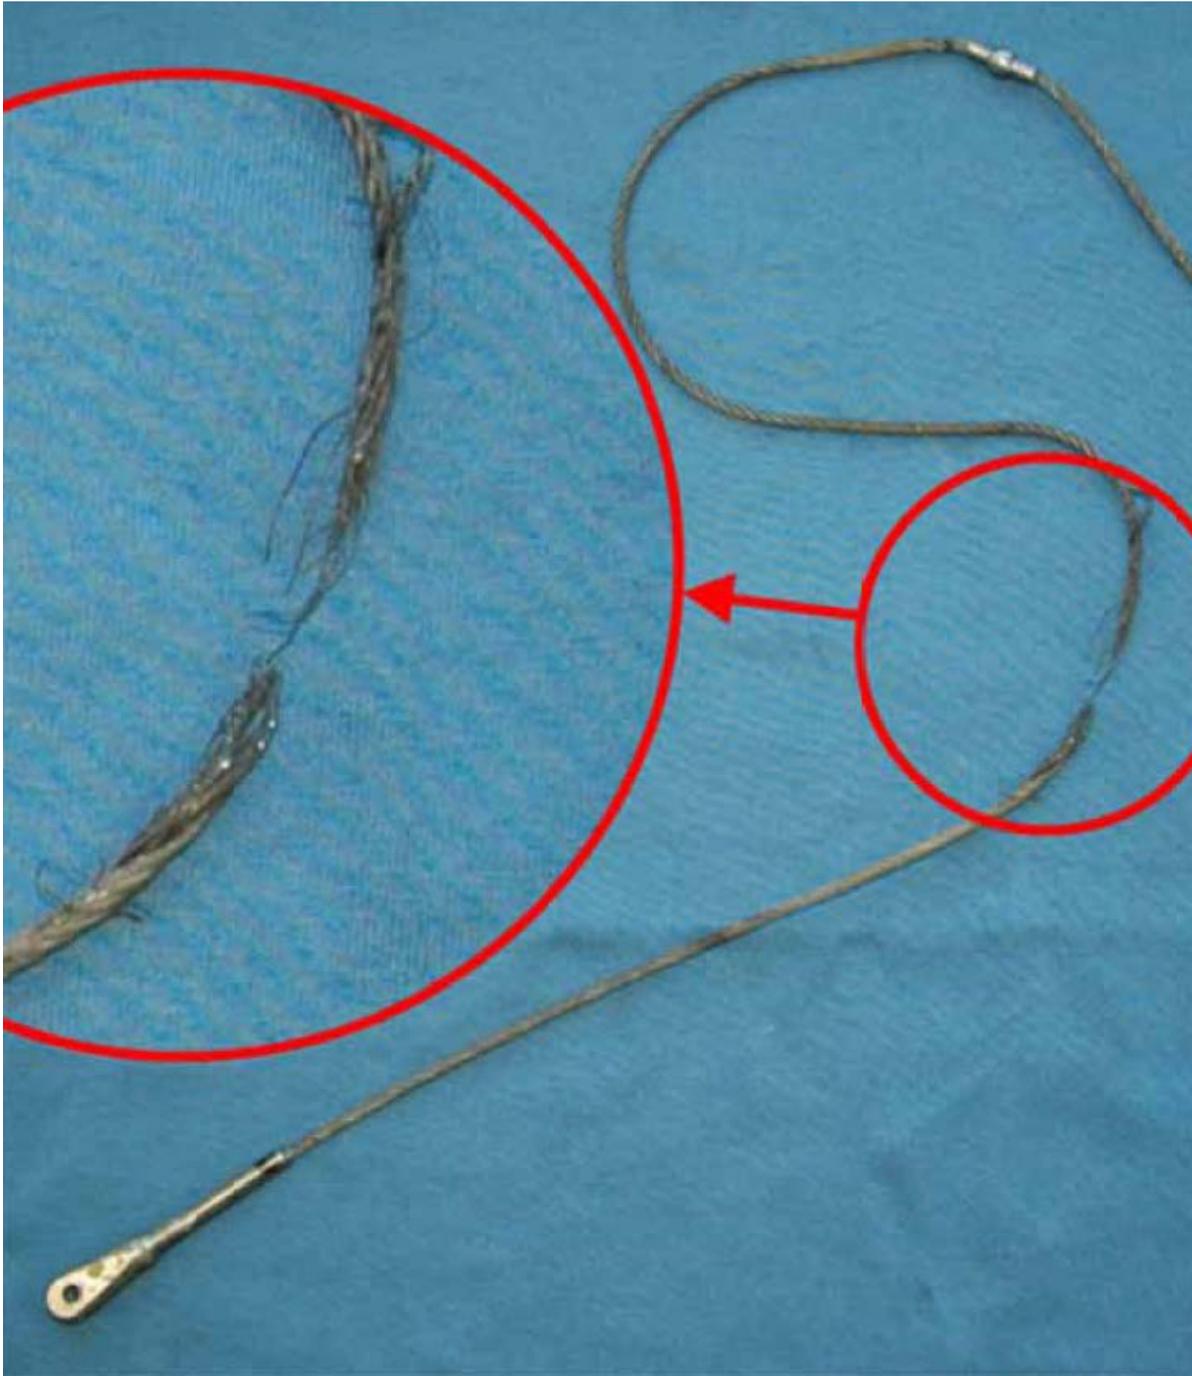
On December 4, 2011, HBC received a field condition report (FCR) from the owner/operator of a 1968 Bonanza Model E33 airplane with 4610 flight hours. A part number (P/N) 33-524000-63 forward elevator cable assembly was reported to have frayed to the point that only a few strands of cable remained intact. This discovery occurred just prior to takeoff. Figure 1 shows the frayed cable that was removed.

Frayed Elevator Control Cable
Figure 1

HBC reminds owners/operators of the importance of maintaining corrosion preventive compound on control cables and applying proper lubricants to control cable system components as defined in the applicable airplane Shop or Maintenance Manual. Replace control cables showing evidence of corrosion.
