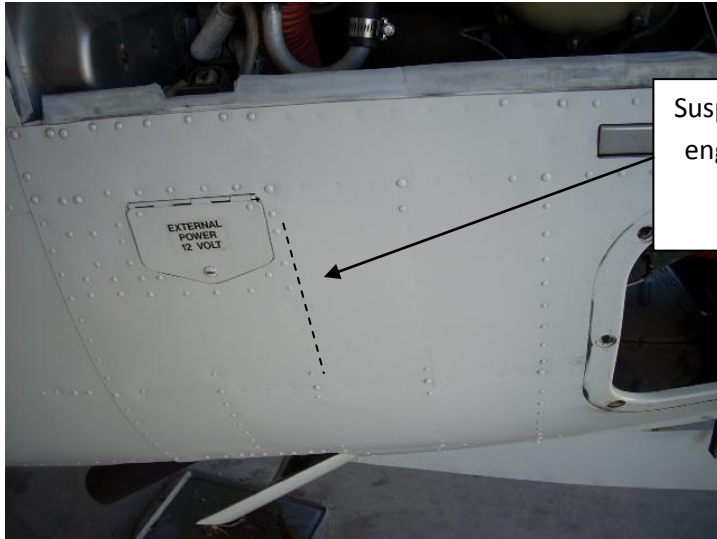
Suspect aluminum rib is located inside engine compartment at this location (A36)

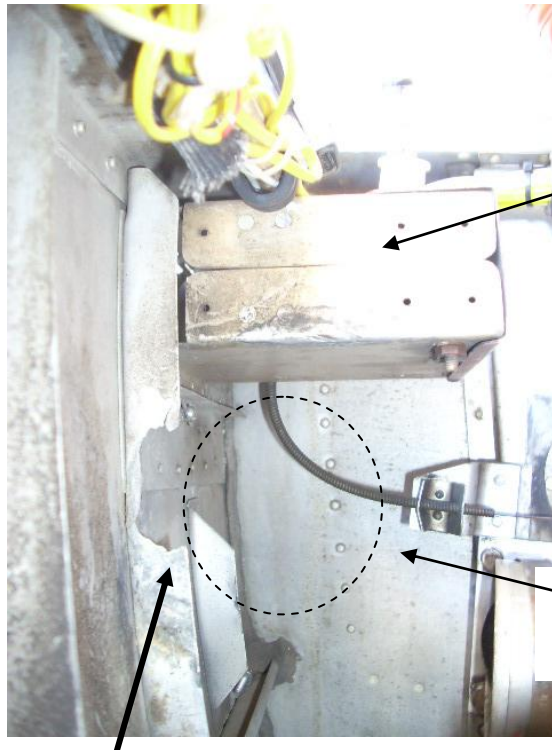
View looking toward firewall. Heater Hose has been removed for this photo

Corrosion location
