MAJOR REPAIR AND ALTERATION (Airframe, Powerplant, Propeller, or Appliance)

1. Aircraft	Make Beechcraft	Model S35
	Serial No. D-7924	Nationality and Registration Mark N8939U
2. Owner	Name (As shown on registration certificate) Siegfried, Robert W. II	Address (As shown on registration certificate) 711 Millbrook Drive Downers Grove, IL 60516

8. Description of Work Accomplished

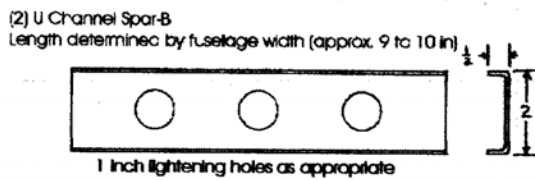
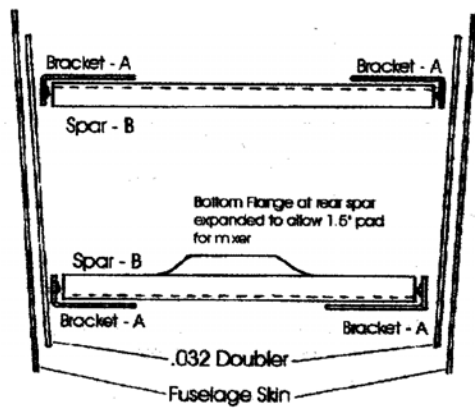
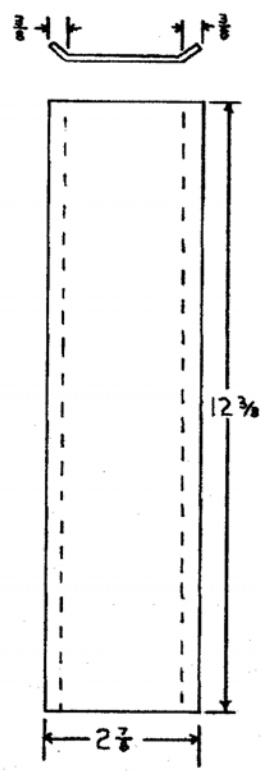
Comant Model CI 120 GS VHF Navigation antenna blades installed on either side of the aft fuselage at station 265. The leading edges of the blades are four and one-sixteenth of an inch above the lowest point of the fuselage in that area and the trailing edge is four inches above the bottom of the belly skin at that point. There is a doubler of .032 2024 T3 aluminum placed on the inside of the fuselage skin. For corrosion protection, Hysol EA 9309NA epoxy paste adhesive was applied between the doubler and the fuselage skin in accordance with the manufacturer's instructions. The doubler is riveted to the skin at four points with AN 470 AD 3-3 rivets. Suitable brackets and braces connect the two antennas and provide mounting structure for the antennas. Dimensions for the doublers, brackets and braces are given below. All four brackets and both braces are made of .040 2024 T3 aluminum. Brackets connect to braces using AN 470 AD 3-4 rivets. Antennas are mounted to brackets using manufacturer supplied 8/32 screws into NAS 697-08 plate nuts which are riveted to the brackets. Sketches below depict orientation and contain dimensions of the brackets, braces and doubler plates. A pad for the attachment of the Power Combiner P/N CI 120-3 is provided for on the bottom of the rear brace. All work has been conducted in accordance with manufacturers instructions and/or AC 43.13-1B, Chapter 4, Section 4, AC 43.13-2A, Chapter 3, paragraph 39. Weight, balance and equipment list adjusted as required. Prior to IFR flight, proper VOR, LOC and Glide Slope reception is to be verified in accordance with instructions contained in King KX 170/175 Series Installation Manual 006-0085-01 and so noted in aircraft records.

.032 Doubler
