**SERVICE BULLETIN****SB20-06**

**TECHNICAL PORTIONS  
FAA APPROVED****SUBJECT:** Hydraulic Lifter Assemblies**PURPOSE:** Inspect and replace affected hydraulic lifter assemblies (Part No. 657912) or lifter sockets (Part No. 657917) shipped by Continental between *17 January 2019* and *22 October 2020*.**COMPLIANCE:** Inspection upon notification of this service bulletin and replacement by next 100-Hour, Annual, or Progressive inspection, or maintenance event.**MODELS****AFFECTED:** Continental Aerospace Technologies new or rebuilt C90; C125; C145; 0200A, B, C, D; 0300A, B, C, D; G0300A, B, C, D, and RR C90; RR 0200A, B, C; RR 0300A, B, C, D aviation gasoline (AvGas) engines assembled, overhauled or repaired with affected 657912 lifter assemblies or 657917 lifter sockets.**I. GENERAL INFORMATION**

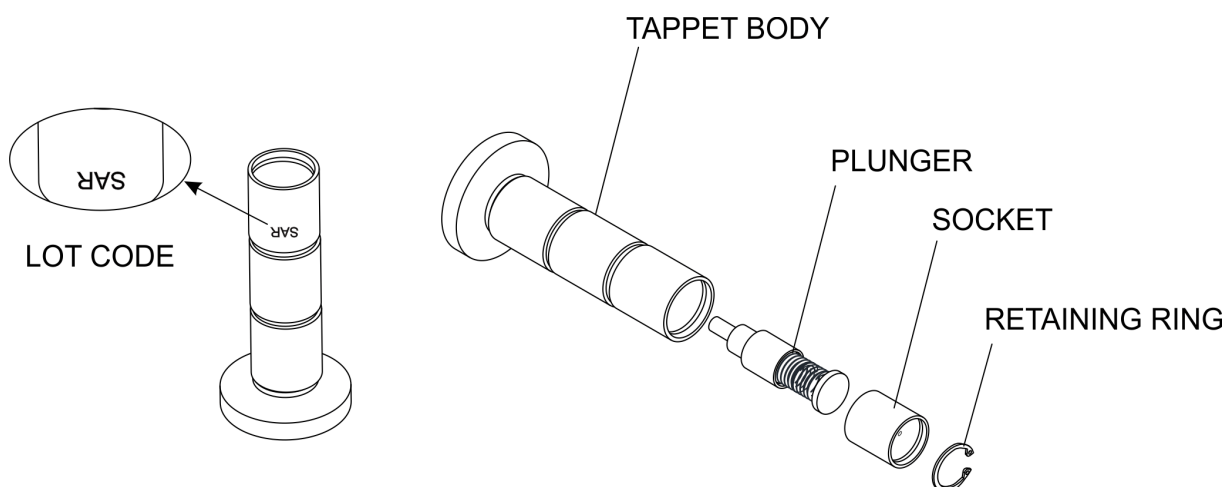
**Figure 1. Lot Code Marking Location**

The suspect nonconforming hydraulic lifter sockets have no identifying marks. A lot code is etched near the top of the lifter bodies (see Figure 1). The lot code is visible in the crankcase with the pushrod housings and pushrod adapters removed from the crankcase and the camshaft rotated to the top of the lobe. Affected lifter assemblies lots, listed in Table 3 contain the suspect sockets. Lifter assemblies (Part No. 657912) with these lot codes must be removed from inventory and service unless the socket is replaced.

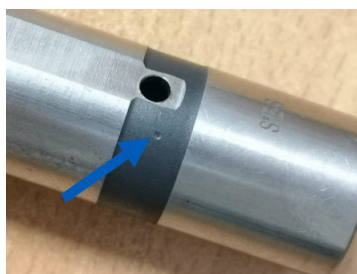
**Figure 2. Reworked Lifter Identification**

The supplier has reworked a limited quantity of lifters by replacing the affected sockets to expedite corrective action. If the lifter is identified with a lot code from Table 3, but a single punch mark (Figure 2) is present on the neck, lifter rework has been accomplished.
