ELECTRICAL PROBLEMS

Troubleshooting fuel gauge(s) & associated components.

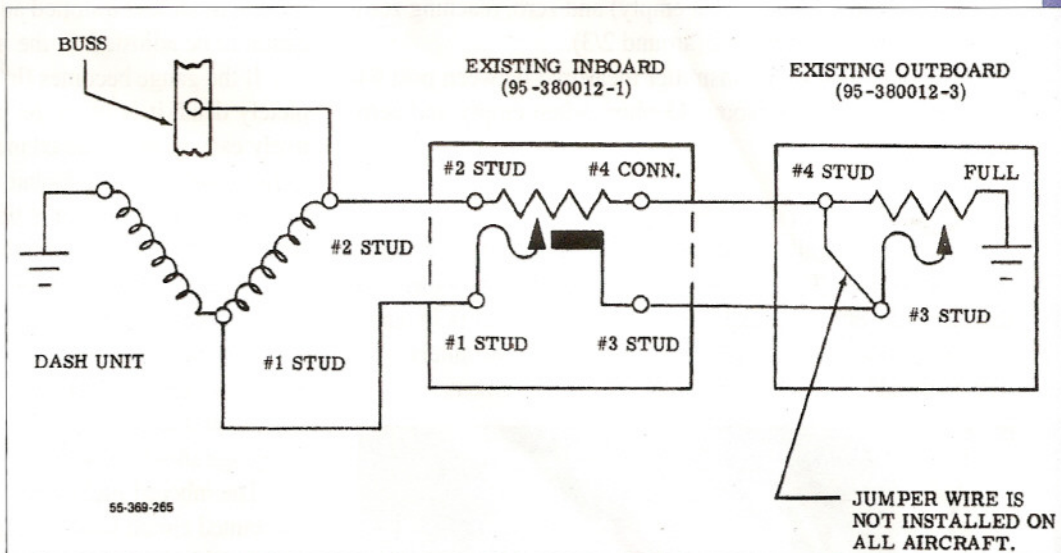
Figure 1 - Original transmitters 1962 thru 1969

When the voltage output from the transmitter is at zero volts (ground), all of the current flows thru the full position coil and the empty position coil doesn't have current flowing through it because the voltage on both sides of the coil is zero. Therefore the gauge indicates full.

When the voltage output from the transmitter is at 12 volts, all of the current flows through the empty position coil and the full position coil doesn't have current flowing through it because the voltage on both sides of the coil is the same, 12 volts. Therefore the gauge indicates empty.

When the voltage output from the transmitter is at 6 volts, the current is the same in both the full position coil and the empty position coil because they both have 6 volts across them. Therefore the needle indicates half full (or half empty if you are a pessimist).

There are two vintages of transmitters and they can be intermixed. The *original transmitters* have four studs (inboard) and two studs (outboard). The *replacement transmitters* have two studs (inboard) and one stud (outboard).

To troubleshoot the system, remove the inspection panel above the inboard fuel transmitter. With the master switch on, verify that you have +12 volts on stud #2 of the transmitter.

Stud #1 has the wire that goes to the gauge. If you remove the wire from stud #1 (open), the gauge should read half-scale. If you ground the wire terminal lug, the gauge should read full. If you touch the terminal lug to the #2 stud (+12 volts), the gauge should read empty. Turn off the master switch. *If your gauge doesn't read properly, have it overhauled.*

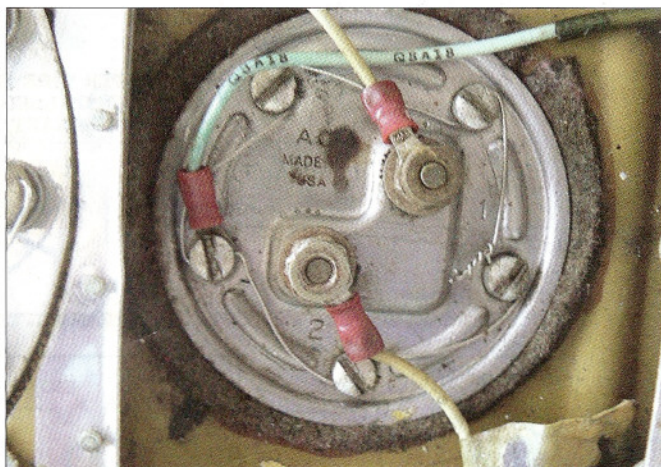
Figure 3 - Inboard fuel transmitter - replacement style 1962 thru 1969

The inboard fuel transmitter case should be isolated from ground by a felt washer (Figure 3). If it is not, the gauge will read full until the actual fuel level is close to 2/3 and then will move the rest of the way faster than the change in the fuel level, although it will read correctly when the tank is empty.

Remove the wire attached to the case and that connects to the outbound fuel transmitter. Verify that the case is not grounded. If the case is grounded, reseal or replace the felt washer.

With the wire from #1 stud and the case still removed, the resistance between the #2 stud and the case should be around 76 ohms. The transmitter wiper (stud #1) should vary between the full resistance value (when empty) and zero, reaching zero well before being topped off (around 2/3).

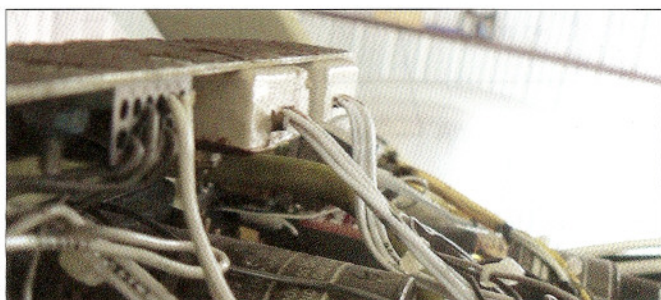
Figure 4 - Printed circuit modules 1970 and later

Each side's transmitters are attached to a printed circuit module mounted above the fuel gauges under the angle mount for the glareshield support (Figure 4). On the rear lefthand side of each module is a slotted adjustment that allows the full indication to be adjusted on the indicator.

If the gauge becomes flaky and bounces around or is completely dead, it is often the printed circuit module. It is relatively easy to swap the connectors on the back of the left and right modules to help isolate the problem module. If the fault goes with the module, it is time to send it out for repair. Birks Aviation Products (309-686-0614) rebuilds and exchanges these modules for a flat \$430. Birks advertises in the classified-ad section of the *ABS Magazine*.

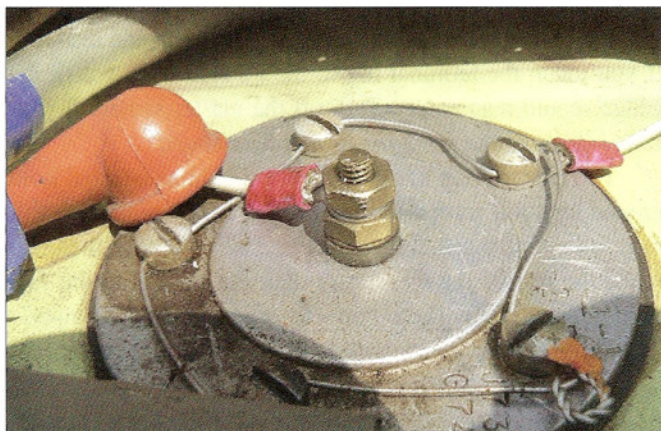
Figure 5 - Inboard fuel transmitter 1970 and later

The inboard fuel transmitter has one post that connects to the printed circuit module (Figure 5). The case is the other terminal and is attached to the outboard transmitter. The circuit is completed by the outboard transmitter, which is grounded to the airframe.

The inboard fuel transmitter has a felt washer under the case to isolate it from ground. If this is missing, the case will be grounded and the tank will never read above 2/3. If the outboard transmitter is shorted internally, it will cause the same symptom.

When the tanks are full, measure the resistance of the inboard transmitter from the post to the case and verify it is close to 76 ohms. Verify the case is not shorted to ground; if it is, verify the felt washer is installed and isolating the case from ground.

Verify the outboard transmitter is close to 43 ohms, post to ground. If you remove the transmitters, they should smoothly vary in resistance between zero and the maximum value as they are moved through the float arm range.
