**AIRBORNE ELECTRONICS**  
**350A PROPELLER GOVERNOR**  
**INSTALLATION INSTRUCTIONS**  
**and SERVICE NOTES**

INSTALLATION INSTRUCTIONS	Page 1
GROUND TEST	Page 3
FLIGHT TEST	Page 4
IF TROUBLE, WHERE TO START	Page 4
AIRFRAME SYSTEMS TEST (S/N 1)	Page 5
DEFECTIVE MAGNETOS (S/N 2)	Page 8
WRONG GEARS (S/N 3)	Page 8
BRUSH SERVICE (S/N 4)	Page 8
INACCURATE PANEL TACH (S/N 5)	Page 9
INTERMITTENT PROBLEMS (S/N 6)	Page 10
BLOWN FUSES (S/N 7)	Page 11
OPEN MAG LEAD (S/N 8)	Page 11
MANUAL WIRING (S/N 9)	Page 11
HIDDEN SCREWS (S/N 10)	Page 12
WEIGHT and BALANCE (S/N 11)	Page 12
FIGURE A	WIRING DIAGRAM
FIGURE B	WRONG GEARS
FIGURE C	EARLY WIRING
FIGURE D	LATE WIRING
FIGURE E	KNOB MOUNTING and TEMPLATE
FIGURE F	CHASSIS MOUNTING
FIGURE G	FLIGHT MANUAL SUPPLEMENT
FIGURE H	SUPPLEMENTAL TYPE CERTIFICATE

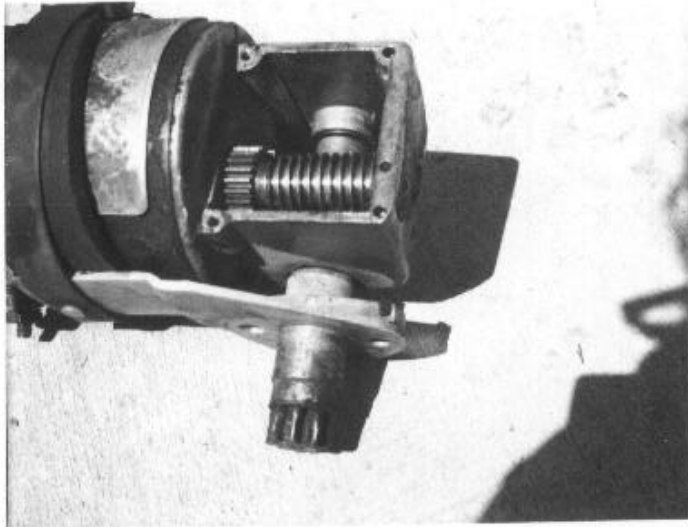
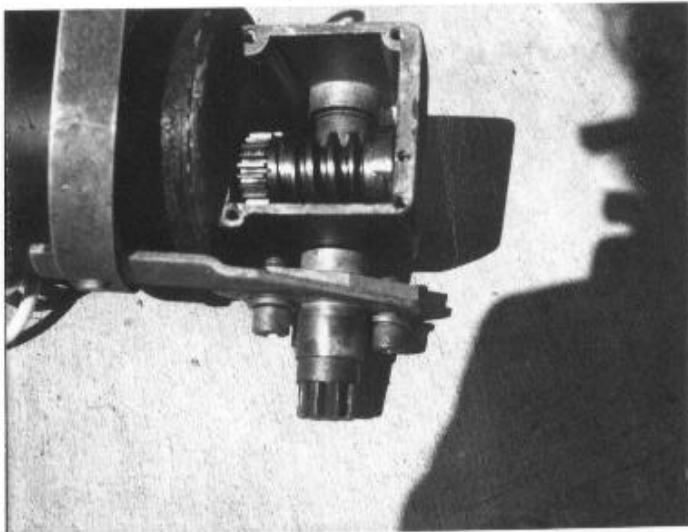
FIGURE B

215-210 propeller control motors have been found in the field with wrong gears installed. The worm gear and the output helical gear from the Bonanza flap actuator will fit the propeller motor but will result in a 3 to 1 smaller gear ratio. See figure B.

A simple test can be performed to determine if wrong gears are installed. With the engine not running, measure the time required to operate the propeller between pitch extremes manually. This time should be between 16 and 32 seconds. If flap actuator gears are installed, the time will be between 6 and 12 seconds. If wrong gears are suspected, the gear box cover can be easily removed without removing the motor.

The smaller gear ratio can result in unstable operation of the model 350A governor. Also, the smaller ratio is potentially dangerous whether or not the aircraft is equipped with a governor, as the reduced gear-motor friction can allow the prop to drift toward full coarse pitch with no voltage applied. In the event of an electrical failure, this situation could become serious.

PROPELLER PITCH  
MOTOR WITH CORRECT  
GEARS INSTALLED

PROPELLOR PITCH  
MOTOR WITH FLAP  
ACTUATOR GEARS  
INSTALLED
