Beech on a Budget

By Mike Caban

Strut Rebuild – Low Cost and Simple

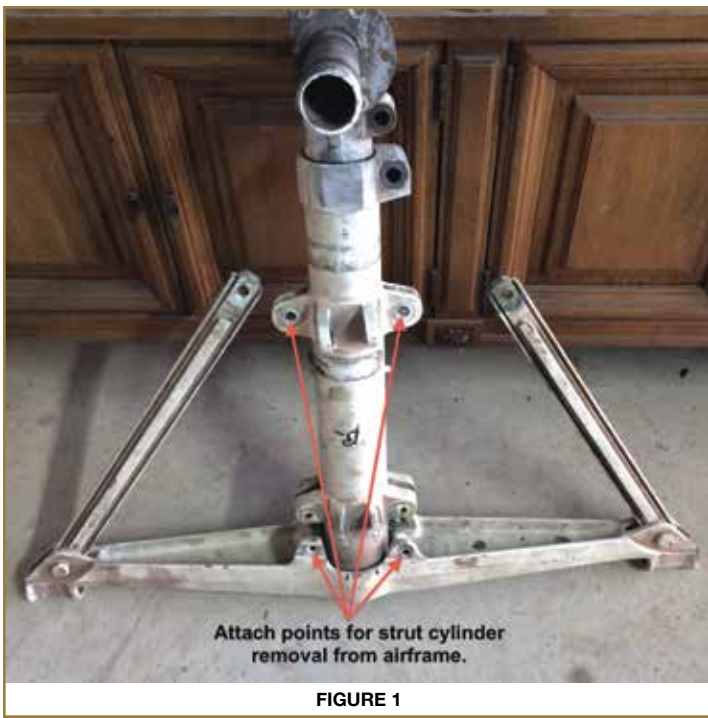
FIGURE 1

My IA suggested that our best approach would be to remove the cylinder from the airframe without disturbing the bolts holding the support frame in the wing, and replace it with the rebuilt low-time serviceable unit. **Figure 1** shows the serviceable unit removed from the support frame.

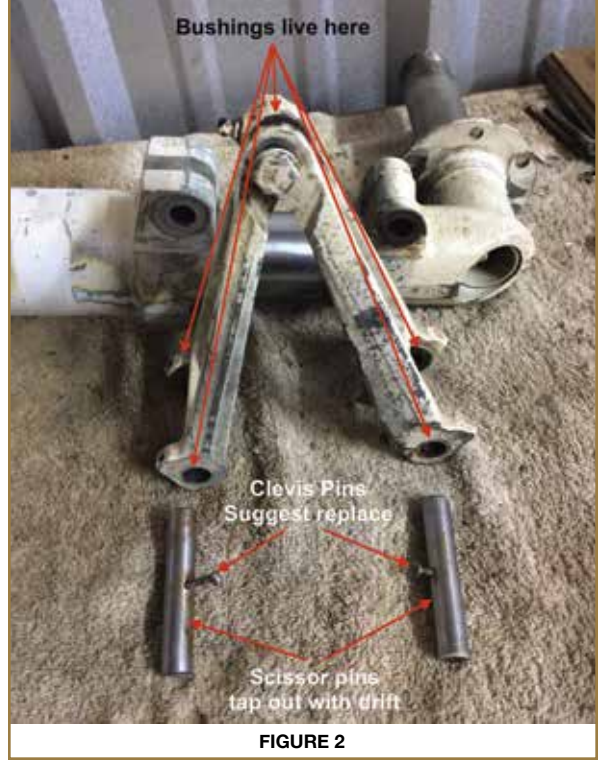
FIGURE 2

Next, remove the scissors from the shock and cylinder. They are held in place by floating pins that are secured in place by clevis pins and cotter pins. **Figure 2** shows the pieces laid out on the bench. When reassembling your scissor section to the base of the cylinder, be sure to remember to properly configure the stop, which prevents the pin from sliding out (**Figure 3**).

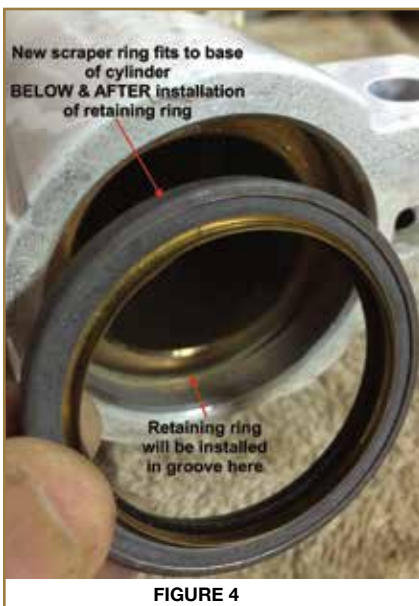
FIGURE 4

Then it was a good time to remove the old scraper seal at the base of the cylinder. **Figure 4** shows a new scraper seal for installation. I grabbed the old scraper seal at its protruding inner lip and began to maneuver the seal out. The scraper seal for my particular aircraft SN is P/N 504271. Beechcraft is sure to have it, or it can be sourced from www.kscdirect.com for around \$10.50 each.

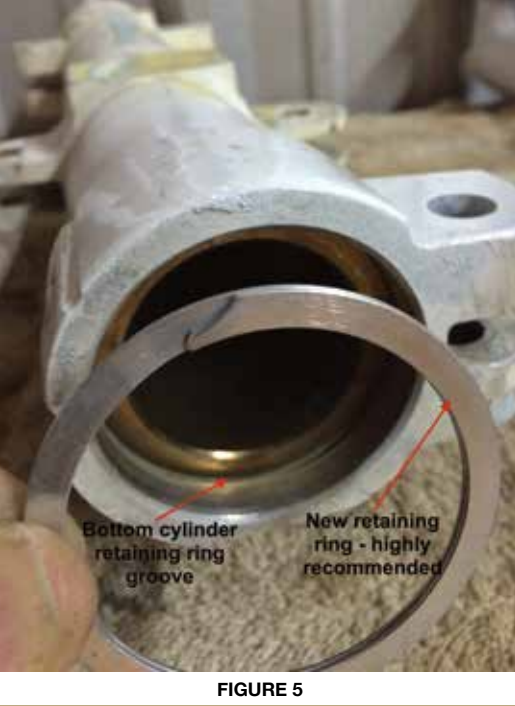
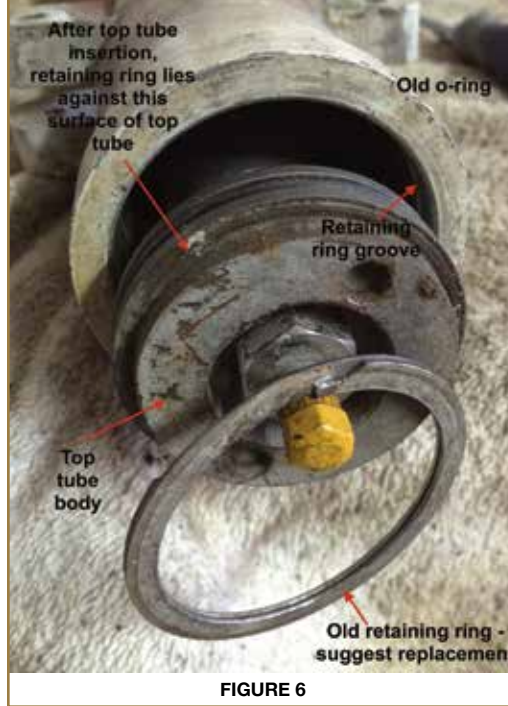
FIGURE 5

Next I removed the old retaining ring at the base of the bronze section of the cylinder (**Figures 5 & 6**).

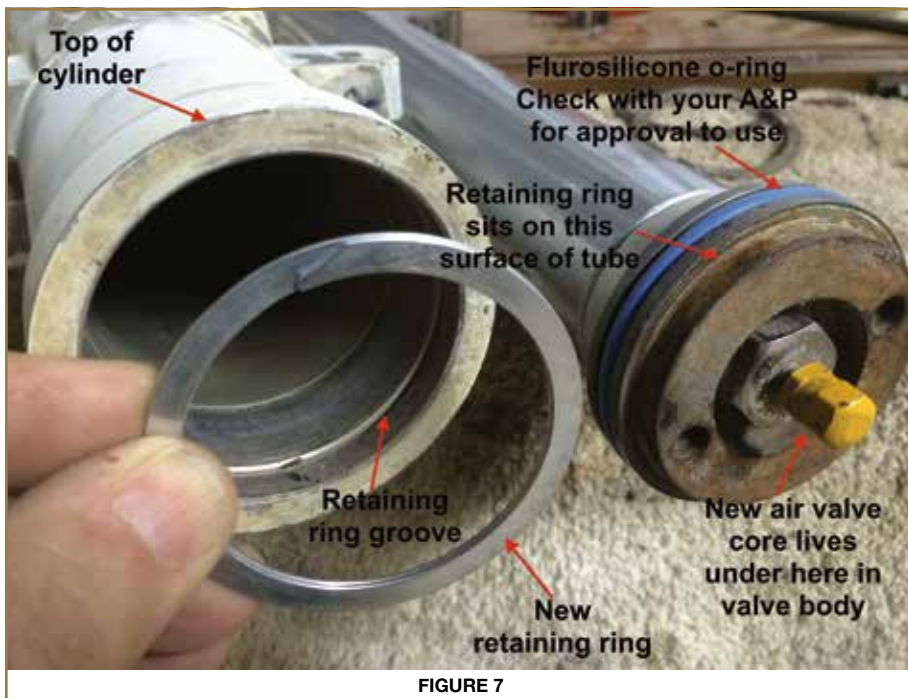
FIGURE 7

Moving to the top of the cylinder, I removed a similar retaining ring that holds the perforated tube in the cylinder. This allows the tube to be pulled out of the cylinder, which exposes the top O-ring that will need to be replaced (**Figure 7**). This is also a good time to replace the Schrader valve core through which you will service the unit with nitrogen, and remove the old O-ring and position your new one.

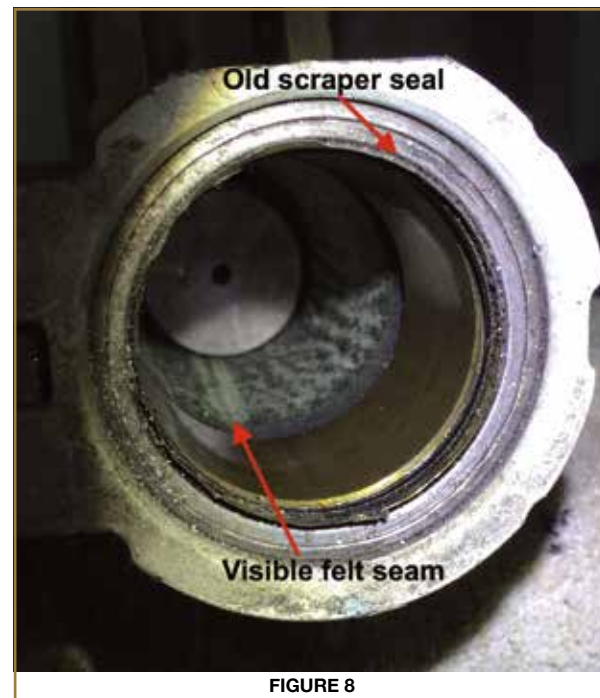
FIGURE 8

I then moved to the other end of the cylinder to attack the felt at its seam (**Figure 8**). With a long screwdriver, I carefully (without scratching any of the cylinder barrel) picked at the felt seam to lift a corner section such that a needle nose plier could be employed to grab the felt corner to twist and pull it out of the cylinder (**Figures 9 & 10**). New Beechcraft felt for my SN is P/N 35-815247-9 (**Figure 11**). With your mechanic's approval, one of these lower-cost felt

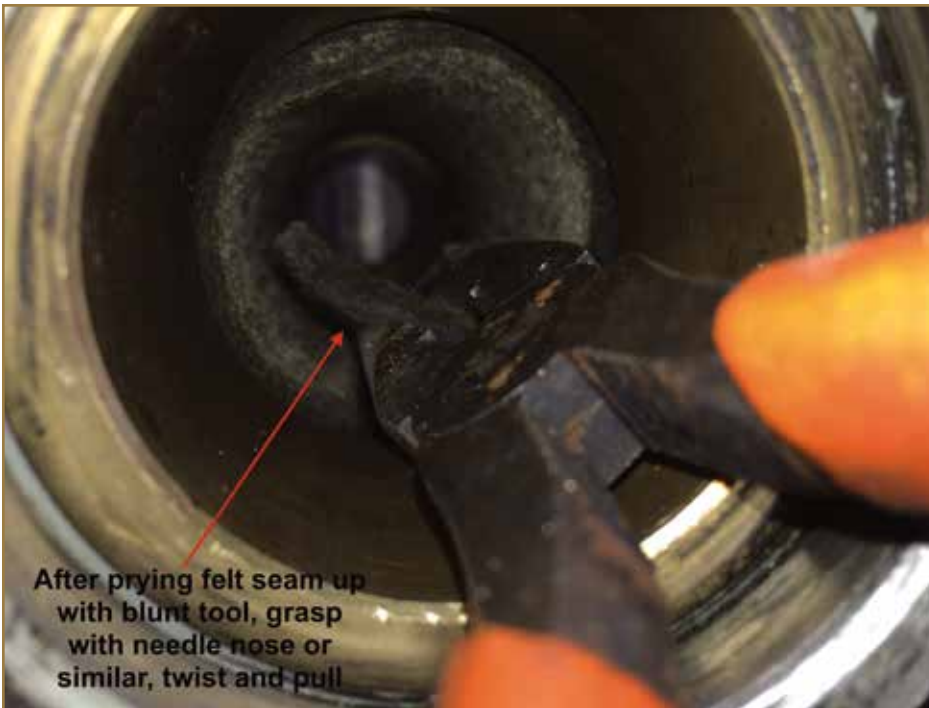
FIGURE 9

After prying felt seam up with blunt tool, grasp with needle nose or similar, twist and pull

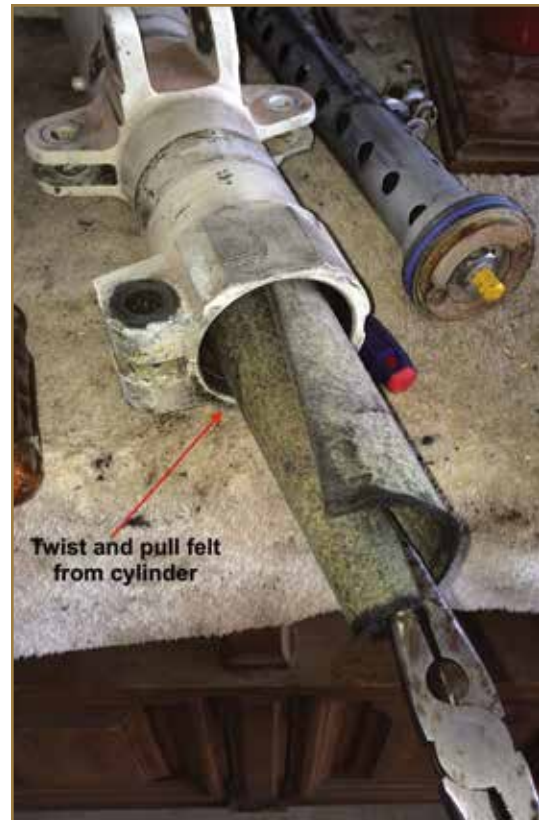
FIGURE 10

Twist and pull felt from cylinder

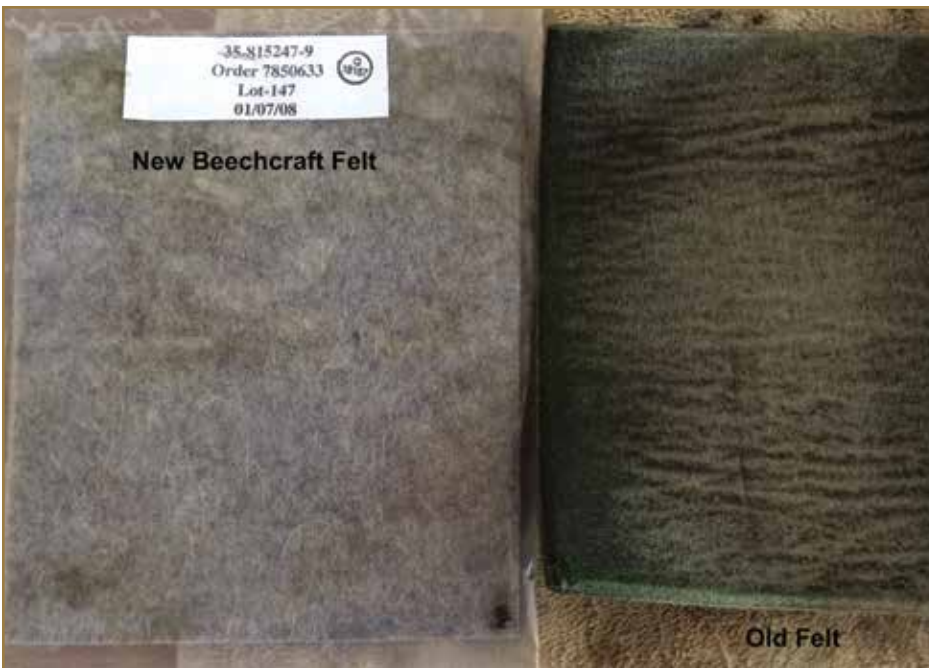
FIGURE 11

-35-815247-9
Order 7850633
Lot-147
01/07/08

New Beechcraft Felt

Old Felt

options from WW Grainger might be viable: P/N 2FHG2 or 2DAH9 (SAE Grade F1, which is highest wiping grade), which looks to be about \$12 for a 12" x 12" sheet. Depending on your mechanic's opinion of your felt's condition, you may not need to replace it. But personally, I'd like to see these go another 50 years before

they need to be touched again, so I replaced mine. Use of 10W-30 oil is noted in the manual for soaking the new felt prior to reinsertion. Don't over-soak the felt or you risk it swelling, and that would be problematic. I gauged the amount of oil on the old one and soaked to approximately that level.

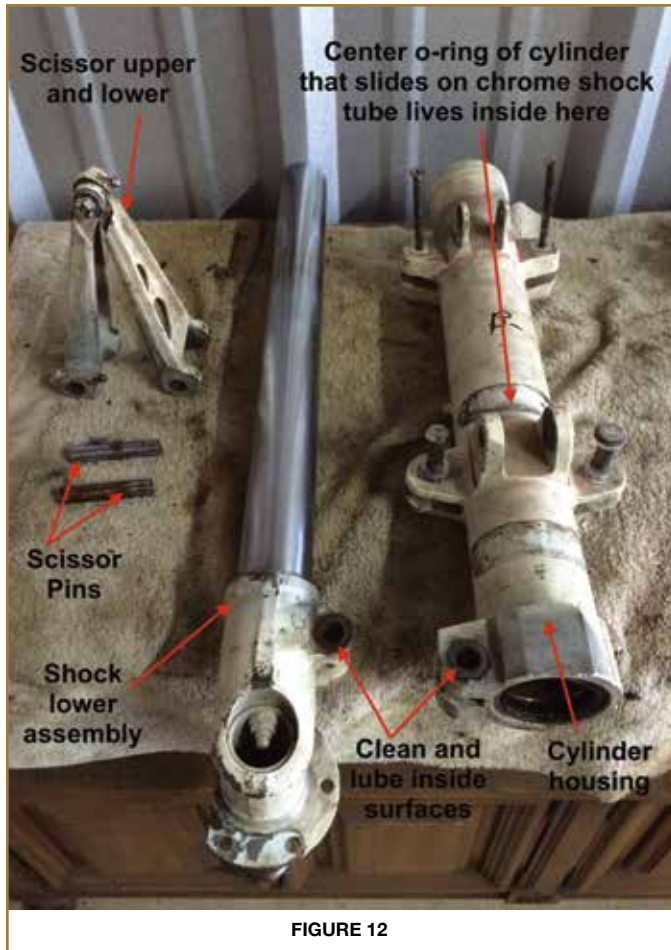
FIGURE 12

The time had come for what seemed to me to be the toughest part of this rebuild: the removal of the O-ring that lies about midway in the center of the cylinder (**Figure 12**).

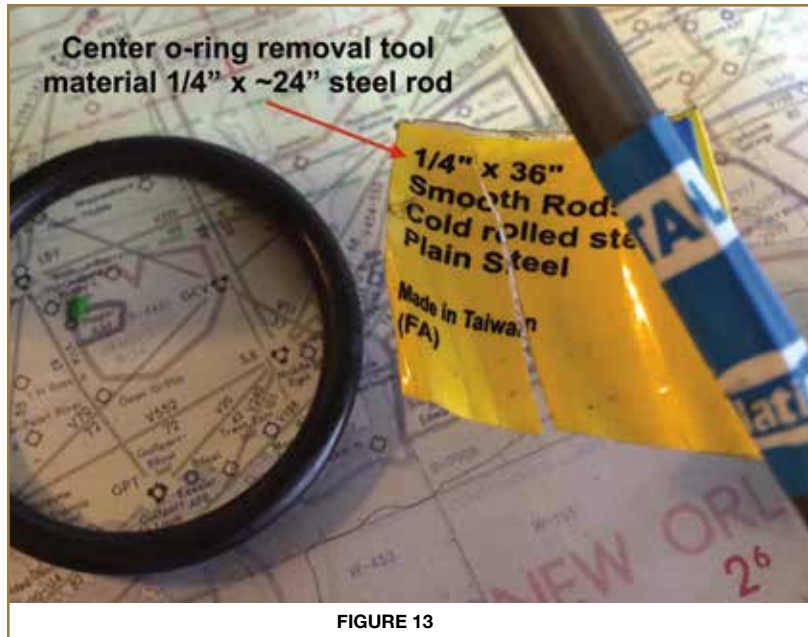
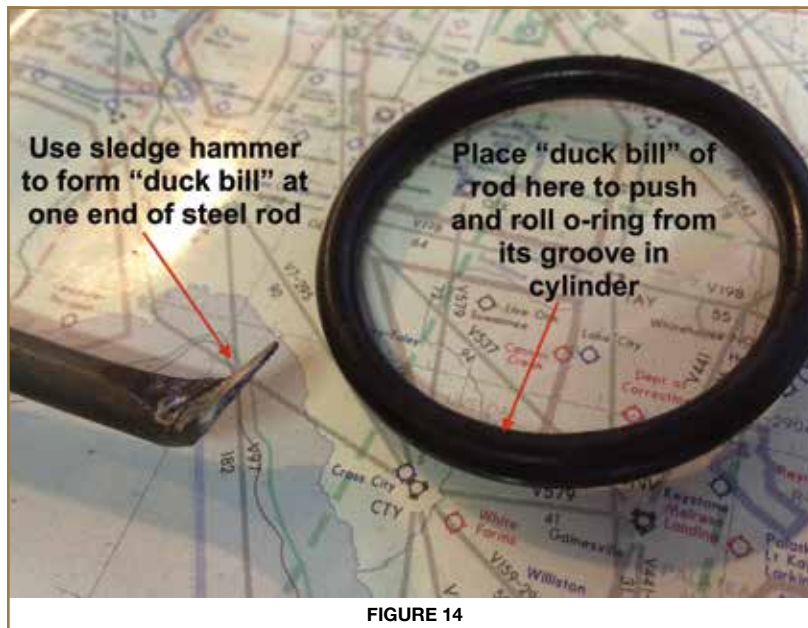
FIGURE 13

To accomplish this, a special tool with significant rigidity and a “duckbill” end needed to be fabricated to allow for the extraction of the O-ring from within its groove down in the barrel. **Figures 13** and **14** show the tool that was fabricated from approximately 24" length of 1/4" diameter steel rod. Pounding the end of the rod into submission with a short-handled sledgehammer formed the “duckbill” shape and angle necessary. The 1/4" rod is rigid enough to allow you to get onto the old O-ring and pull up on it to extract it. Smaller diameters just bent when trying to pry the O-ring up and out. **Figure 15** shows what appears to be a crack in the old O-ring and the makings of current difficulties or difficulties in the near future. The new O-ring is helped into place with a wooden dowel to avoid any scratching of the inner barrel.

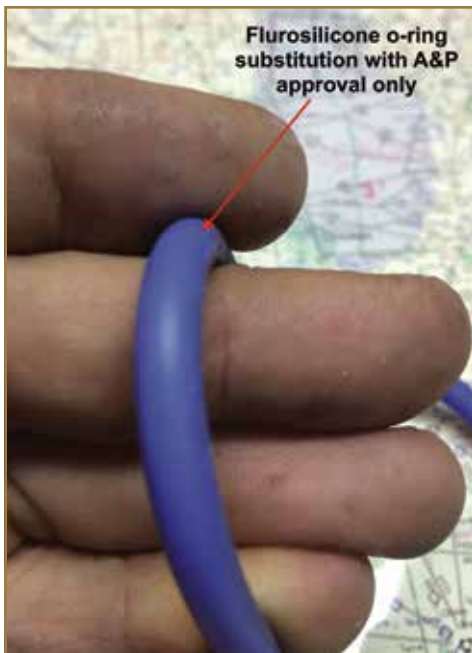
FIGURE 16

Given the good experience we have had with fluoro-silicone O-rings in other applications, my mechanic approved for use the fluoro-silicone versions of the two O-rings for each of the struts (**Figure 16**). The

fluorosilicone O-ring prefix designation is M25988/1-XXX where "XXX" is the O-ring size designation.
