DYNAMIC BRAKE RELAY ELECTRICAL FUNCTION & CONNECTIONS

DYNAMIC BRAKE RELAY REMOVAL. MAINTENANCE AND REINSTALLATION

DYNAMIC BRAKE RELAY ADDENDUM 1 - June 2017

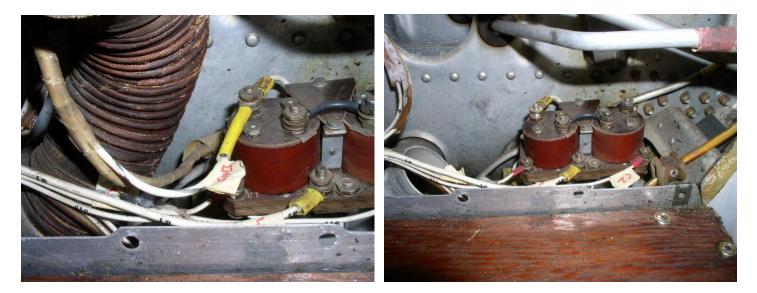
The dynamic brake relay is used with the Beechcraft 24 vdc airplanes (Travel Air, Baron and later Bonanzas) to control the high-amperage landing gear motor running and stopping circuits. This overcomes problems with other systems like those in Bonanzas that used only the limit microswitches to control the system directly. The microswitch contacts are unsuited to heavy currents and burn up with normal use, but the relay contacts are much more robust. Our relay was made by Cutler-Hammer in 1962 as p/n 6046H39A. The photos above show the relay as mounted under the right front passenger seat next to the flex heater duct (left) and more fully exposed with the duct and gear motor removed (right). Wiring to the relay connects the related aircraft power circuit breakers, limit switches and the landing gear motor itself.

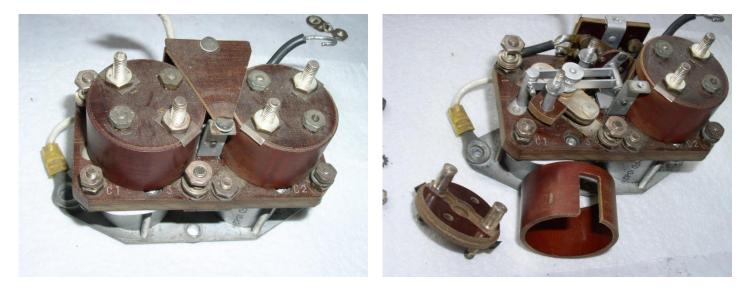
4. The heavy black jumper wire seen in the top photos must be removed from the inboard two top terminals (above left) to allow removal of the triangular shuttle switch cover and the individual cylindrical solenoid switch covers. Each circular solenoid switch assembly controls a gear up or gear down command from the landing gear handle. As shown, "up" is the left coil; "down" is the right. The photo above right shows the general arrangement of the shuttle switch and the contacts inside the solenoid switch assembly, including those inside the circular cap. The shuttle switch on the vertical bakelite piece between them at the back "latches" in the appropriate position to select either the "up" or "down" motor winding for the braking function when power is removed. When the gear is being raised the "down" motor winding is selected by the shuttle switch for braking, and vice versa. As shown, the switch is positioned for "gear down" without power applied to the relay. The shuttle switch arm is connecting the contacts from upper left to lower right.

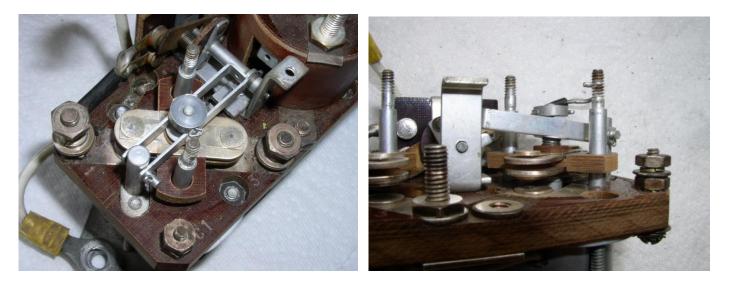
6. These photos show more clearly the upper relay contacts and the layout of the lever mechanism that moves the shuttle switch. The contacts exhibit some tarnish and pitting. Each lever is cushioned with a small spring so it only pulls down on the shuttle switch cam when its solenoid is activated. The cam pivot is seen at the hole through the vertical aluminum bracket in the upper right picture.

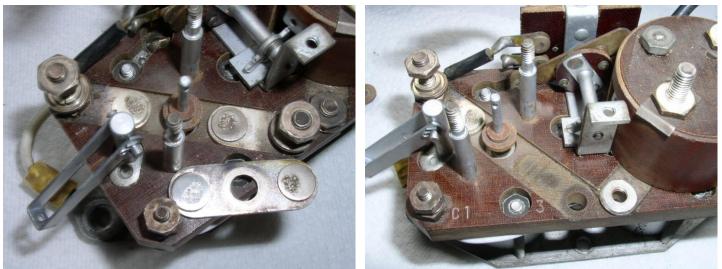
8. The lower contacts, shown above, can also be removed to remove pits and polish the surfaces. Simply remove the nuts from the mounting plate securing the contact (a screw from beneath serves as the threaded stud. – see addendum 1.) As shown at right, each lower contact segment sits in a machined groove and is easily removed. *NOTE: Pitting on the upper contacts to this extent WILL cause dynamic braking problems and is not acceptable.* All the contact plates and nuts are silver plated and are subject to tarnishing, as can be seen, but they polish up very well using fine files, mild abrasives or chemical means.

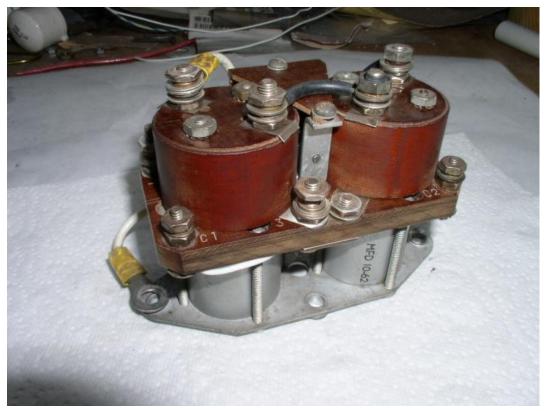
- 11. Reassembly was essentially the reverse process, with careful reference to photographs to arrange washers, springs and other small items in their original configuration. The most tedious part of the process is replacing the tiny washers and spring under each solenoid lever, and then inserting the cotter pins into the small metal buttons. The pins fit rather tightly so if the holes aren't well aligned or the cotters aren't straight the cotters won't go in. Double-check that the shuttle switch is placed in the gear down position, with the contact pivot running from upper left contact to the lower right contact (roughly 10 o'clock to 4 o'clock) as seen at the top of the lower photo on the previous page.

The wiring can be reconnected to the relay either after the relay is mounted back in its tray in the airplane, or beforehand with the relay on the cabin floor just aft of its under-seat location. Clean all the wire terminals. Before mounting the relay in the tray it's a good idea to clean the area of the debris that always accumulates, and be sure to clean the ground connections. Access in the mounted position is poor and if a nut or washer is dropped into the underfloor area it may be hard to find without removing everything again. A small cloth laid underneath will help avoid losing dropped items. The photos on the previous page show the locations and engraved markings of the terminal connections. The next annotated photo shows which functions are connected to each terminal.

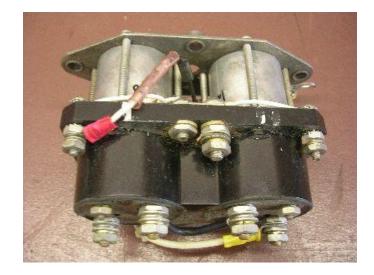
Cutler-Hammer (Eaton) SM50D7 (used on F33A series with numerous SDR write-ups.) Very similar design using a plastic housing for the contacts, as shown at right.

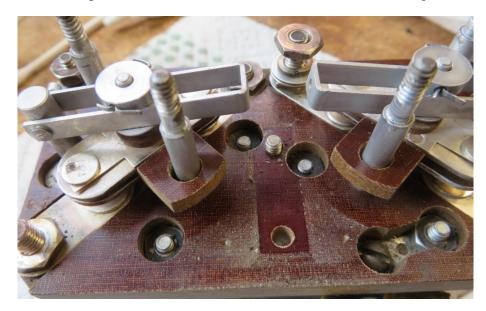
The shuttle switch footprint is seen below after removal with its 2 mounting screw holes.

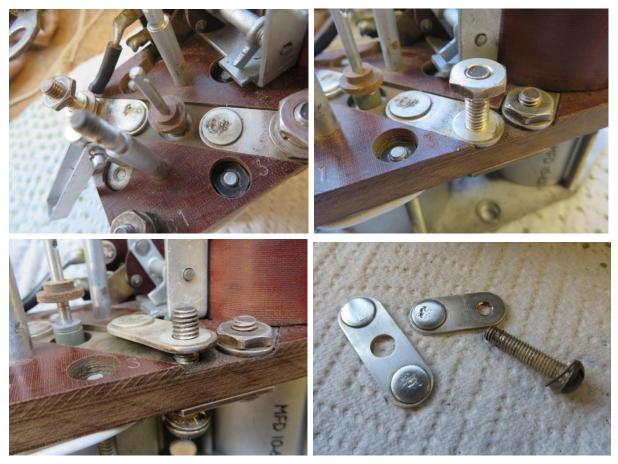
3. The lower fixed contacts shown earlier are easily removed for cleaning as shown below. The first photo shows the pitted contacts before removal. First take off the contact nut (top right photo), then loosen the attaching screw from beneath the base plate. The screw threads into the contact itself, shown lower left. The final photo shows the lower fixed contact after cleaning next to its mounting screw, and the mating movable lower contact plate to the left.
