## Wing Root & Landing Gear Door Seal Replacement

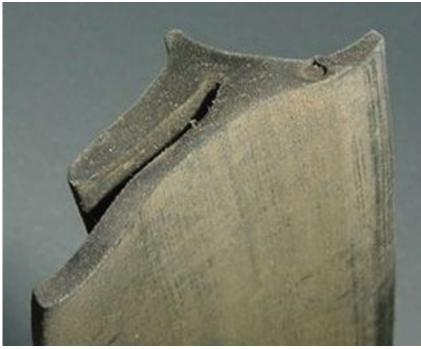
Figure 1

One of the oldest original components remaining on my Baron (and likely other members planes) was surely the stiff and ragged wing root seal. In researching this component I learned that the wing root and tail seals were installed on the wings and tails before the marriage to the airframe. What lies below the top skin of the wing and tail is a length of rubber "finger" (Figure 1) as an integral part of the seal.

This "finger" holds the seal in place and was likely glued at the factory, grabbing the backside of the wing and tail skin. With time and age these original rubber seals have taken quite a beating. With an extended winter annual downtime this year I chose to tackle this really tedious project while waiting for other components that were out for overhaul. A word of caution, this is as tedious as it gets if you choose to dig out the finger from below the top surface skins using the very narrow gap between the skin and the fuselage.

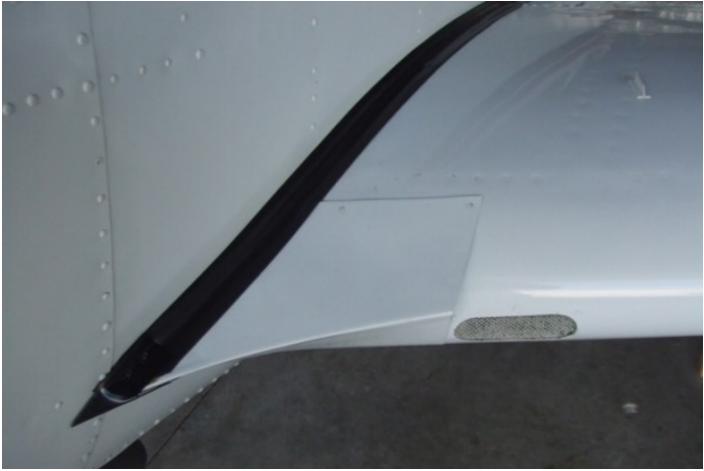
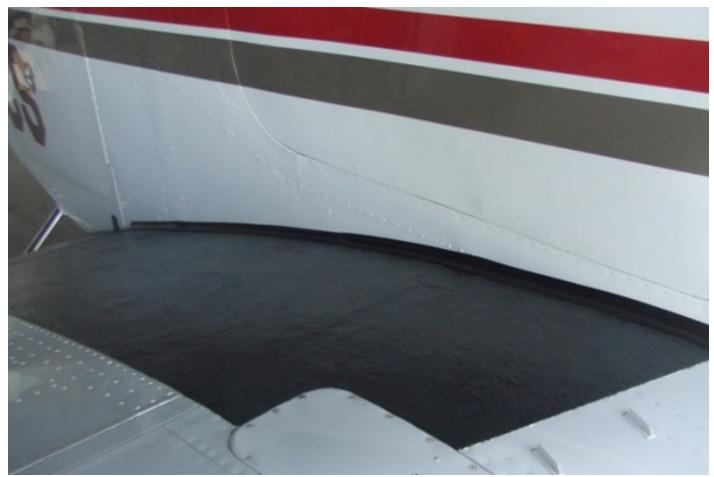
the old glue using MEK. (Caution: MEK fumes can damage acrylic aircraft windows so use with care and in a well ventilated area or use an alternative adhesive remover like Goof Off, Citrasafe or Peerco 321) Now for the fun part - installing the new seals. From what I had read I was dreading this, but it went very well. I used Go-Jo hand cleaner for a lubricant, and was able to install both root seals without having to cut off the lip as some have suggested. The seal, when lubed with Go-Jo will fit in the narrowest of gaps using a little elbow grease. Just lubed it up, put the lip between the wing and fuselage, and using my fingers, was able to push the seal in to place. Again, nowhere did I have to cut off the lip, except over the wing attach fittings. When the seal was in place, I cleaned the seal and wing skin with a mild solvent to get the Go-Jo off, as well as to generally clean up the rubber. Then using masking tape to mask off areas where I didn't want to apply glue, I applied contact cement on the wing skin and rubber, and once dry, pressed it down for a good flat seal. It really looks great. Go-Jo is VERY slippery, and it worked extremely well as a rubber lubricant." Figure 2 and 3 show the seal installation results achievable using this method.

"I cut the majority of the old seal off using razor blade, leaving a small lip sticking above the wing. I then used a small pick bent at a 90 degree angle, with about a 3/8" 'hook' on the end. Using the hook, I stuck it under the wing skin, between the skin and the old rubber wing seal lip under the skin, and forced it along the chord of the wing. This broke the rubber lip on the under side of the wing skin free from the wing. Then I fished out the rubber pieces that were now broken free. Once all of the old rubber was off, I cleaned up

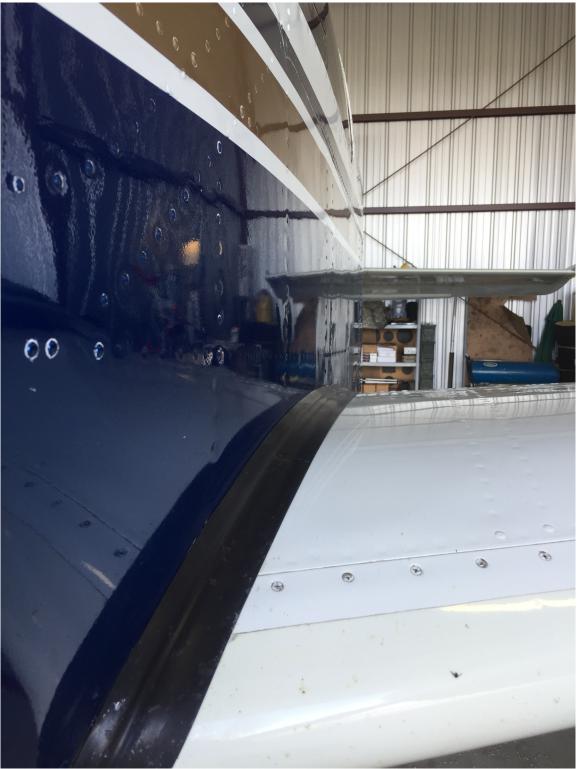
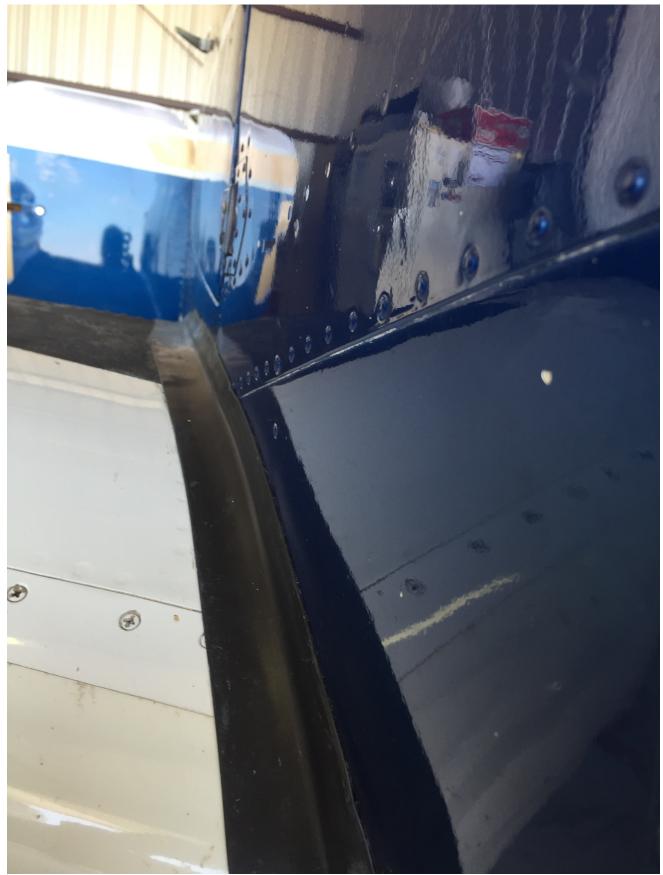
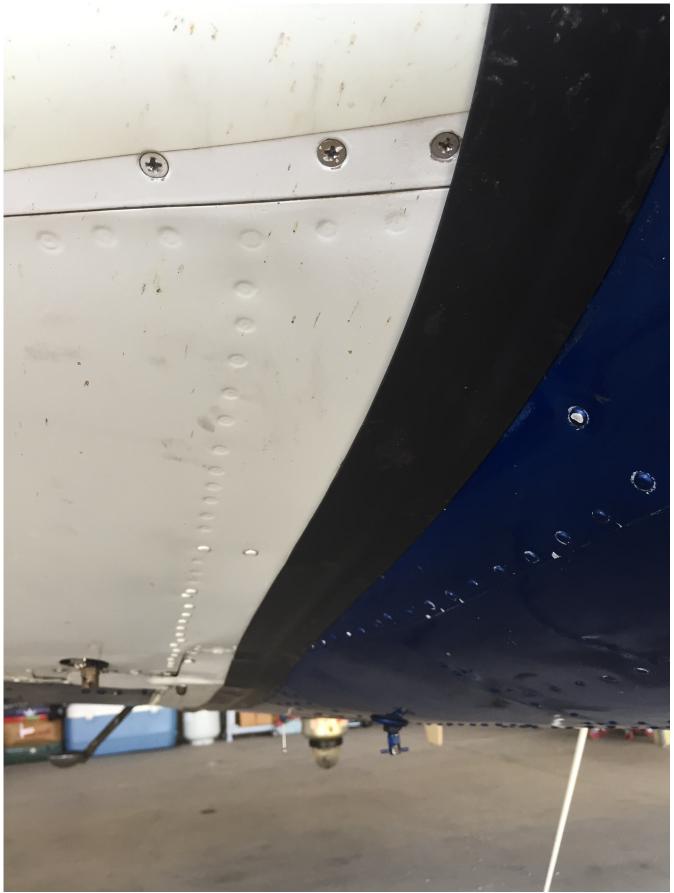
Figure 4

The Gee Bee supplied adhesive is a two-part silicone cement that is extremely strong after the catalyst is added and the adhesive begins to cure and develop "legs". Figures 4, 5 and 6 show the results of my silicone wing root seal install.

Now for my shortcut confession, granted, the picking of the underside "finger" off the underside of the wing skin using 90\* picks is truly the best way to go, however, in the interest of the time I had available, I chose to cut my old seal off with a razor at the top wing skin and leave the old "finger" in place while removing all the old adhesive from the top skin areas. I then carefully cut the finger from the new silicone seal and set about to glue the seal to the wing skin. I did not apply any glue to the section of seal that lies up against the fuselage as this piece of the seal is "snappy" and wants to naturally press against the fuselage.

The underside was a little more time consuming because gravity was working against me which required allowing the cement to cure on about six inches at a time before moving on to cementing the next section.

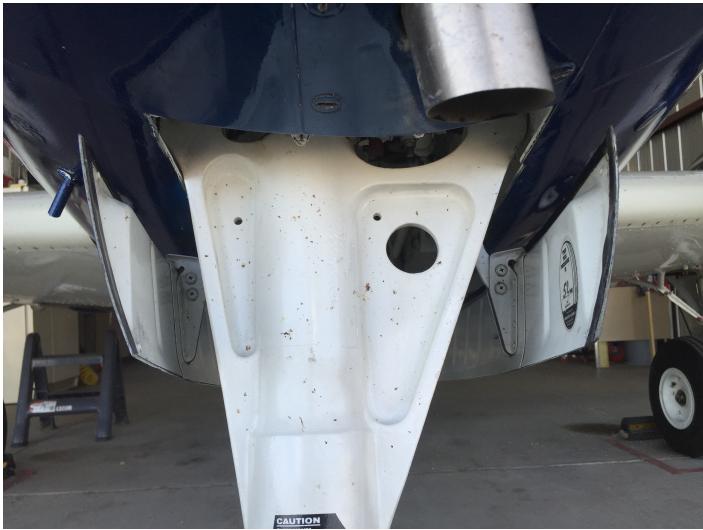
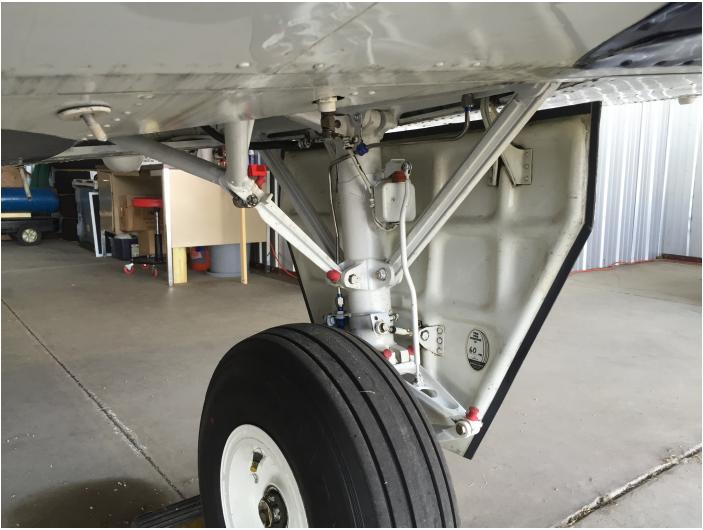
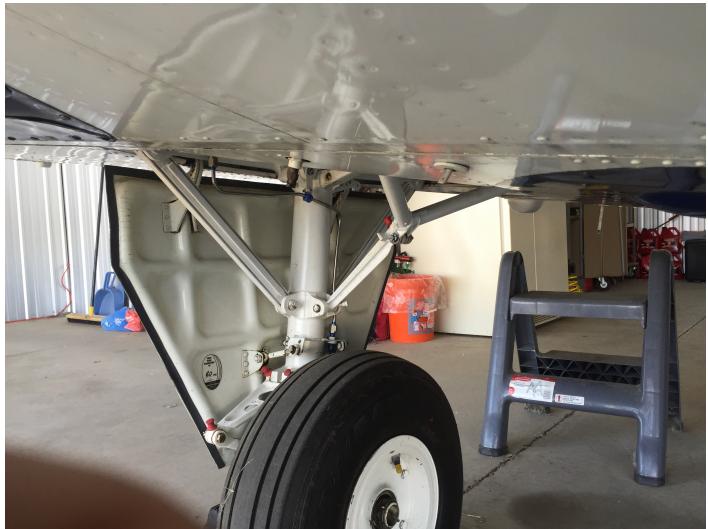
Figure 7

Figures 7, 8 and 9 show my landing gear door seal install results. I took an unconventional approach on the main gear doors by applying the seals to the doors as opposed to the much narrower ledge in the airframe. My reasoning was that there was much more surface area to grab onto by using the door edge surfaces.

After tackling my wing root seals I moved on to my landing gear door seals, again from Gee Bee in silicone material using the same aggressive two-part clear silicone cement. The main gear door seals sell for \$55 and the nose gear seal kit is \$35. These seals prevent metal-to-metal chaffing of the gear doors on the airframe. Clean surfaces are absolutely essential for proper adhesion of any seal materials to our airframes and the previously mentioned adhesive removal products do a great job. It's worth mentioning that while Peerco 321 is highly touted by many, it is only available in gallon cans at ~\$100/gallon. On request Gee Bee will provide 16oz portions of Peerco for \$35. PS: you'd be well advised to use the gloves when applying the clear silicone cement provided.

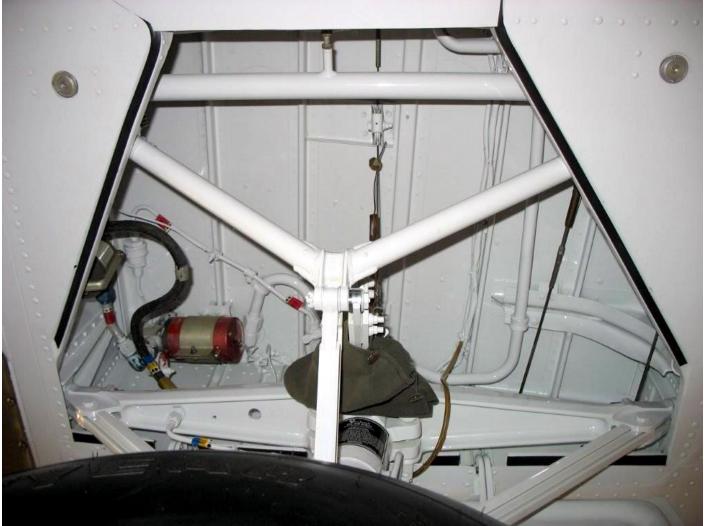
Figure 10 depicts a main gear well with the seals applied to the wing underside edges.
