ELECTRICAL PROBLEMS

Troubleshooting fuel gauge(s) & associated components.

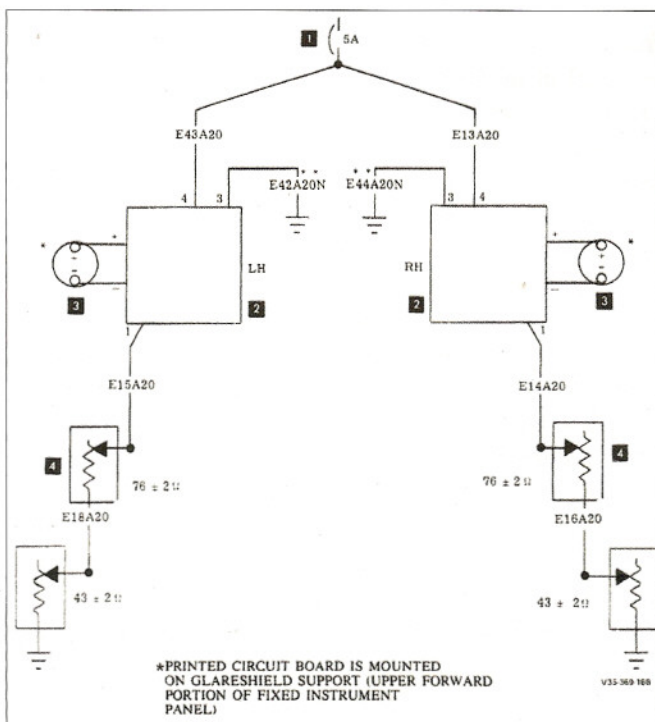
Figure 6 - Fuel indicating D9569-D9817

The inboard fuel transmitter has a felt washer under the case to isolate it from ground. If this is missing, the case will be grounded and the tank will never read above 2/3. If the outboard transmitter is shorted internally, it will cause the same symptom.

removed from the inboard fuel transmitter, the gauge should read above full. With the wire shorted to ground, the gauge should read empty.

You can troubleshoot the transmitters by removing the inspection panels. Remove the wires attached to both the transmitter posts and make sure the outboard wire is not grounded to the airframe or you will get a false ground reading on the case of the inboard transmitter. With the wire
