Safety Communique

December, 2010

SUBJECT: FLAP ACTUATOR ATTACHMENT BRACKET AND NOSE RIB ASSEMBLY

Safety Communiqué No. 313

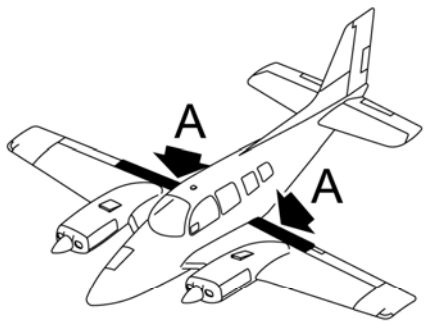
BARON SHOWN, OTHER MODELS SIMILAR

HBC has received ten reports from the field of crack damage on the part number (P/N) 35-165050-84 nose rib assembly for the flap actuator attachment bracket. Refer to Figure 1. In October 2007, a pilot reported a split flap condition during flap extension to a 14 CFR Part 145 repair station. The repair station found the flap actuator mounting plate cracked. The mounting plate is secured to the flap by three screws, which are attached to the nose rib assembly by nutplates. Further inspection of the flap revealed cracks in this nose rib. Since the repair station regularly performed inspections on several models of HBC airplanes, they began paying particular attention during inspections to these areas and submitted six service difficulty reports on Model 33, 35, 36, and 95 airplanes. In January 2008, Advisory Circular 43-16A was issued detailing these reports. The flap actuator mounting is of similar design on all of the reported airplanes. Through May 2010, this repair station addressed four additional service difficulty reports for cracks found on the same part number nose rib assembly.

HBC reminds maintenance facilities of the importance of adhering to existing inspection and maintenance procedures in the applicable airplane series Maintenance Manual or Shop Manual and specified spare parts in the applicable Illustrated Parts Catalog when replacing components during routine maintenance.

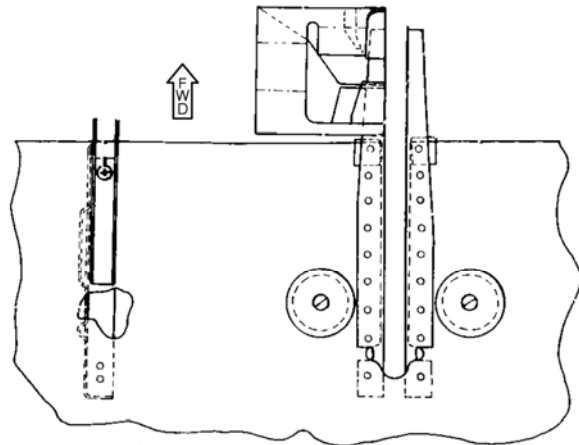
VIEW LOOKING DOWN ON FORWARD EDGE OF FLAP

Flap leading edge nose rib and/or the flap actuator mounting bracket cracking has the potential to cause the part to become disconnected, and could result in a split flap condition.

AREA OF POTENTIAL CRACKS
DETAIL B
