From: Savvy Aviation support@savvyaviation.com
Subject: Melted Piston
Date: January 25, 2022 at 2:00 PM
To: [REDACTED]

The aluminum in the oil filter clearly came from the #1 piston, so why was Roy's shop so intent on tearing down the engine?

Melted Piston

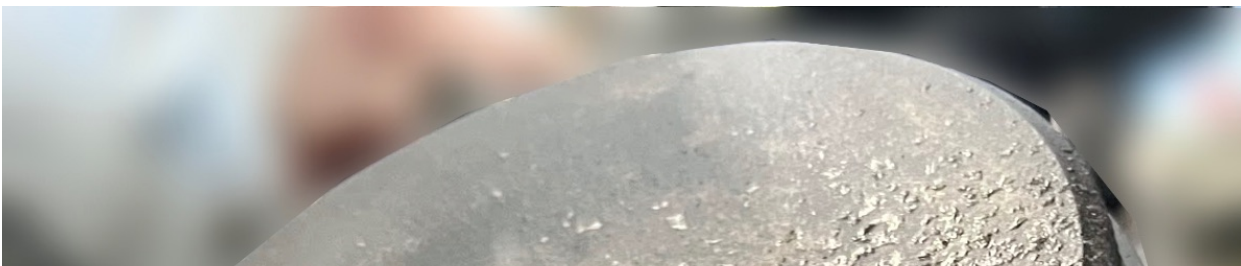
"A borescope inspection of right engine cylinder #1 revealed scoring of the cylinder walls and some corner melting of the piston," Roy continued. "The shop asked for permission to pull the cylinder, which I approved since it seemed obvious that this needed to be done."
