# AD 90-08-14/95-04-03

ABS Air Safety Foundation Spar Web Investigation  
Overview Information  
August 17, 2010

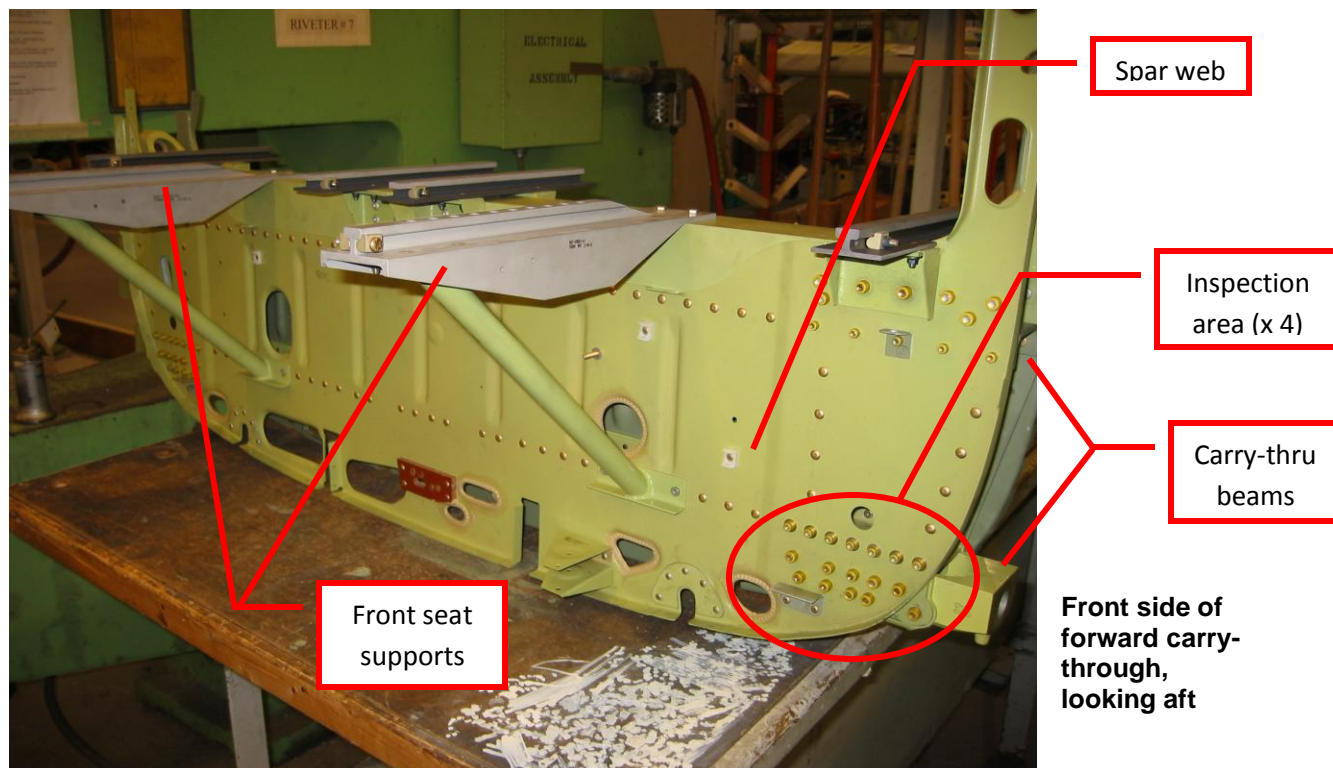
Visualize two I-beams, one above the other. Bolt a thin, flat piece of metal on the front and back of each I-beam, so all together the beams and flat plates form a box. The I-beams are the main wing spar structure as it goes through the airplane's center section. The flat plates are the spar web.

Affected airplanes must receive dye penetrant inspections for cracks in the four lower, outboard areas of the forward carry-thru spar web (two areas each on the forward and aft side of the carry-thru) following this schedule in accordance with MSBs 2269 rev. 1 and 2360:
