ELECTROLUMINOUS PANELS

I often receive requests for troubleshooting assistance with the electroluminescent subpanel lights. These are the backlighting for the subpanel CB and switch labels and are found on the 1970-and-later aircraft. The system consists of three or more subpanels with a built-in back lighting similar to fluorescent lighting. They require AC voltage to excite the lighting material sandwiched in the middle of the panel to produce light. The AC is generated by an inverter that produces up to 120 volts at 400 Hz.

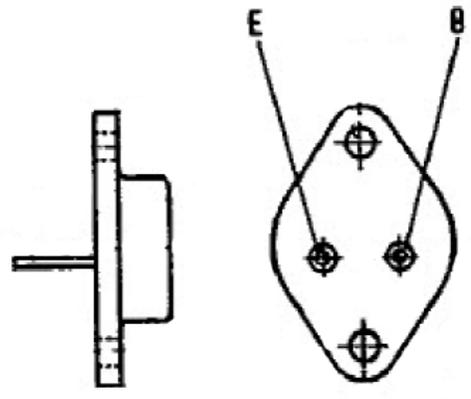
The transistor collector (labeled C) is electrically connected to the transistor case and should be at battery voltage for your aircraft. The transistor base (labeled B) should follow the voltage of the rheostat between battery voltage when full on and zero when full off. The transistor emitter (labeled E) is attached to the inverter circuit and should follow the base voltage less about a half a volt. See Figure 3 to determine which transistor lead is the base and which is the emitter.
