Replacing the internal Garmin GPS battery

The Problem: Some of us have had issues with the Garmin 296/396/496 not picking up the satellites after a week or two in the hangar. Mine failed to connect to the satellite after 30 minutes which prompted this exercise. Most of us agree it is the internal 3 Volt DC battery mounted to the circuit board that is at fault. Here are instructions on how to replace it ...

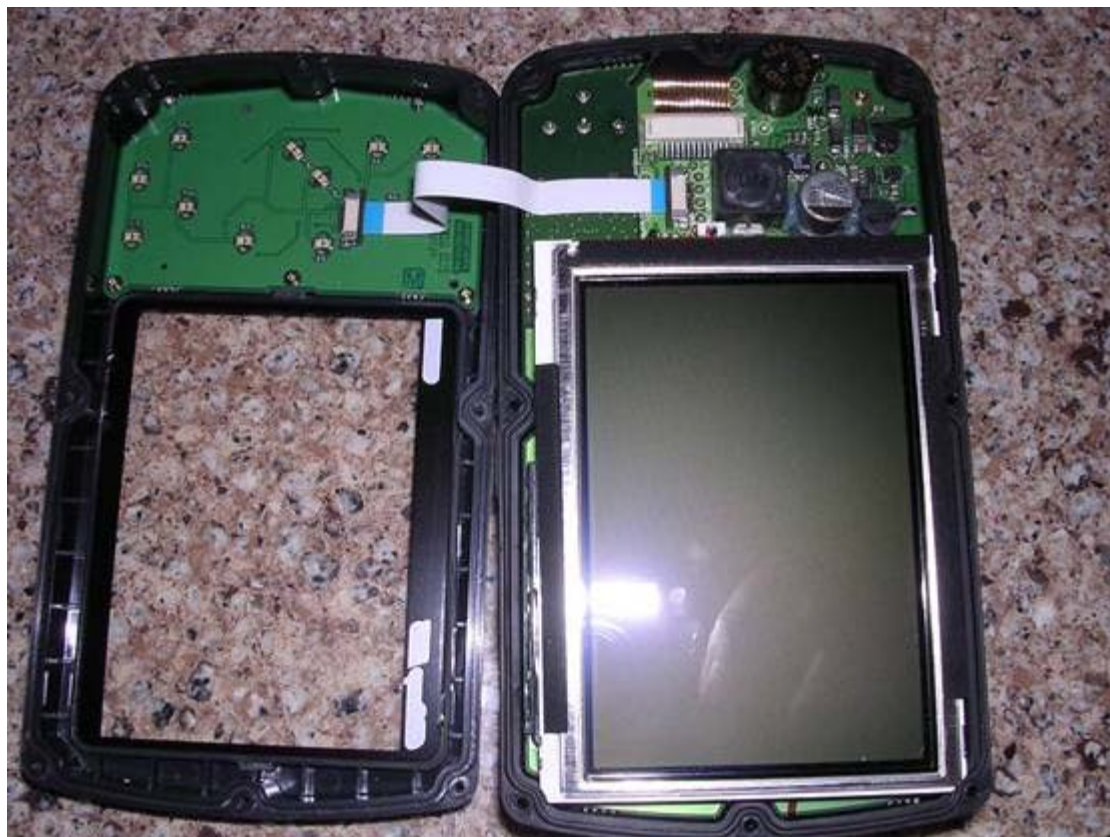
With halves apart you will find the following ...

Remove the white ribbon cable that goes top both halves by gently sliding it out of the slot on the "screen" half.

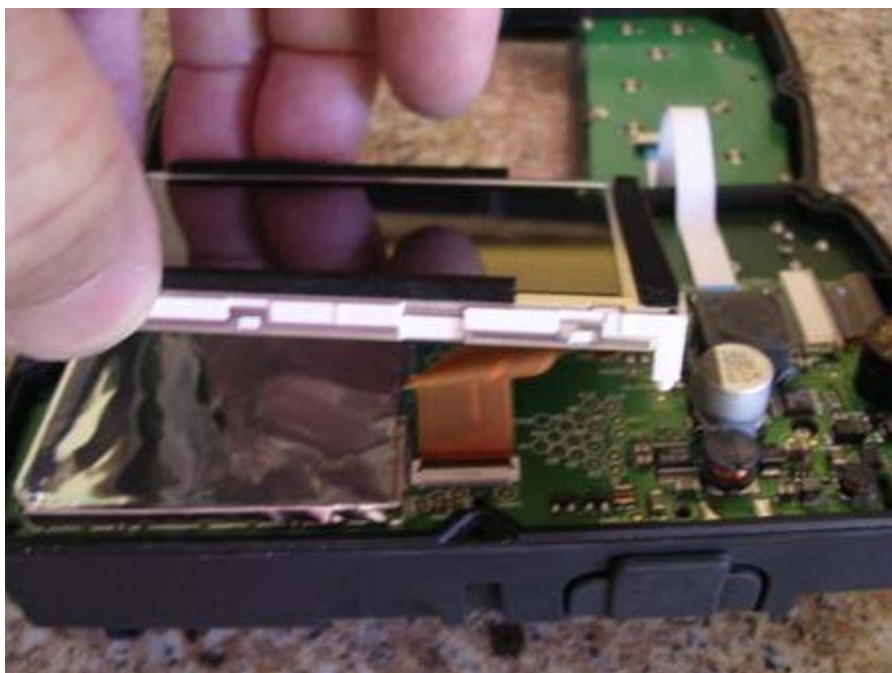
Next - gently lift the screen and take look at the ribbon cable & 2 wire connectors attached.

I left the copper colored ribbon in place, but you must remove the red & black "power" wire at the side. To remove this you must hold the base (connected to the board) while pulling the wire plug straight up with tweezers. Be careful or you will have to solder this part on also!

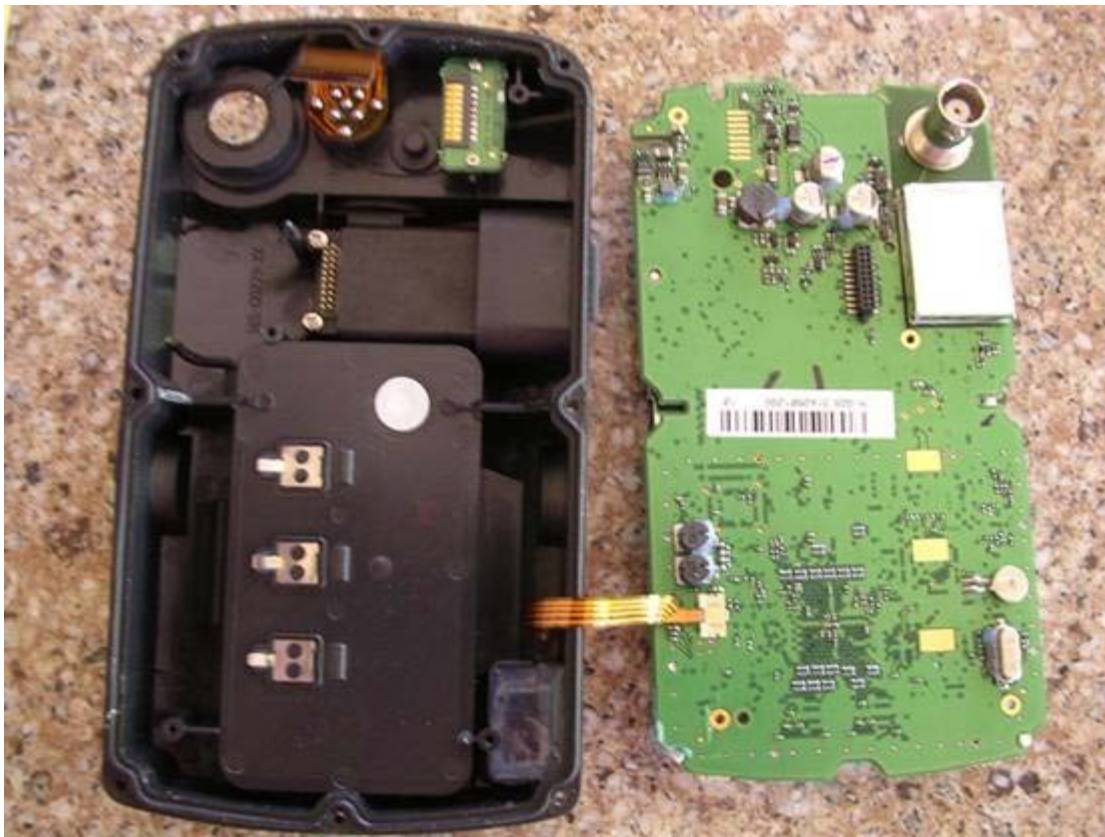
You are now ready to remove the screen/circuit board combo and get to the other side.
