We had wanted for some time to replace the ancient Narco VOR antenna mounted on the fuselage of our S35 with the modern blade style Nav antennas mounted on the aft fuselage. In fact, we had even run the wiring for the eventual installation when the interior panels were removed to replace the rest of the antenna wiring a few years ago. After the plane sat outside in the rain for three days during a trip this spring, we decided that we really needed a canopy cover, and if we were going to get a cover, we really should remove the old VOR antenna. Getting a cover can be expensive!

My Installation of Blade Style Navigation Antennas

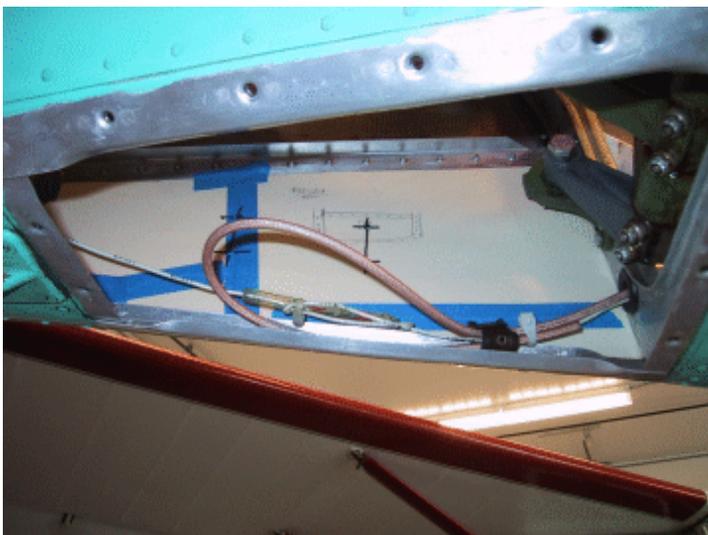
Figure 1.

Following the reasoning given by “Old Bob” in the sidebar, we attempted to locate the antenna elements as they are in the Mike Smith installations. A template placed inside the fuselage helped to make measurements and transfer them from side to side. (see Figure 1). Once a small pilot hole for the coax connector is drilled in the fuselage skin, the desired location relative to internal bulkheads and external rivet lines can be verified. Small adjustments can be made by filing the pilot hole until it is centered in the desired spot.

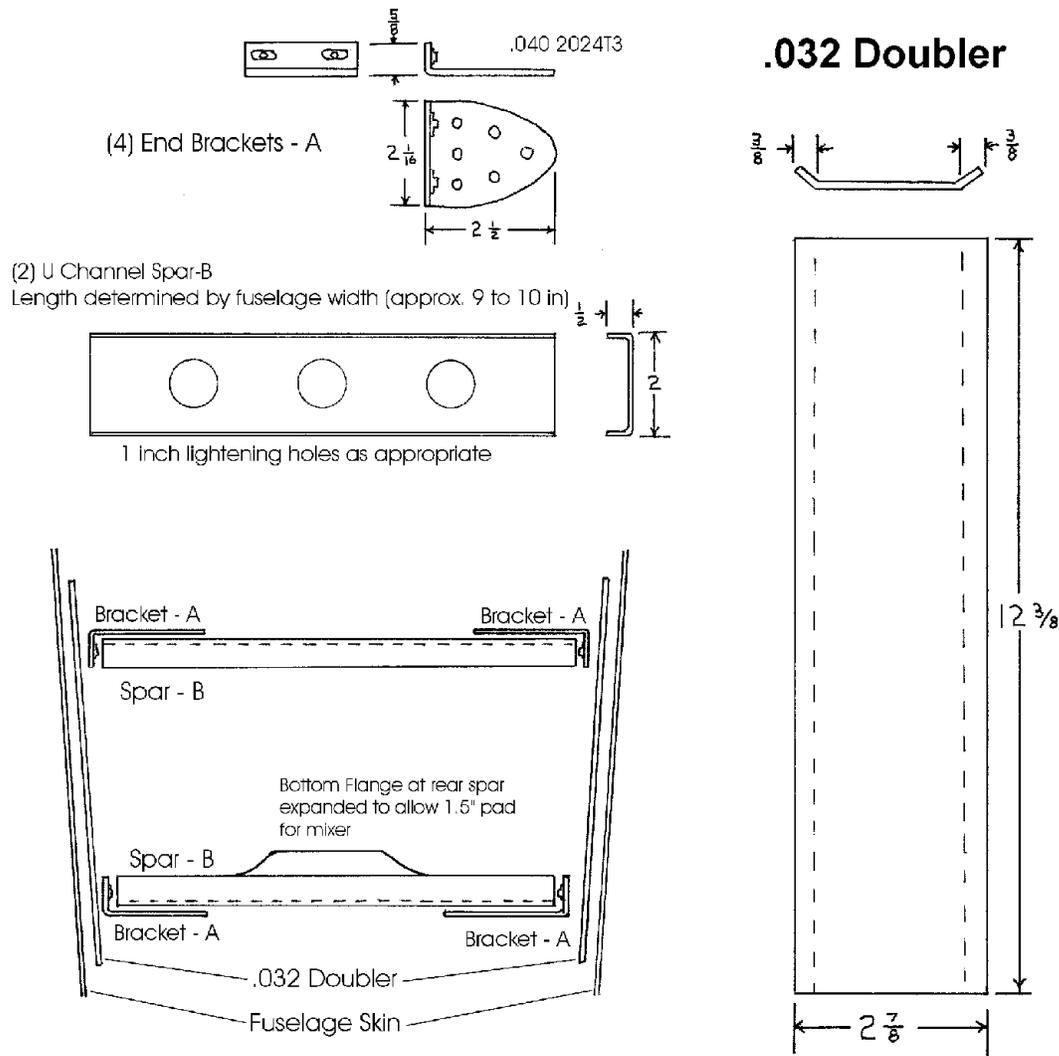
Based on the location of the holes that have been drilled in the fuselage skin, the length for the spars can be measured and the parts fabricated according to the sketch in Figure 2. The spars should be made slightly longer than required, as they can be trimmed later. Figure 3 shows the doublers, the spars, and the mounting brackets cut and bent to shape. At this point, we installed nut plates on the brackets in accordance with the dimensions supplied by the antenna manufacturer, and marked each bracket to ensure that it always went in the same location.

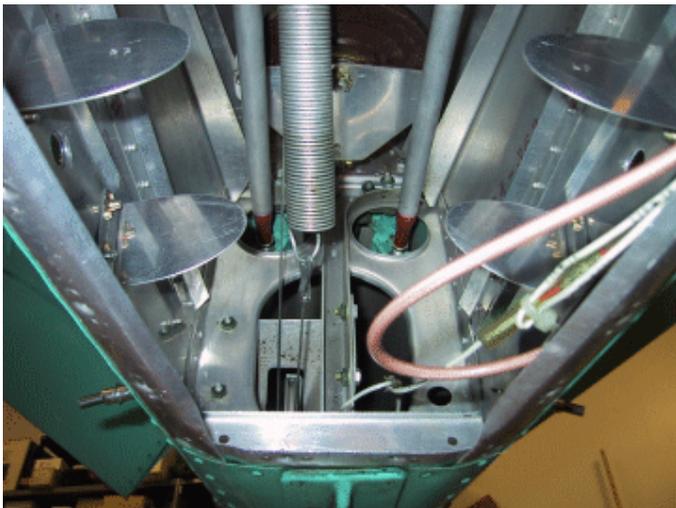
Figure 4 shows the brackets and doublers mounted to the inside of the fuselage skin, without the antenna elements, whose weight might slightly distort the fuselage skin. Once the brackets are bent to be perpendicular to the aircraft centerline, the spars can be trimmed to fit between the brackets. After trimming, we temporarily secured the rear spar to the brackets using clamps (Figure 5). With the spar clamped in the desired position, we drilled the rivet holes in the spar through the pilot holes on the brackets. Figure 6 shows the tight quarters for drilling that would have been avoided if we had marked the desired hole locations on the spar when it was clamped in position, and then removed the spar and drilled the pilot holes in it. As each hole was drilled, Clecos were installed to maintain the relative positioning of the brackets and spars. The rear spar with Clecos installed is shown in Figure 7. Note the shelf on the bottom of the rear spar for mounting the signal mixer supplied by the antenna manufacturer.

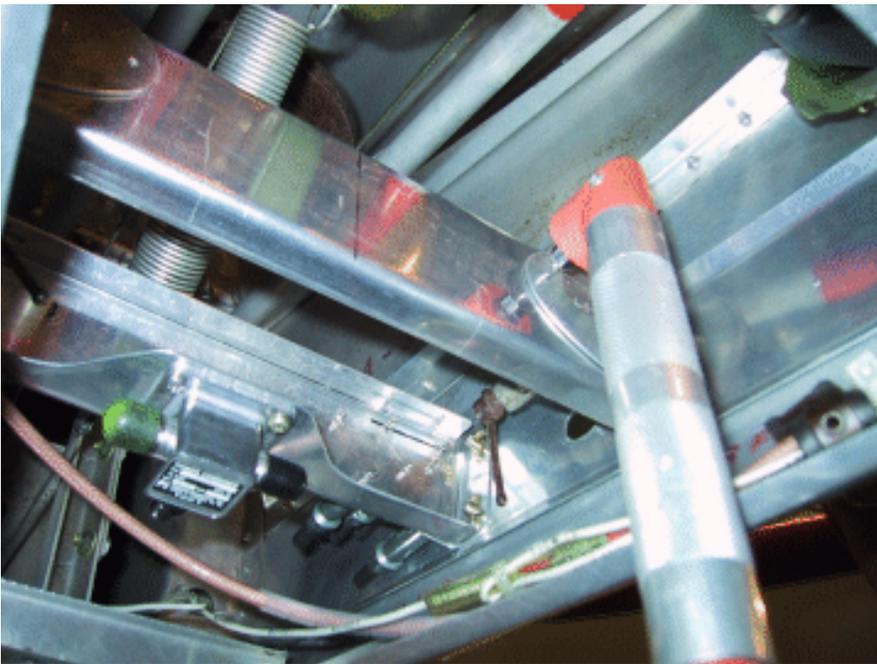
Figure 8

At this point, we removed the rear spar assembly, drilled the remaining rivet holes and secured the assembly with more Clecos. The rear spar assembly was then reinstalled before we drilled the rivet holes for the forward spar assembly. The rivet holes in the forward spar assembly were located and drilled following the same procedure used for the rear spar (Figure 8).

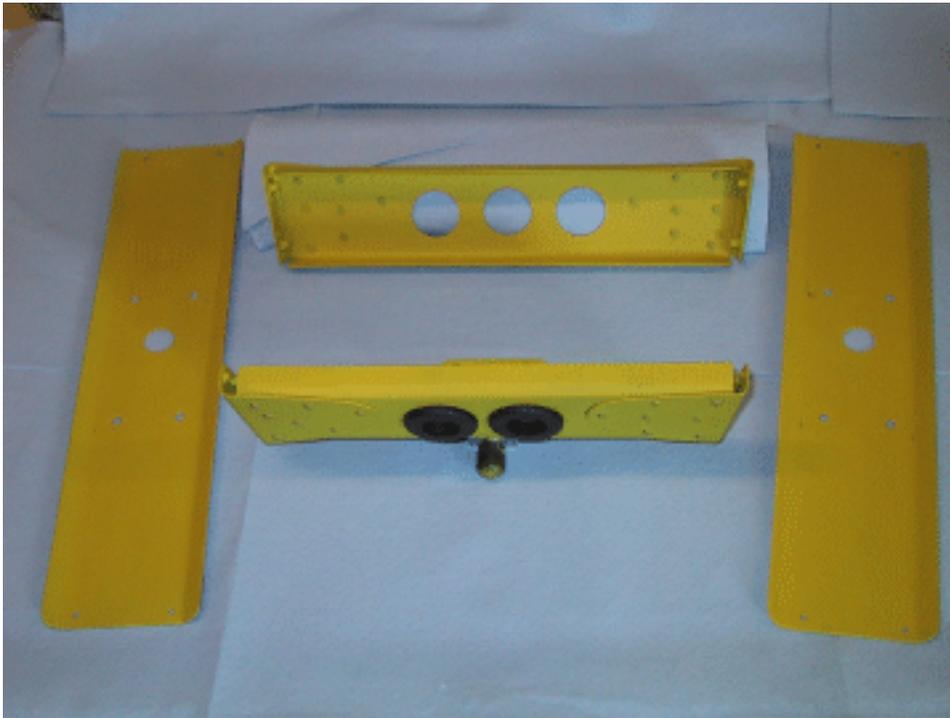
At this point, the lightening holes were drilled in the spars in locations that would not interfere with the brackets. The disassembled doublers, brackets and spars were then etched, treated with Alodine and given a few coats of zinc chromate primer. Since we planned to bond the doublers to the fuselage skin, the side of each doubler destined to be next to the skin was not painted. After we riveted the brackets to the spars, the spar assemblies were given a final coat of primer. Prior to the final assembly of the antenna system, the signal mixer was mounted to the rear spar and grommets were installed to allow the antenna leads to pass through the lightening holes. Figure 9 shows the parts ready for assembly.

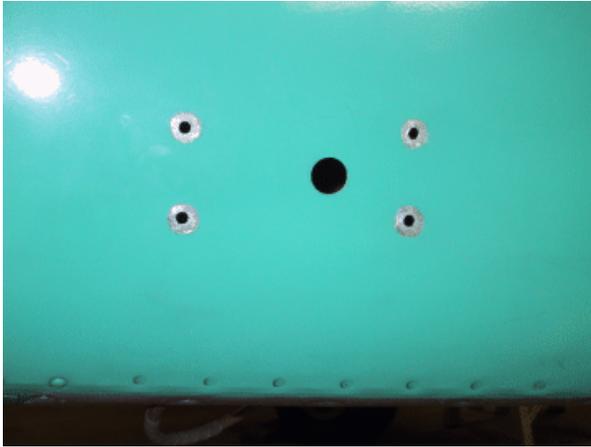
Figure 10

The manufacturer's installation instructions for the antenna specified that the antenna mounting screws have a good connection to airframe ground. To accomplish this, we removed the paint around the mounting holes on the outside fuselage skin (Figure 10) and used washers between the antenna and the skin to ensure good electrical contact in the area around the mounting holes not covered by a cork gasket. The exposed aluminum was treated with Alodine before assembly.

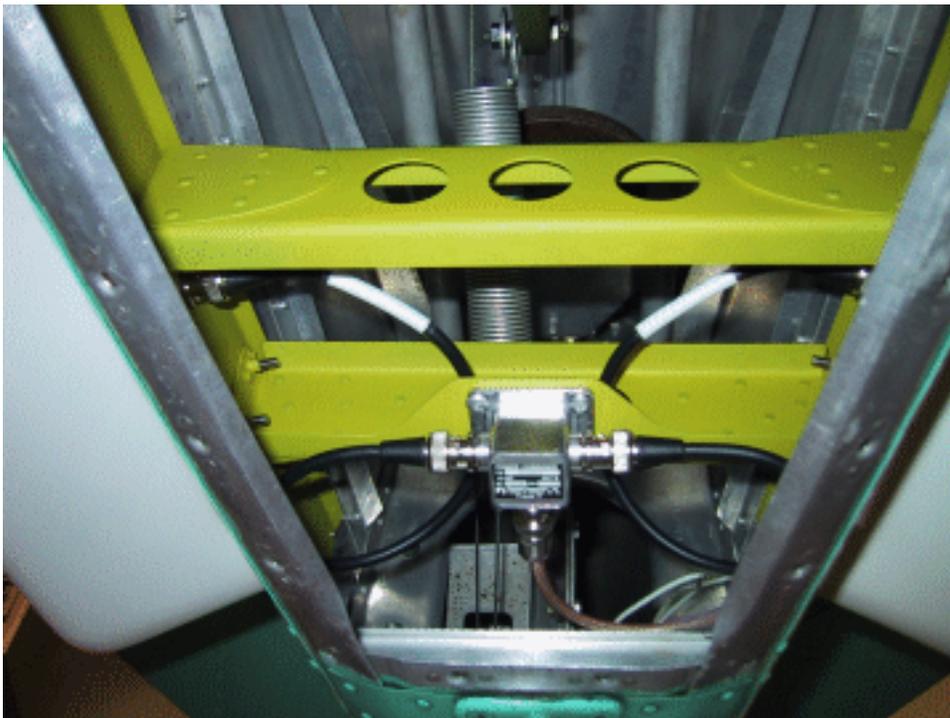
Figure 11

In order to minimize the possibility of trapping dirt and moisture between the doublers and the fuselage skin, the doublers were secured to the fuselage skin with Hysol EA 9309NA epoxy paste adhesive. This adhesive has a working time of 40 minutes, so we gathered all parts and tools together to be fully prepared for the final installation. We assembled everything without the adhesive for a final check of fit. We then applied a thin layer of adhesive to the unpainted side of the doublers, secured the doublers to the fuselage skin with Clecos, and assembled the antenna elements and spar assemblies. After replacing each of the Clecos with a 3/32" rivet, all of the hard work was done. Figures 11 and 12 show the final installation of the antenna elements, doublers, and spars with the antenna wiring connected.

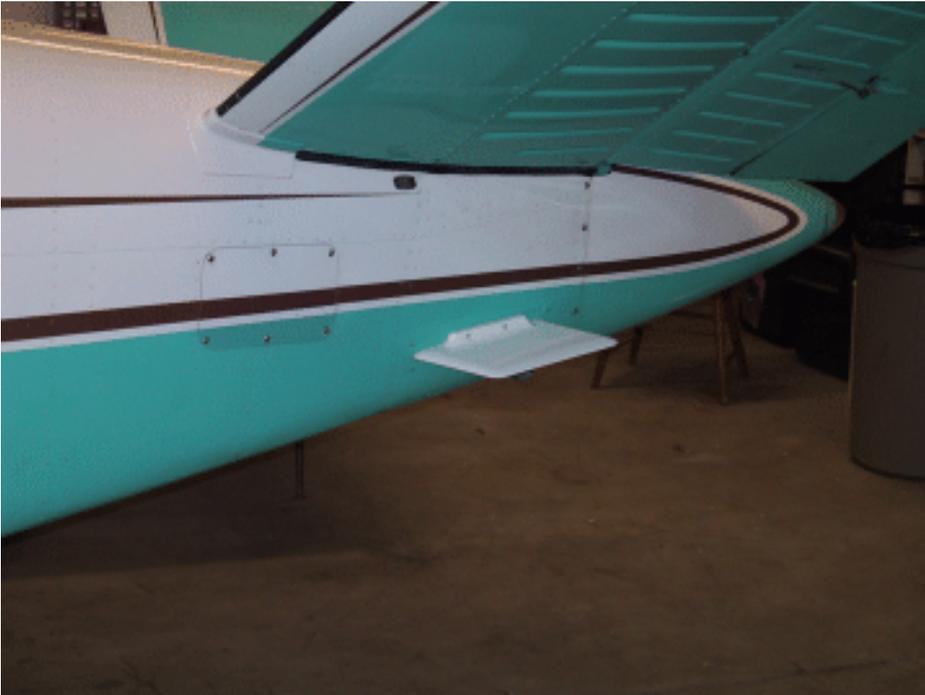
FAA inspector returned the airplane to IFR legal status. Figure 13 is a photo of the finished installation.

Following the antenna manufacturer's instructions regarding sealing around the base of the antenna elements with silicone sealant completed the installation. Replacing the inspection covers, completing the paperwork, and performing the testing requested by our
